L & L STRUCTURAL ENGINEERING SERVICES, INC.
SIX Q STREET
SOUTH PORTLAND, MAINE 04106
PHONE: (207) 767-4830
FAX: (207) 799-5432

BUILDING LOCATED AT
126/128 DANFORTH STREET
PORTLAND, MAINE
FRONT ENTRY REPAIR
SECTIONS AND DETAILS

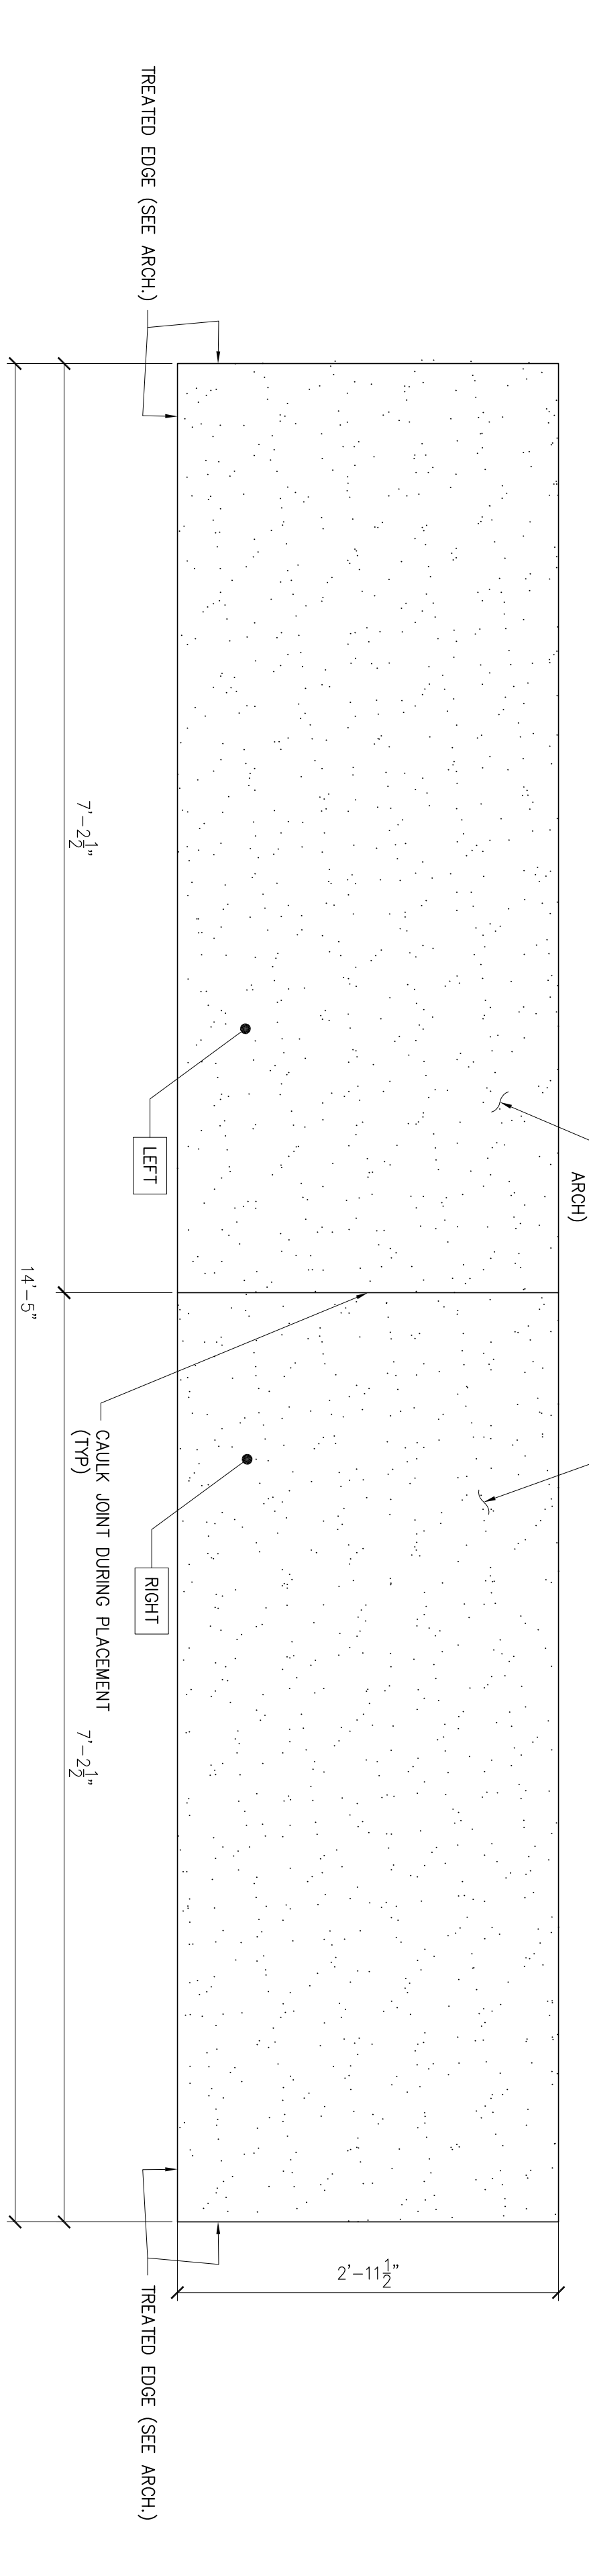
PIECE E - (GRANITE LANDING)

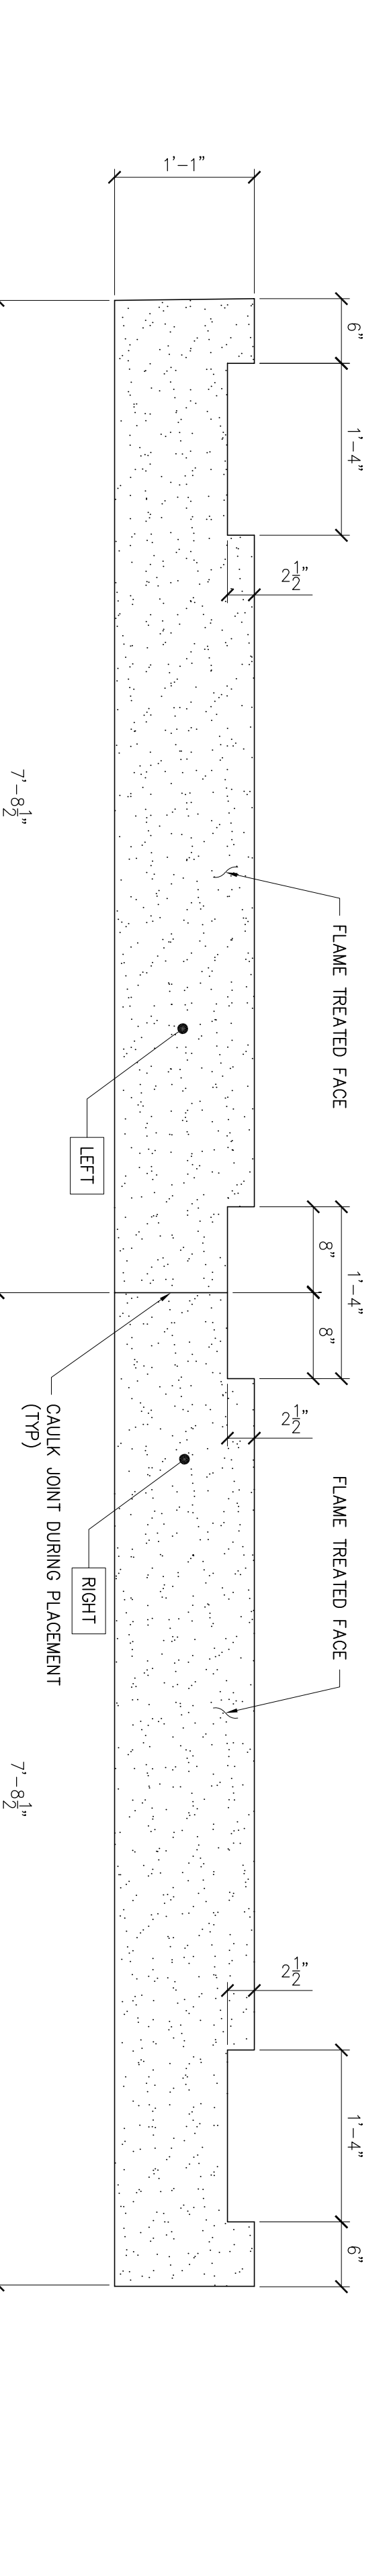
PIECE G - (GRANITE STEP)

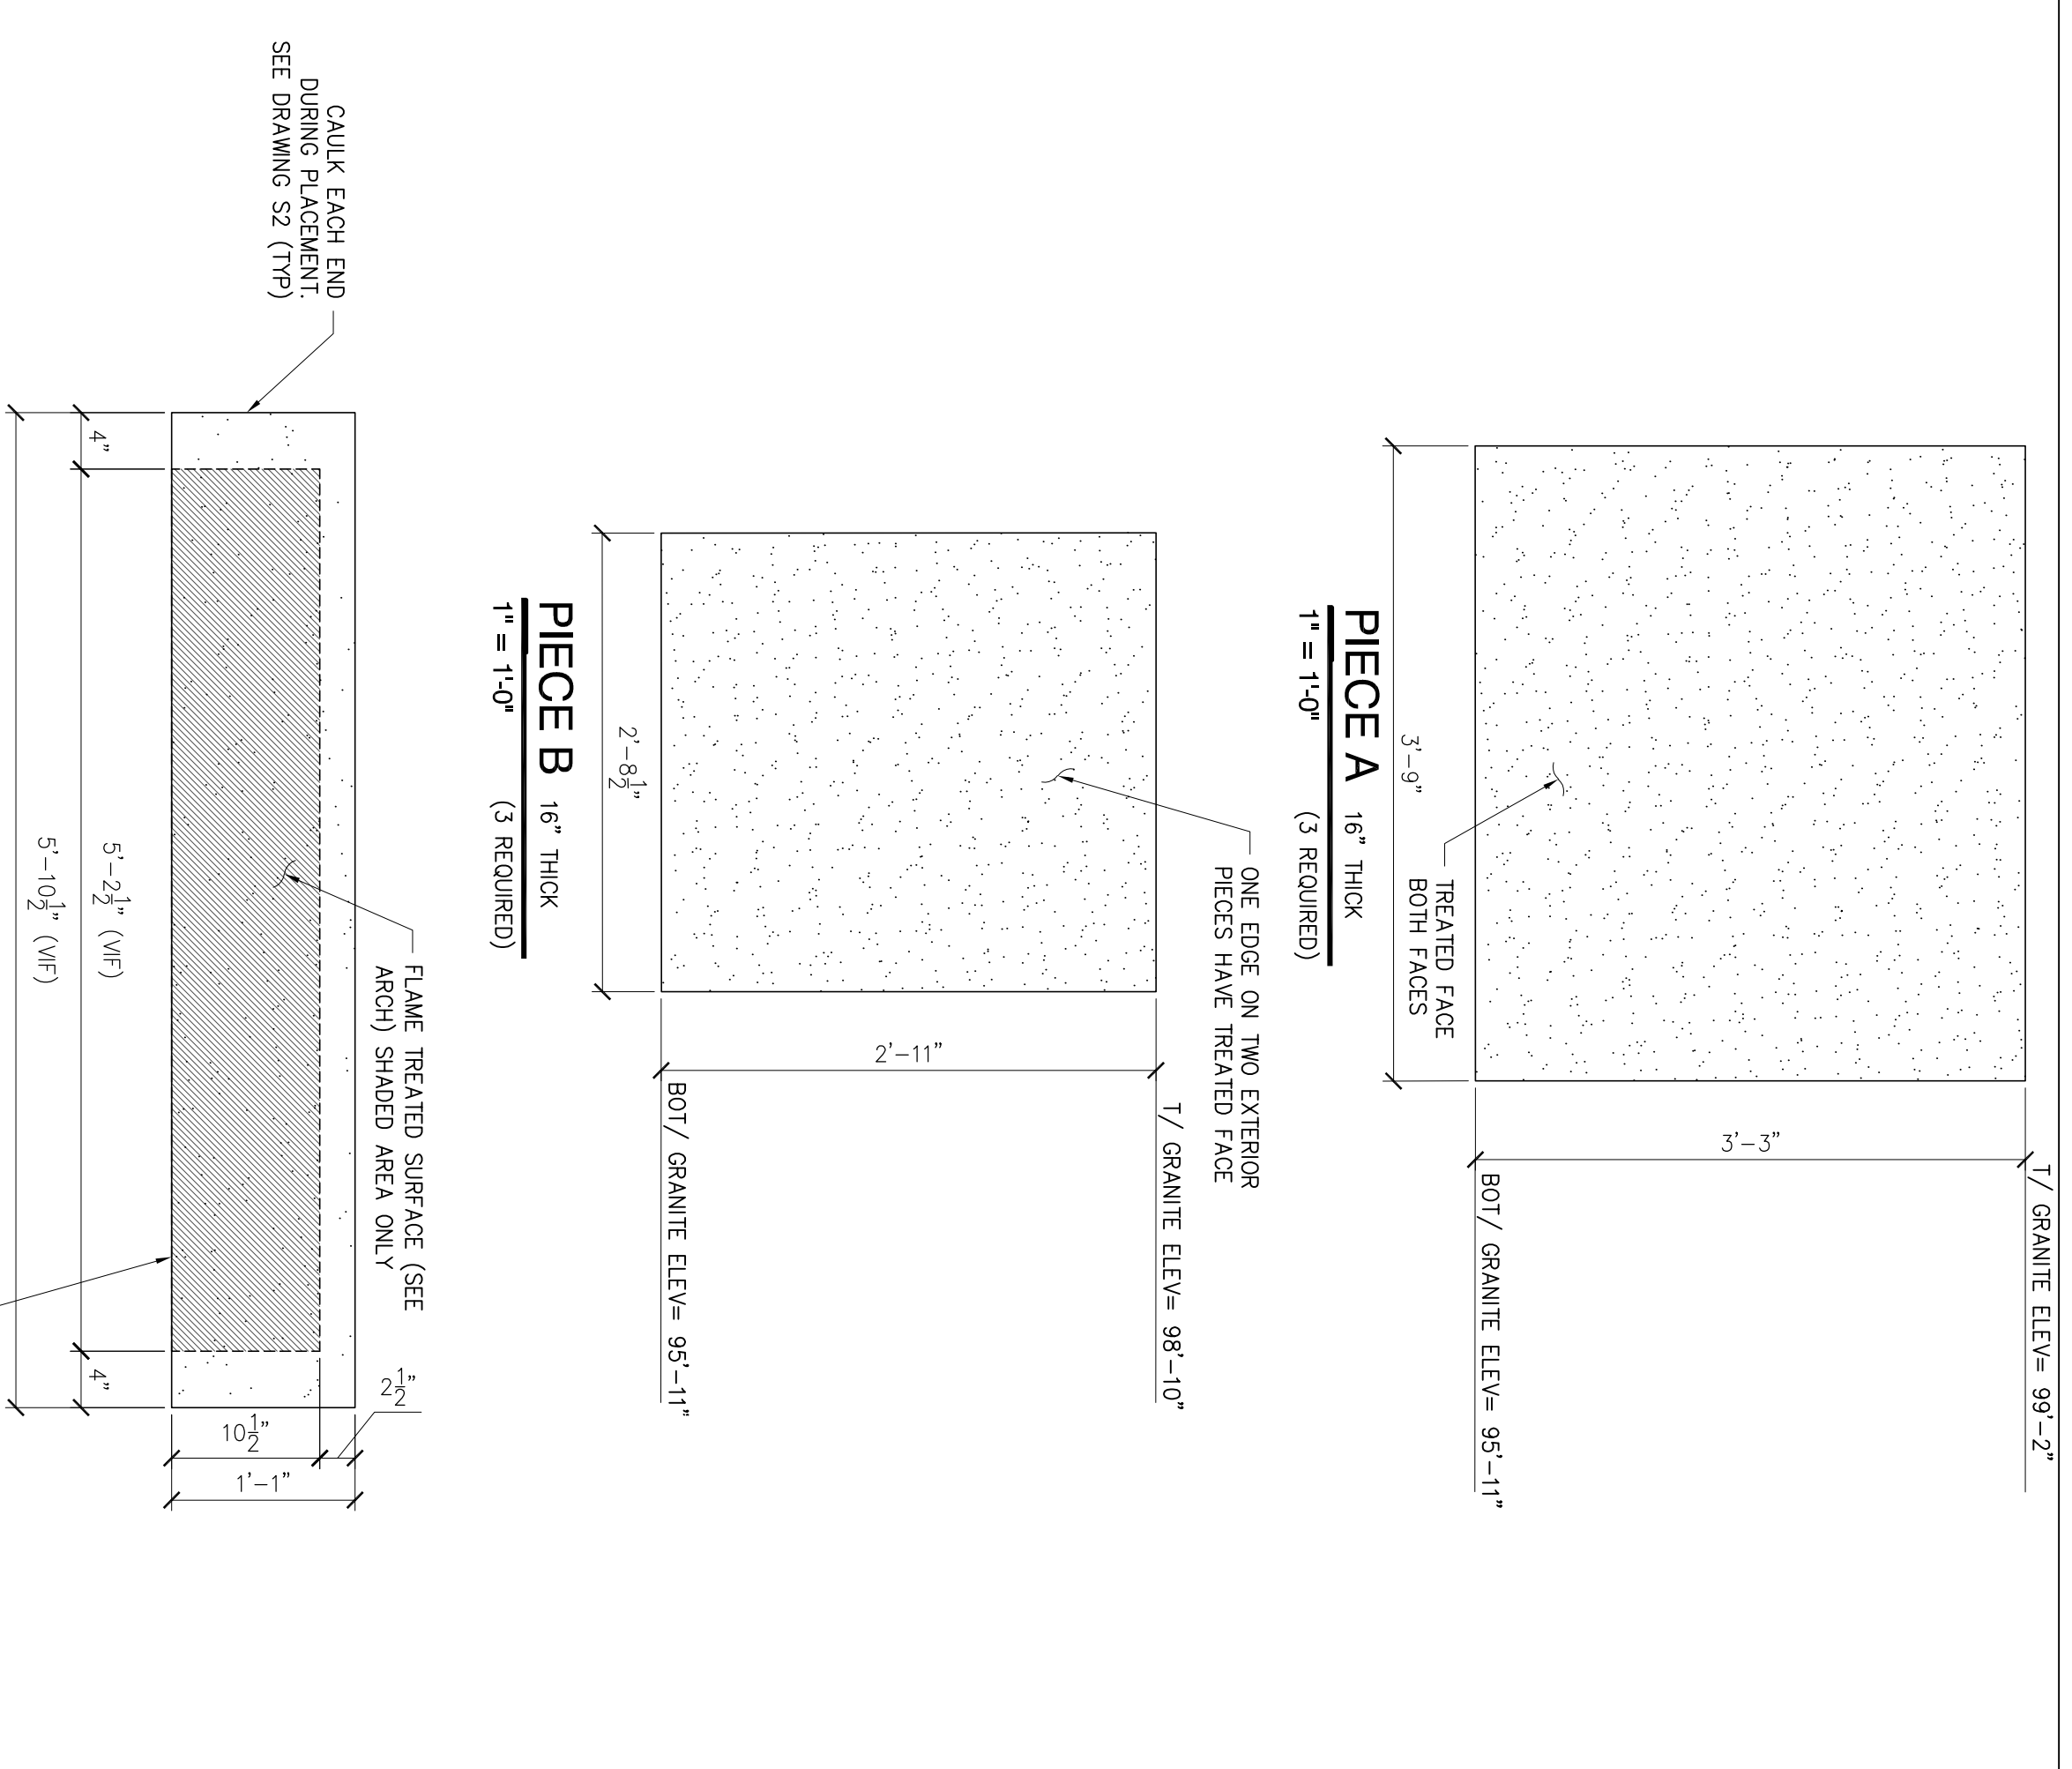
PIECE F - (GRANITE STEPS)
1" = 1'-0" (8 REQUIRED)

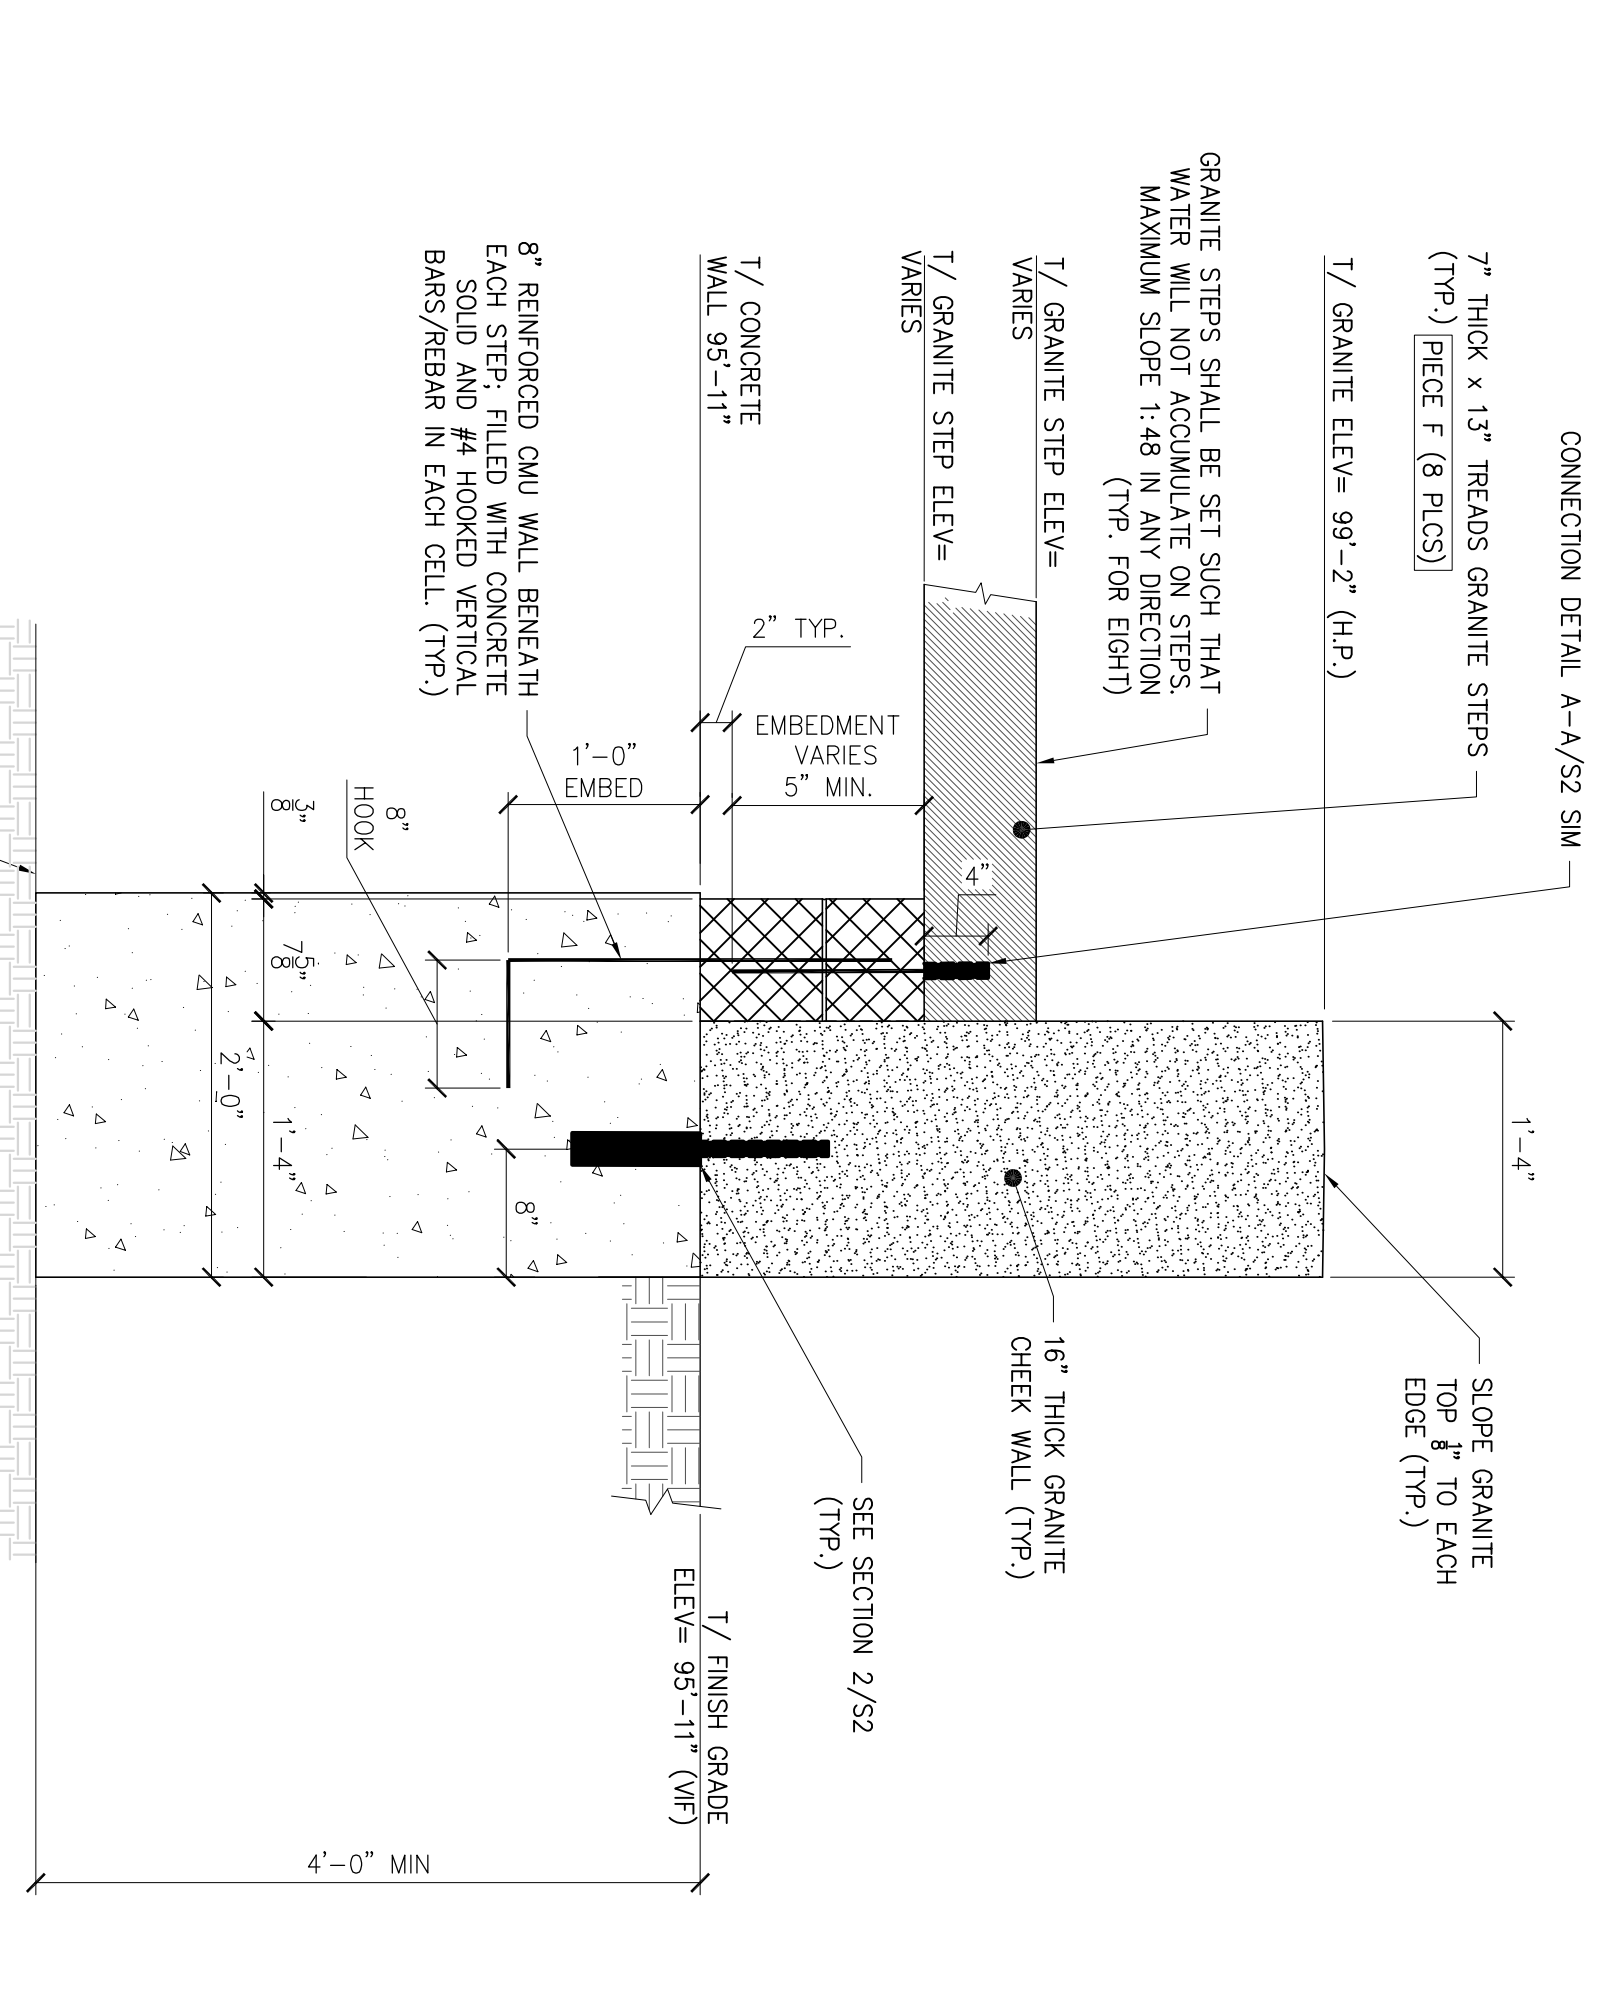
SECTION 5
1" = 1'-0" (TYPICAL STEP SUPPORT)
