STATE STREET CONGREGATIONAL CHURCH
PORTLAND, ME
CHAPEL/CLERESTORY EXTERIOR RENOVATION
REPAIR DETAILS

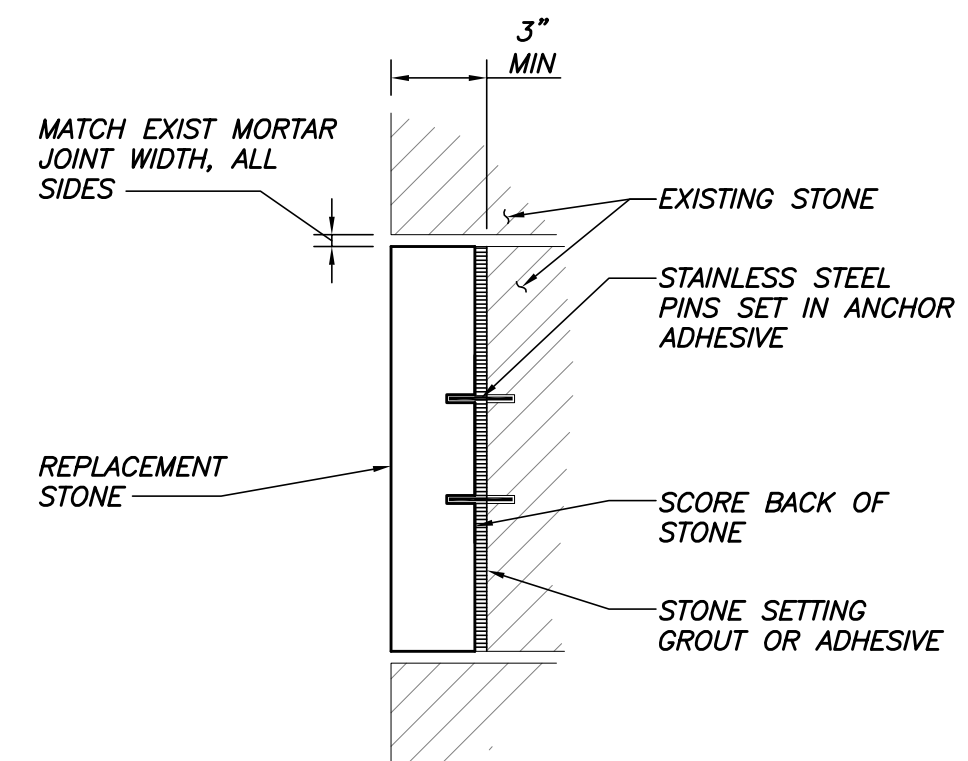
STONE DUTCHMAN REPAIR DETAIL
N.T.S

- NOTES:
- CUT AND REMOVE FULL FACE OF DAMAGED STONE.
 - REPLACEMENT STONE SHALL MATCH EXISTING STONE IN COLOR.
 - REPLICATE TOOLING PATTERS IN STONE IN NEW DUTCHMAN.
 - FOLLOW MANUFACTURERS INSTRUCTION OF ALL DUTCHMAN ATTACHMENT PRODUCTS.
 - THE QUANTITY OF INDIVIDUAL ATTACHMENTS SHALL NOT BE LESS THAN TWO ATTACHMENTS FOR SMALL DUTCHMAN AND ONE ADDITIONAL ATTACHMENT FOR EVERY TWO SQUARE FEET FOR LARGER PANELS.
 - REFERENCE THE PROJECT SPECIFICATIONS FOR ADDITIONAL REQUIREMENTS

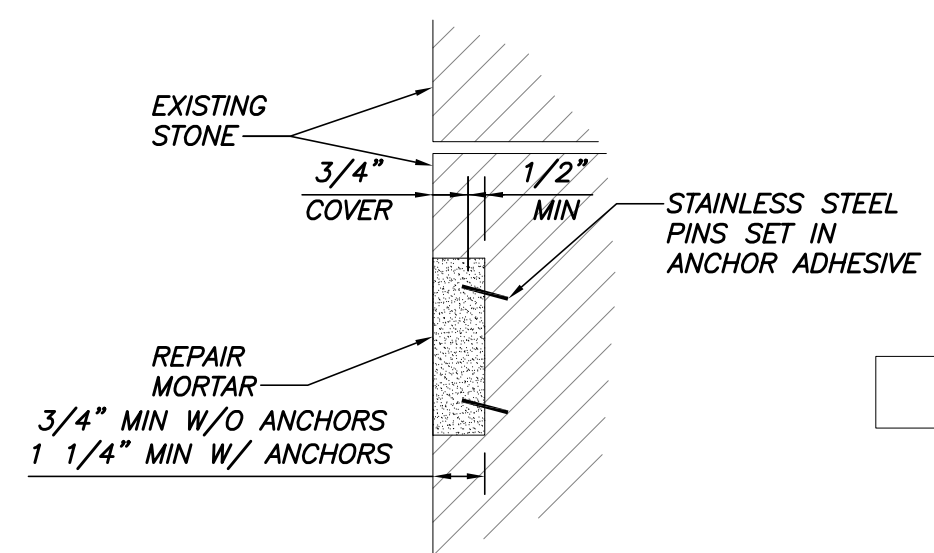
STONE PATCH REPAIR DETAIL
N.T.S

- NOTES:
- REMOVE ALL LOOSE MORTAR AND MASONRY. SOUND MASONRY WITH HAMMER TO VERIFY ITS INTEGRITY.
 - CUT EDGES OF REPAIR AREA. THE EDGES OF REPAIR SHOULD BE SQUARE CUT.
 - REPAIR MORTAR SHALL MATCH EXISTING STONE IN COLOR AND TEXTURE.
 - REPLICATE TOOLING PATTERNS IN STONE IN NEW PATCH.
 - FOLLOW MANUFACTURERS INSTRUCTION FOR INSTALLATION OF ALL STAINLESS STEEL ATTACHMENT PRODUCTS.
 - REFERENCE THE PROJECT SPECIFICATIONS FOR ADDITIONAL REQUIREMENTS

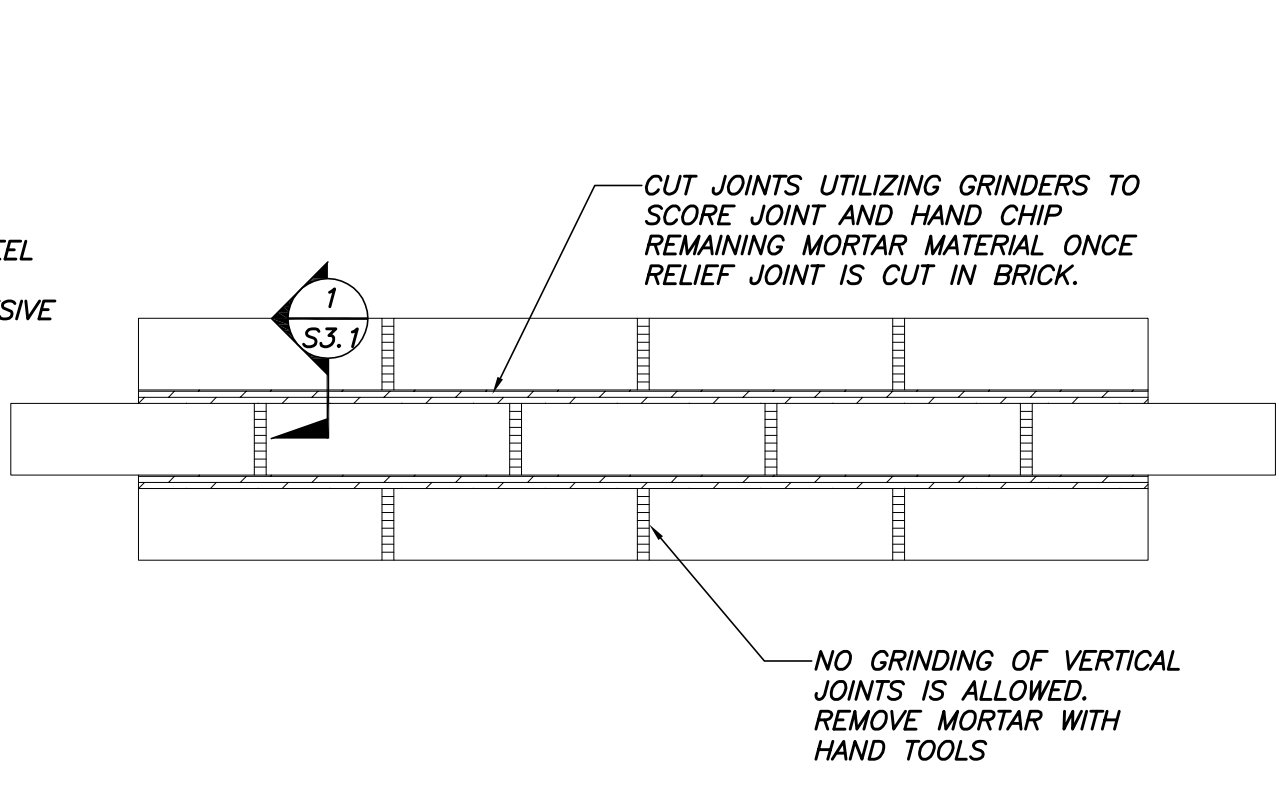
REPOINTING DETAIL
N.T.S

- NOTES:
- HORIZONTAL JOINTS: CUT JOINTS UTILIZING GRINDERS TO SCORE JOINT AND HAND CHIP REMAINING MORTAR MATERIAL ONCE RELIEF JOINT IS CUT IN BRICK.
 - VERTICAL JOINTS: NO GRINDING OF VERTICAL JOINTS IS ALLOWED. REMOVE MORTAR WITH HAND TOOLS.
 - DO NOT DAMAGE EXISTING MASONRY.
 - REPOINTING MORTAR SHALL MATCH EXISTING IN COLOR AND MATERIAL PROPERTIES.
 - TOOL JOINTS TO MATCH ORIGINAL APPEARANCE OF JOINTS.
 - REFERENCE THE PROJECT SPECIFICATIONS FOR ADDITIONAL REQUIREMENTS

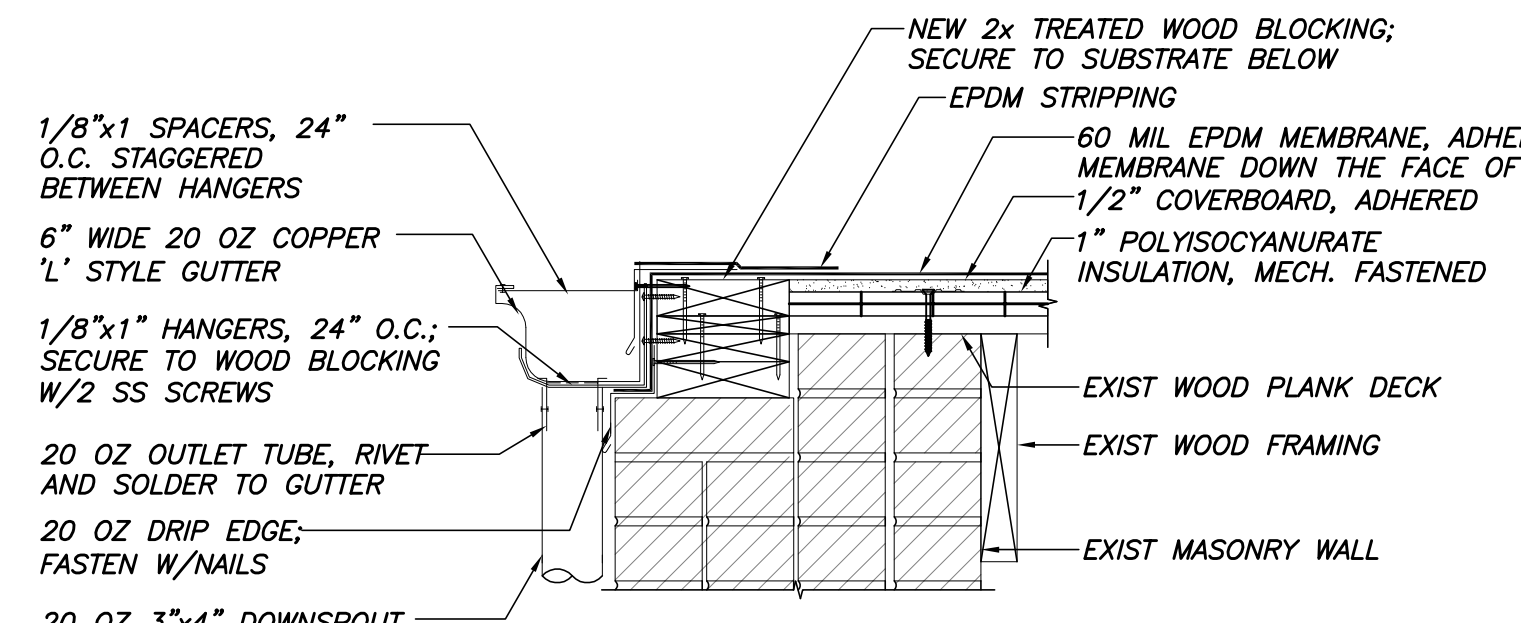
GUTTER 6
1 1/2" = 1'-0"

- NOTES:
- PONDING OF WATER ALONG GUTTER EDGE WILL NOT BE ACCEPTED. MITER AND TRIM WOOD BLOCKING AT GUTTER EDGE TO PROVIDE POSITIVE DRAINAGE INTO GUTTER.
 - NOTIFY ENGINEER TO INSPECT ROOF PERIMETER FOR DETERIORATION TO WOOD STRUCTURE AND MASONRY.
