489 Cumberland Avenue Pointing Project

Project Summary – Currently the building located at 489 Cumberland Avenue is in need of spot pointing and full re-pointing repair on all four brick sides of the building.

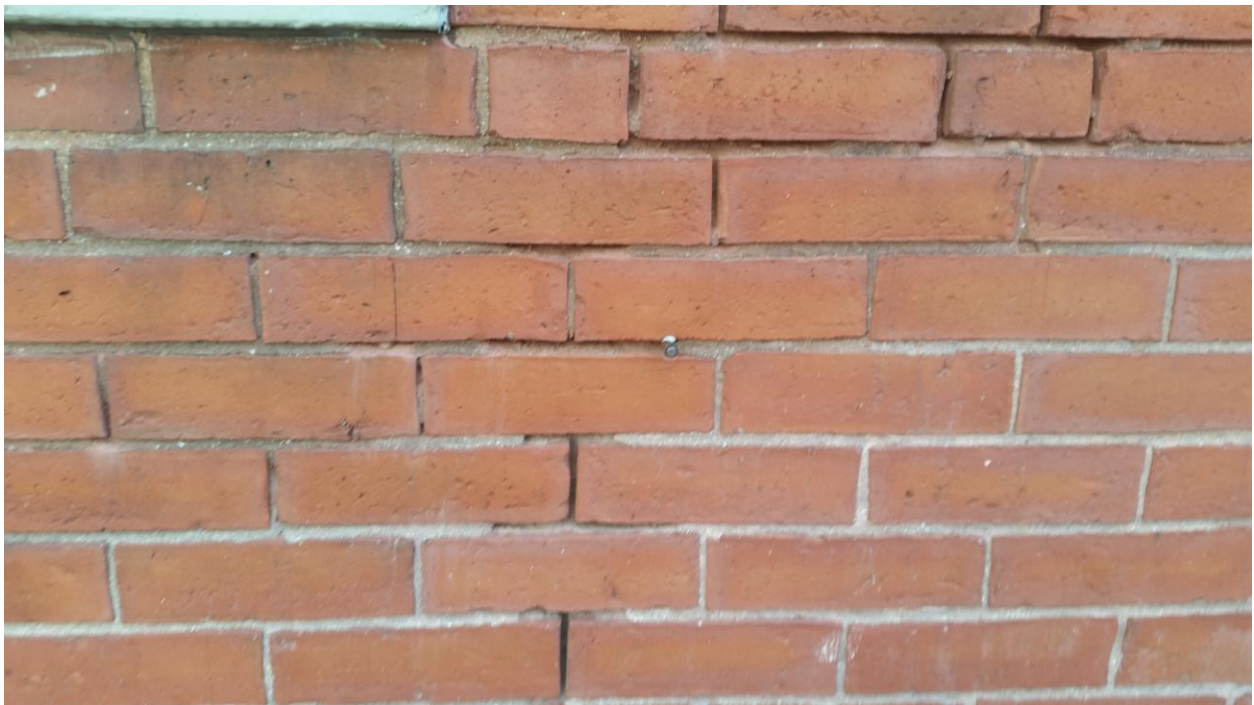
Pic 1

Pictures of typical areas in need of repair.

To do this the brick surfaces will first be power washed in an attempt to see the true color and texture of the original mortar joints. Next the existing affected mortar joints (Affected brick areas – see pictures below) will be ground out to a depth of at least 3/4” or twice the width of the existing mortar joint. Mortar samples will then be prepared for Portland HP to approve so that the aesthetic integrity of the building is retained and the original mortar is matched as closely as possible. Once the color and texture of the mortar is determined all affected areas will be re-pointed. Please note that all mortared joints will be raked back at least an 1/8” to match original mortar. All mortar used will be type O which is a historical match for the age of the building.
