MAINE MEDICAL CENTER
BRAMHALL CAMPUS
MRI #1 REPLACEMENT
PORTLAND, MAINE
ELEVATIONS, SECTIONS, AND
DETAILS

PROJECT MANAGER: DJV	PROJECT NO: 16004
AVE OF RECORD: DJV	
JOB CAPTAIN: MDR	
DRAWN BY: MDR	
SMRT FILE: AE103-16004	SHEET No. AE103

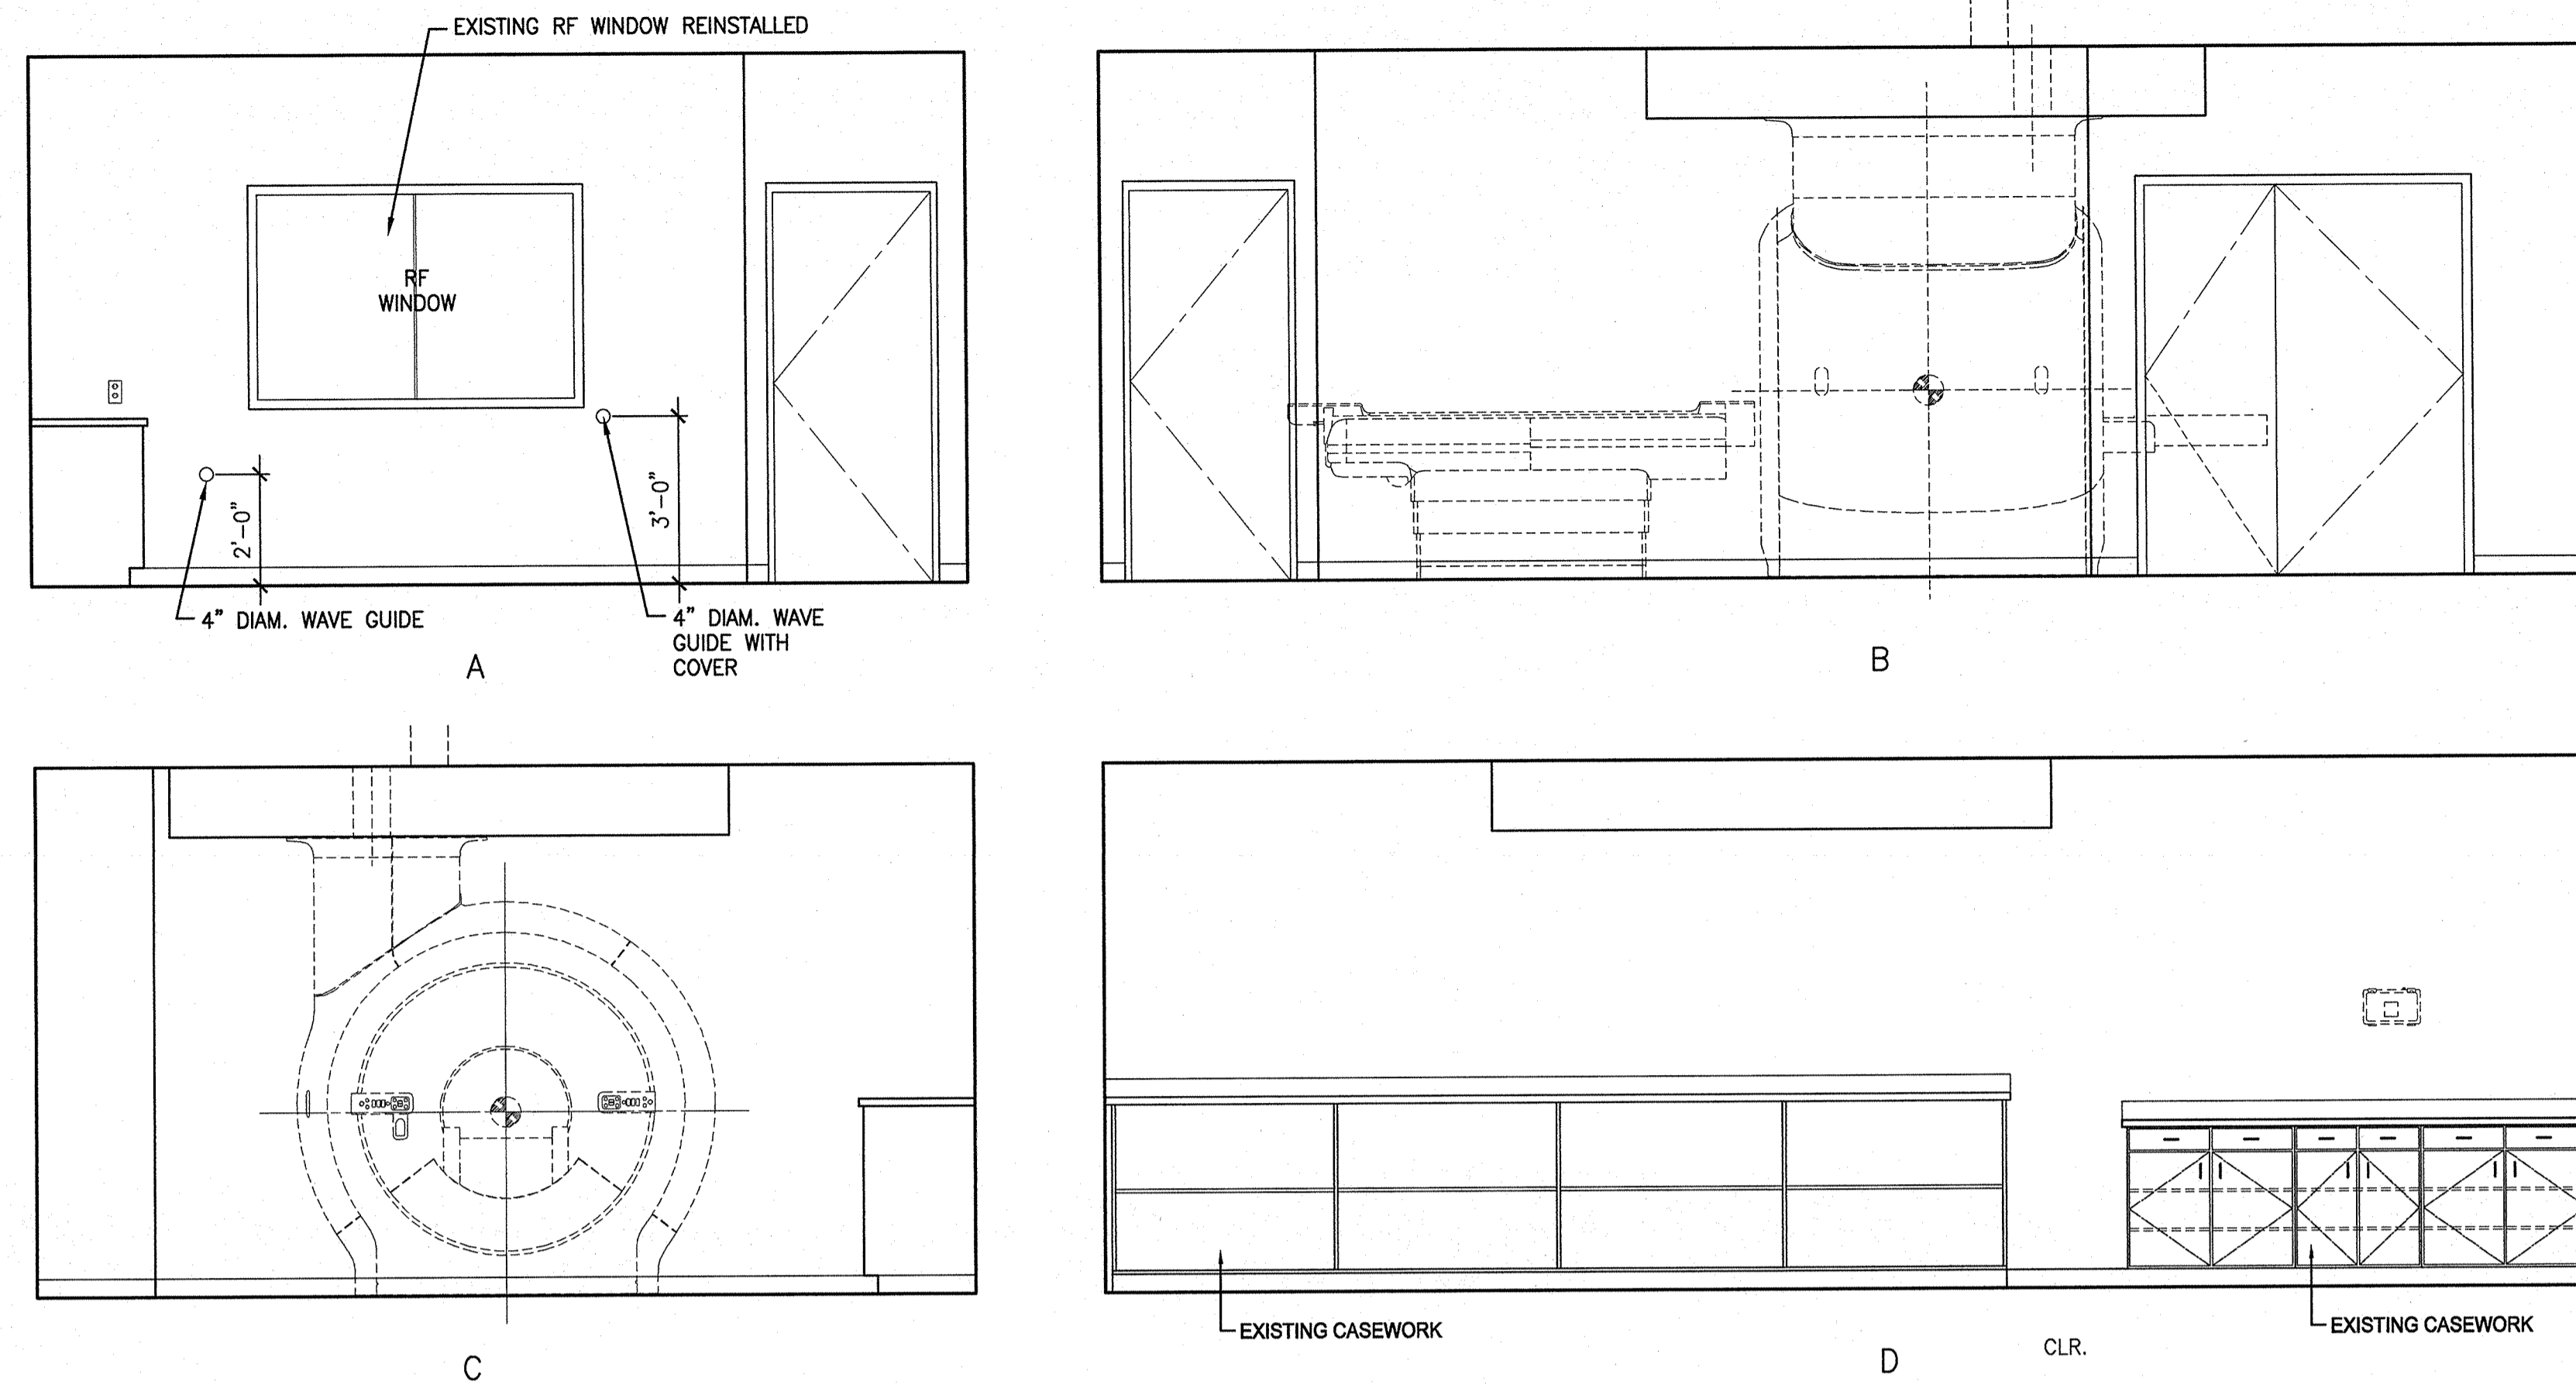
MRI ROOM E8
1/4"=1'-0"

GE 3t machine (to be removed): 17,312 lbs
Philips 1.5t (to be installed): 9921 lbs
