Butler Payson  
pine st.  
state st.  
portland, maine

avesta housing

misc. details

BA5.4

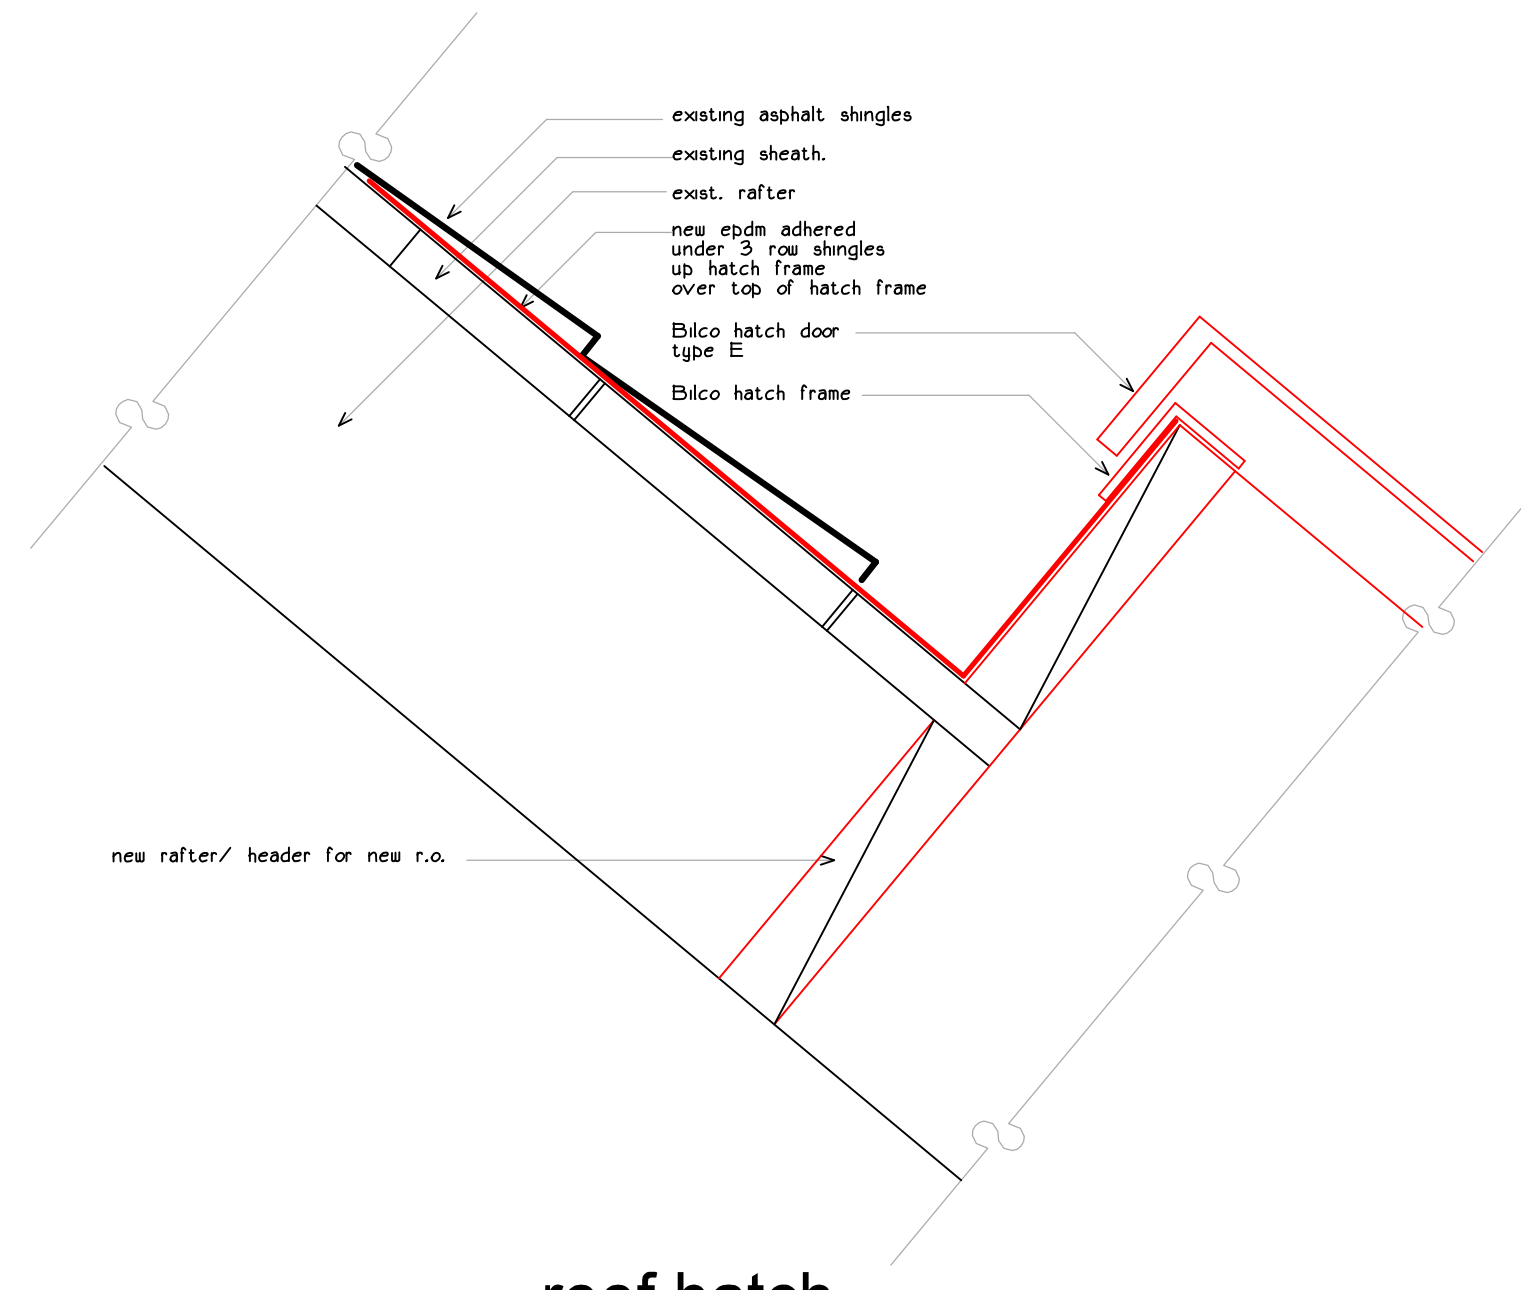
2 roof hatch

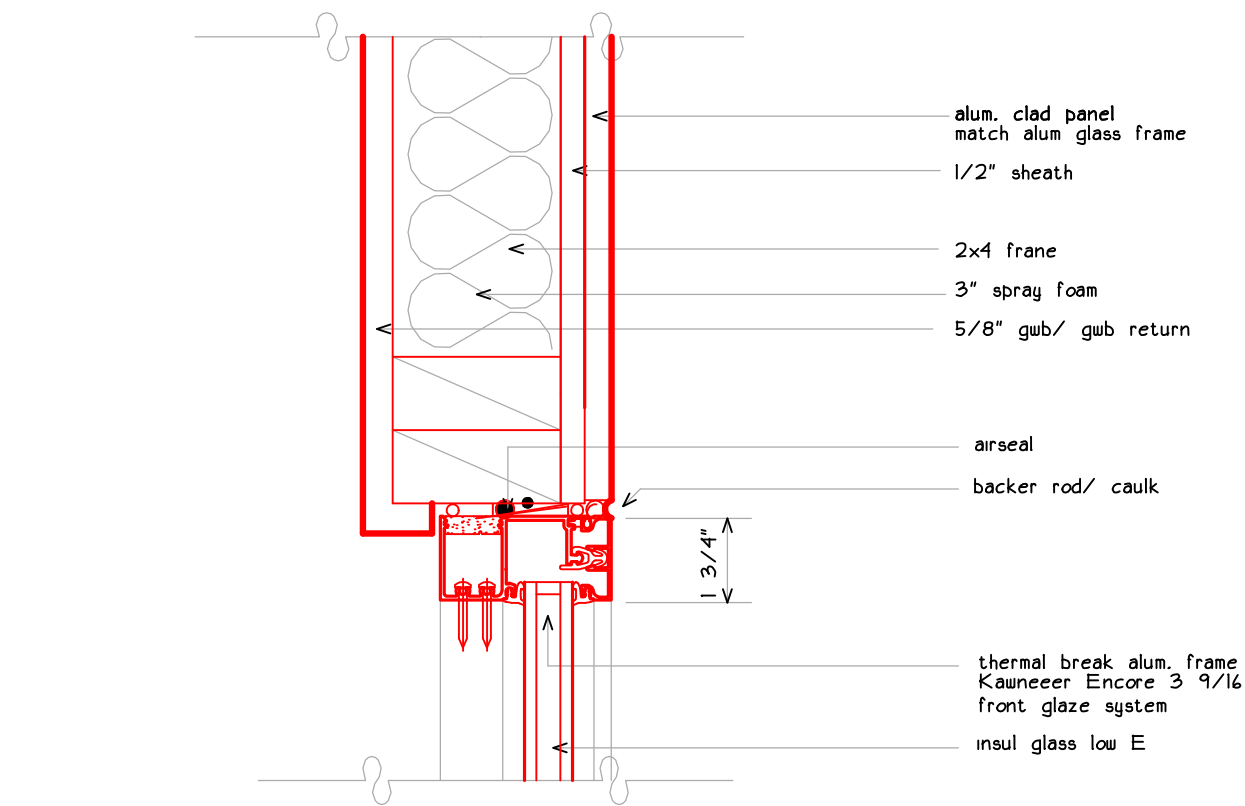
5 vestibule glass/ frame head  
interior and exterior vestibule wall

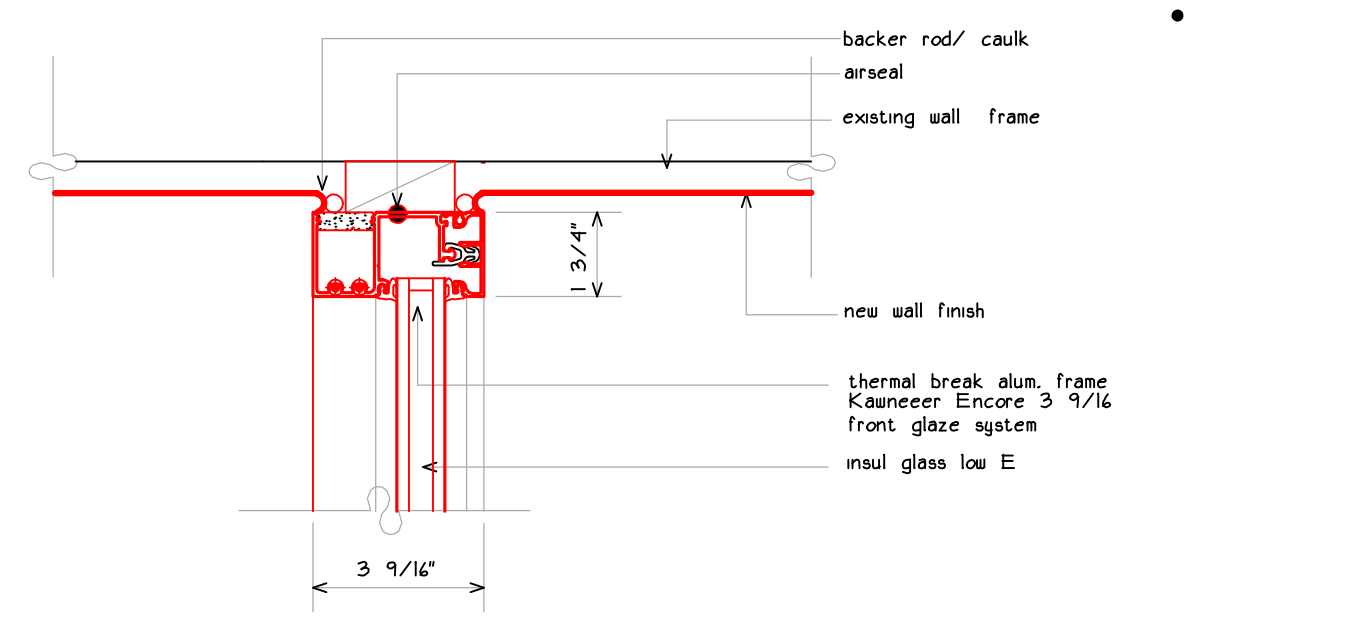
6 vestibule glass/ frame jamb  
interior and exterior vestibule wall

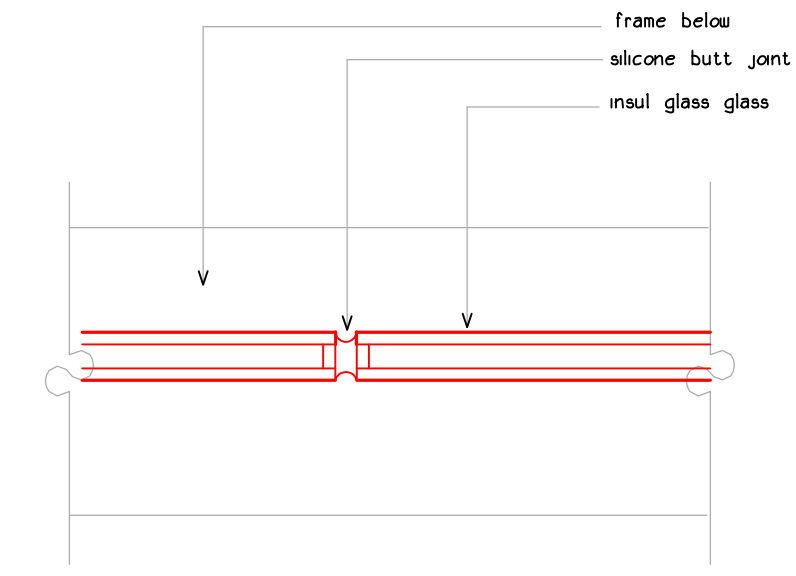
8 interior vestibule glass corner

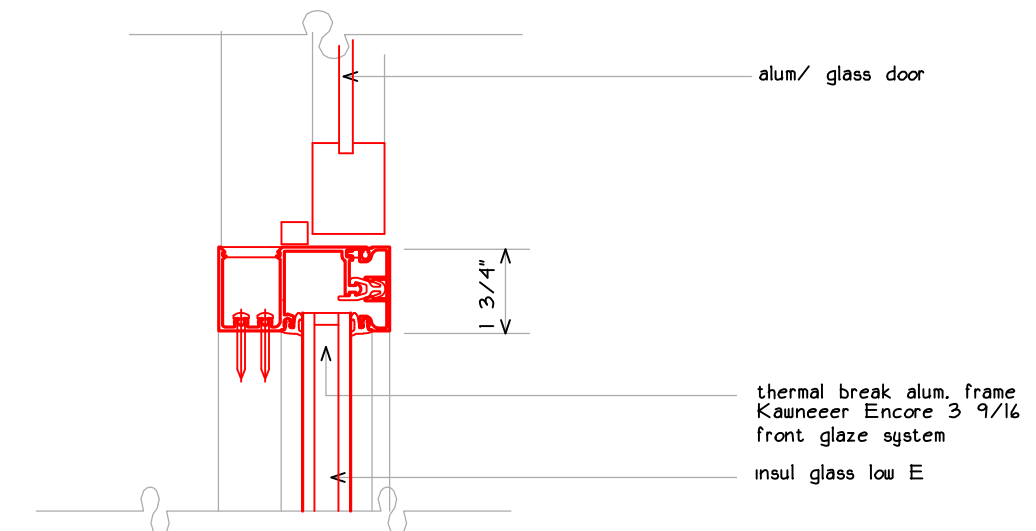
9 vestibule glass/ frame jamb

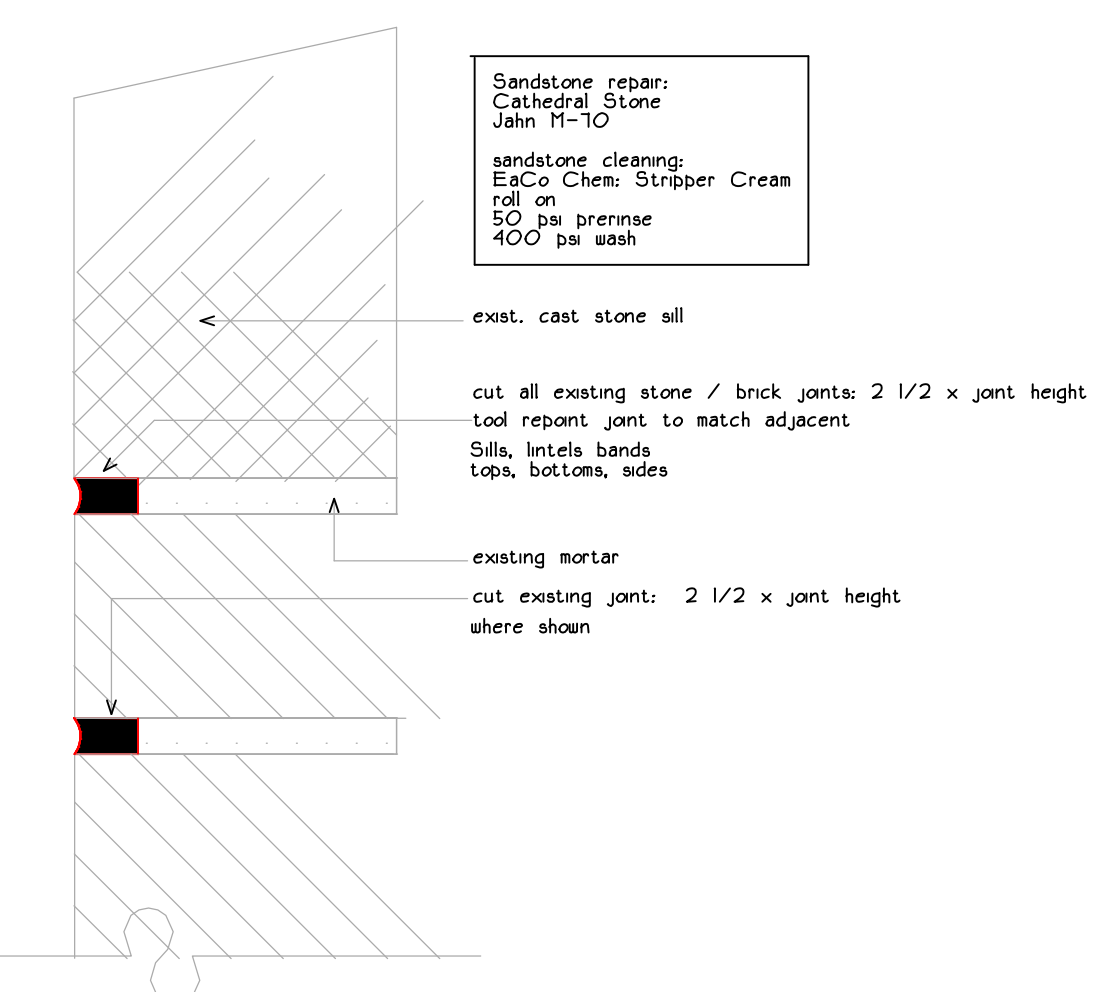
3 sandstone repoint/ repair  
not to scale

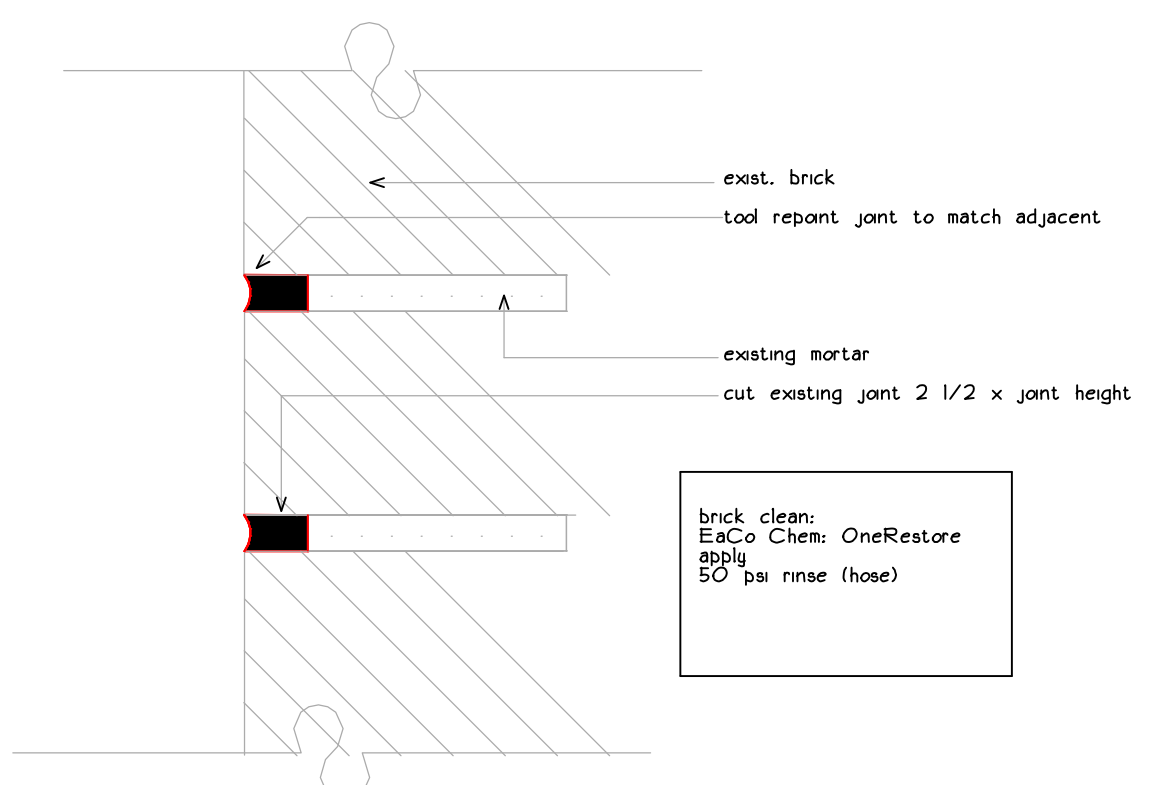
4 typical repoint detail  
not to scale

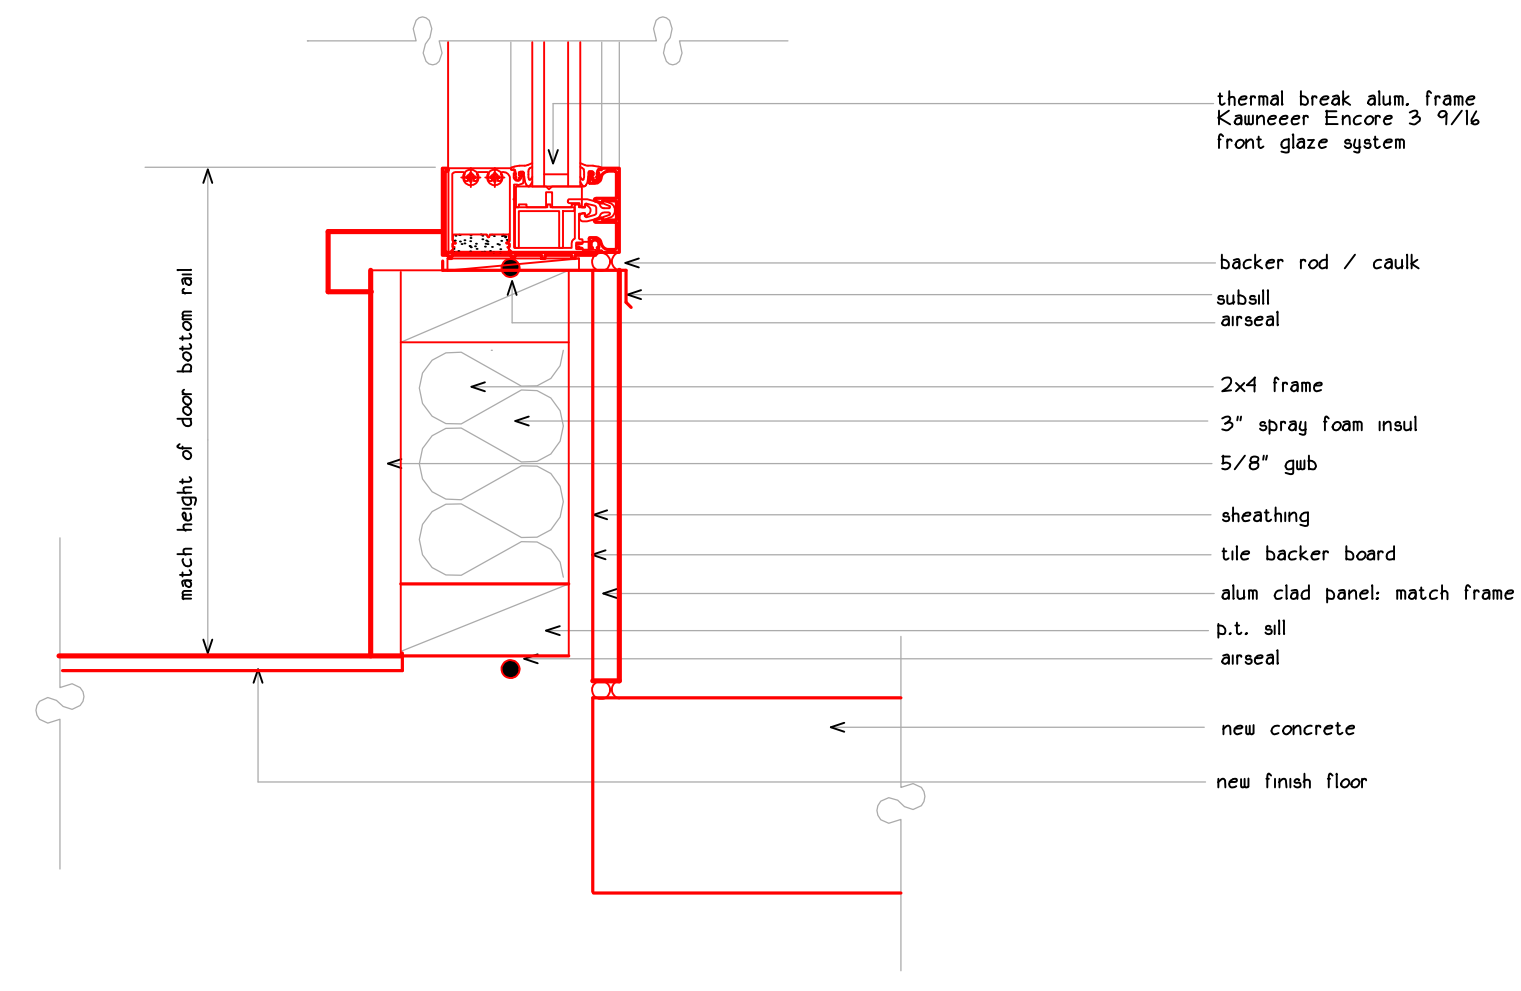
7 vestibule glass/ frame sill adj. door  
exterior vestibule wall similar for interior

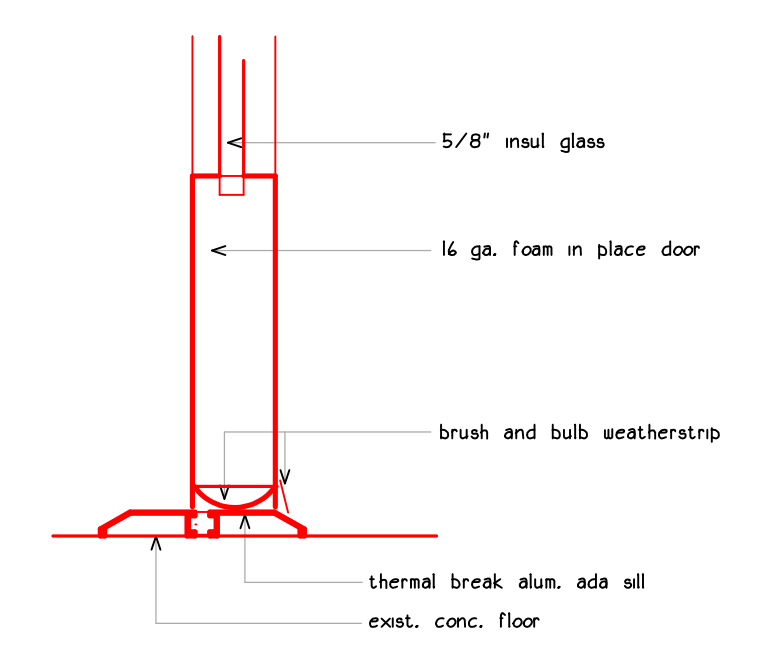
10 vestibule door sill
