ATTACHMENT 11

FUNCTIONAL ASSESSMENT

11.0 Overview

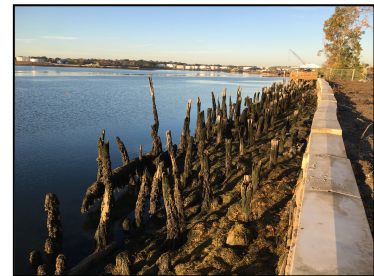
Figure 2

The Fore River shorefront appears to be best characterized as a combination of mixed course and fine flat riprap stabilized shorefront. Although not formed by glacial scouring and bedrock erosion, the majority of the exposed environment along the shorefront is stabilized with granite revetment, riprap, and is similar in appearance to the intertidal habitat classification of "Mixed Course and Fine Flats" with regard to particle/grain size. The intertidal zone across most of the shorefront consists of numerous old pilings that protrude up from the flats during low tide conditions (see Figure 2).

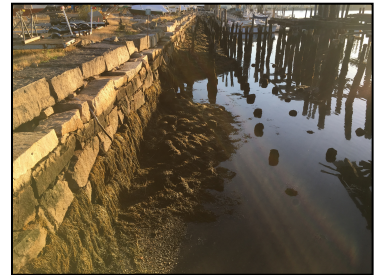
Figure 3

A granite revetment extends across nearly the entirety of the shorefront (see Figure 3). Much of the shorefront is characterized by a former pier area that is currently in a dilapidated condition (see Figure 4). For much of the past 150 years the site's shorefront consisted of these numerous pilings, piers, and related infrastructure that supported the landside gas manufacturing and later rail yard activities. Much of this shorefront infrastructure still remains.

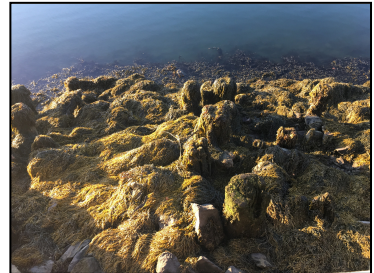
Figure 5

Conditions along this length of waterfront are also exacerbated due to the Combined Sewer Outfalls that the City of Portland maintains in the area. One CSO outfall is located towards the easterly end of the shorefront. A second CSO outfall is located further west of the site. Both outfalls remain active. These conditions, combined with the known environmental issues associated with the waterfront, likely impact the shorefront's opportunity for wildlife or fisheries habitat. We have not performed an in-depth qualitative or quantitative species review or field card checklist of the shorefront due to these overriding site features and we request the Department's acceptance that no further field study is warranted.
