255 DIAMOND AVENUE
NORTH AND EAST EXTERIOR
ELEVATIONS - FINAL

MRS. ALEXANDRA WIGHT
255 DIAMOND AVENUE
PORTLAND, MAINE 04109

DATE	3/19/18
SCALE	AS NOTED
SHEET NO.	A2.0

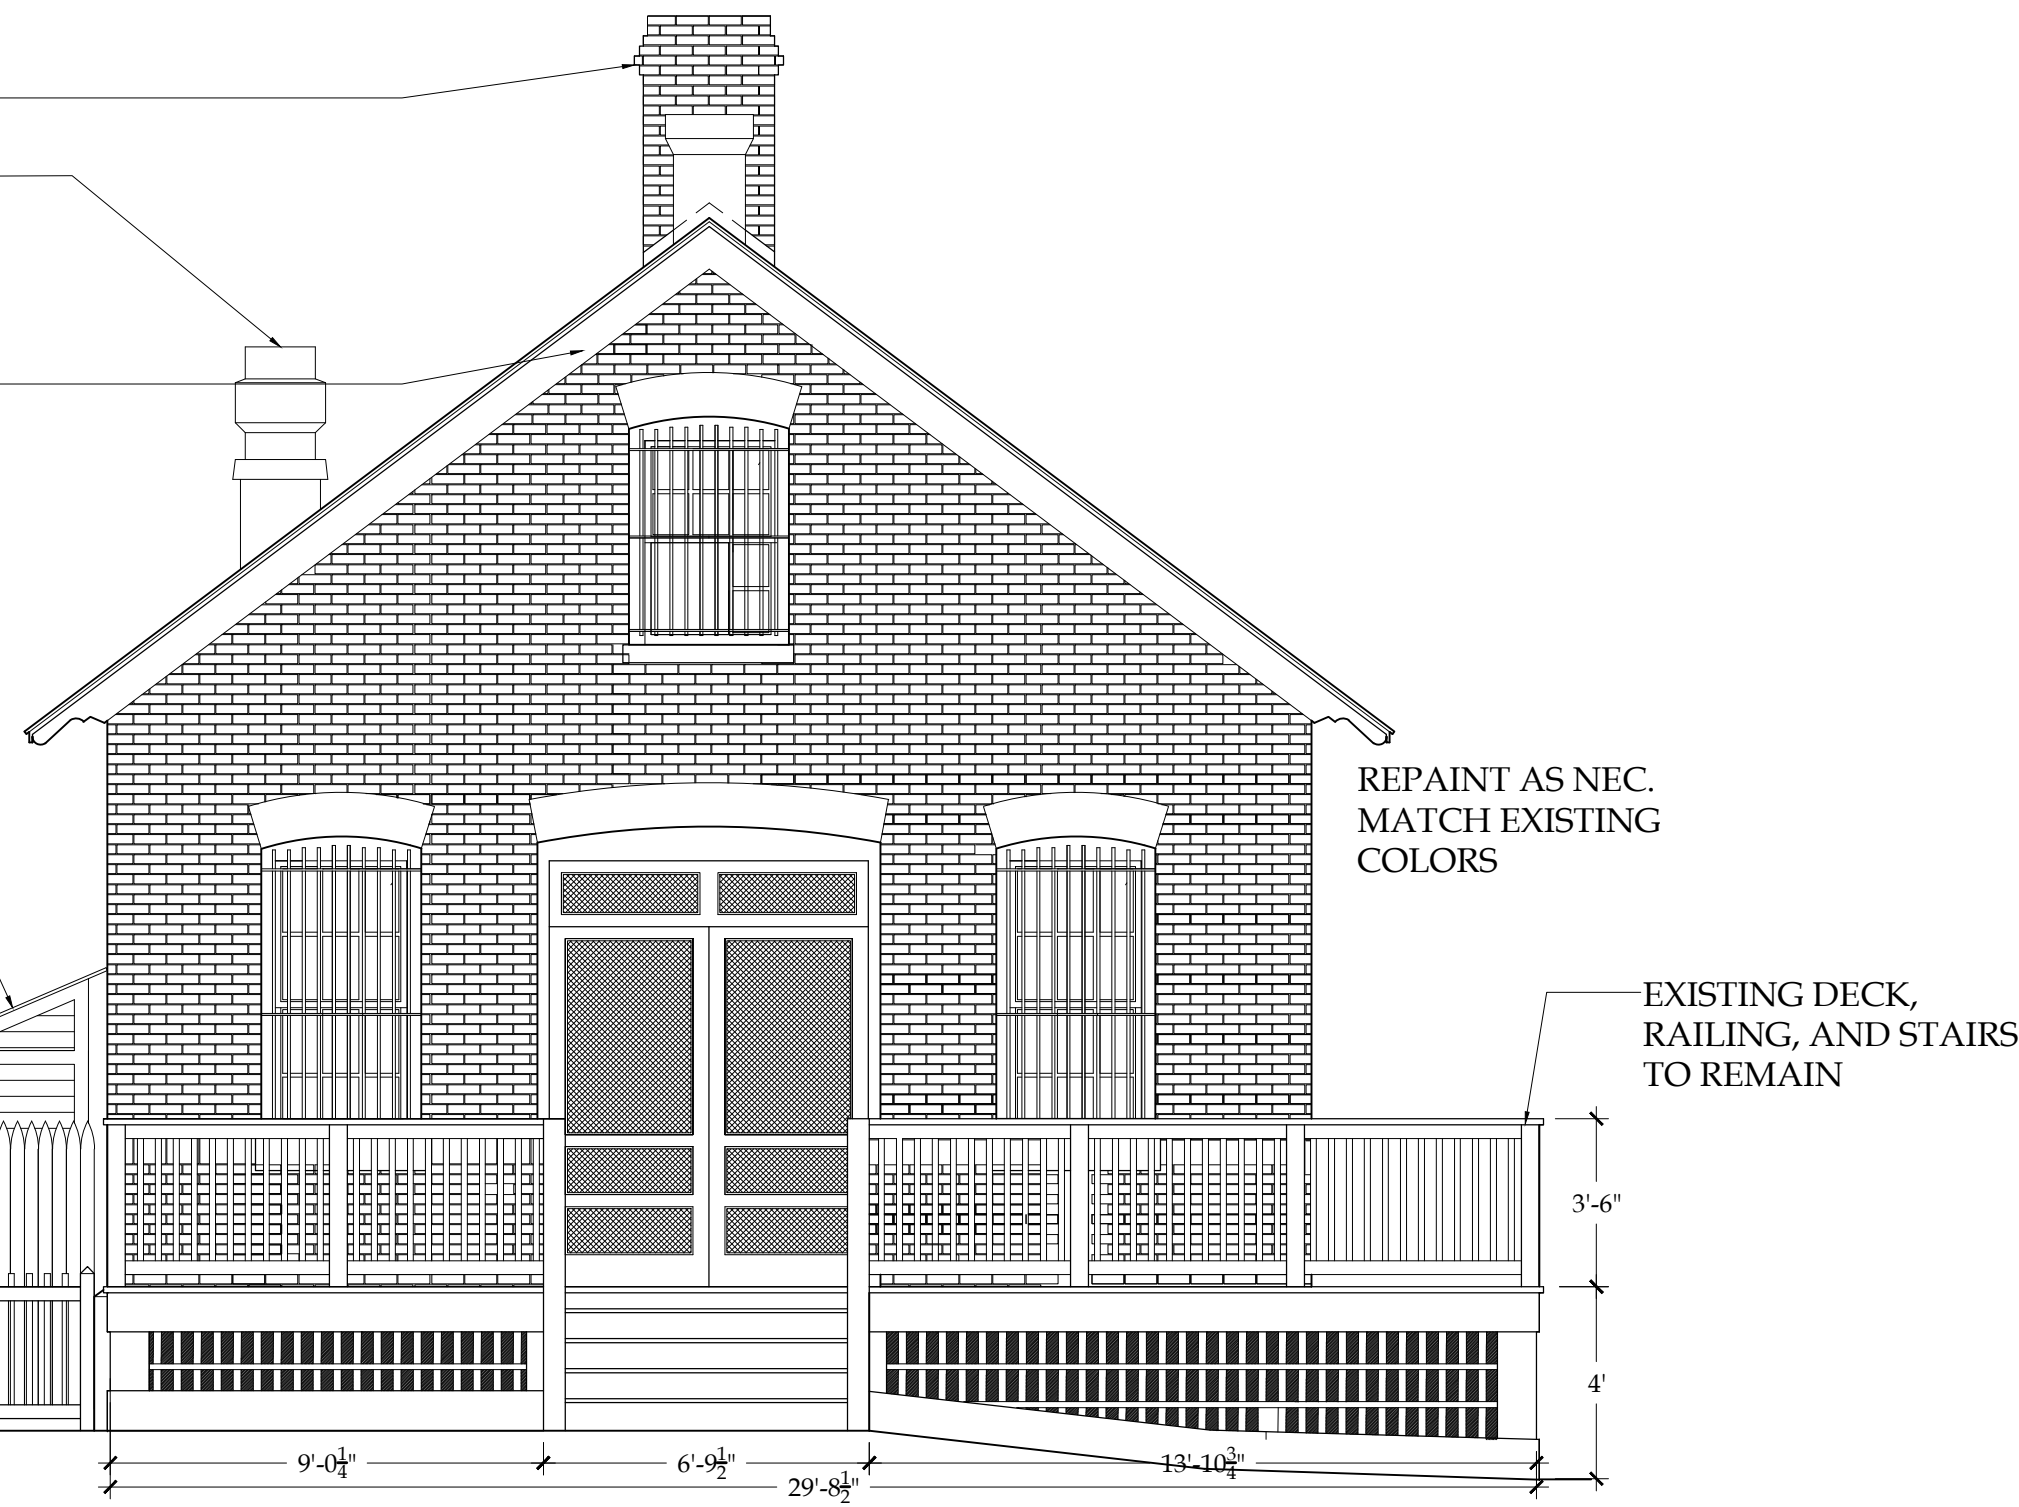
1 NORTH ELEVATION
Scale: 1/4"=1'-0"

CAP OR SCREEN EXISTING CHIMNEY TO PREVENT WATER AND RODENT INFILTRATION
NEW EXHAUST VENT IN EXISTING LOCATION

REPAIR AND/OR REPLACE ANY LOOSE OR ROTTING FASCIA BOARDS TO MATCH EXISTING

RE-POINT BRICK, MATCH EXISTING MORTAR COMPOSITION, COLOR, & JOINT SIZE

REPAINT AS NEC. MATCH EXISTING COLORS

EXISTING STORAGE SHED TO REMAIN

EXISTING STOCKADE FENCE GARBAGE ENCLOSURE TO REMAIN

EXISTING PICKET FENCE TO REMAIN

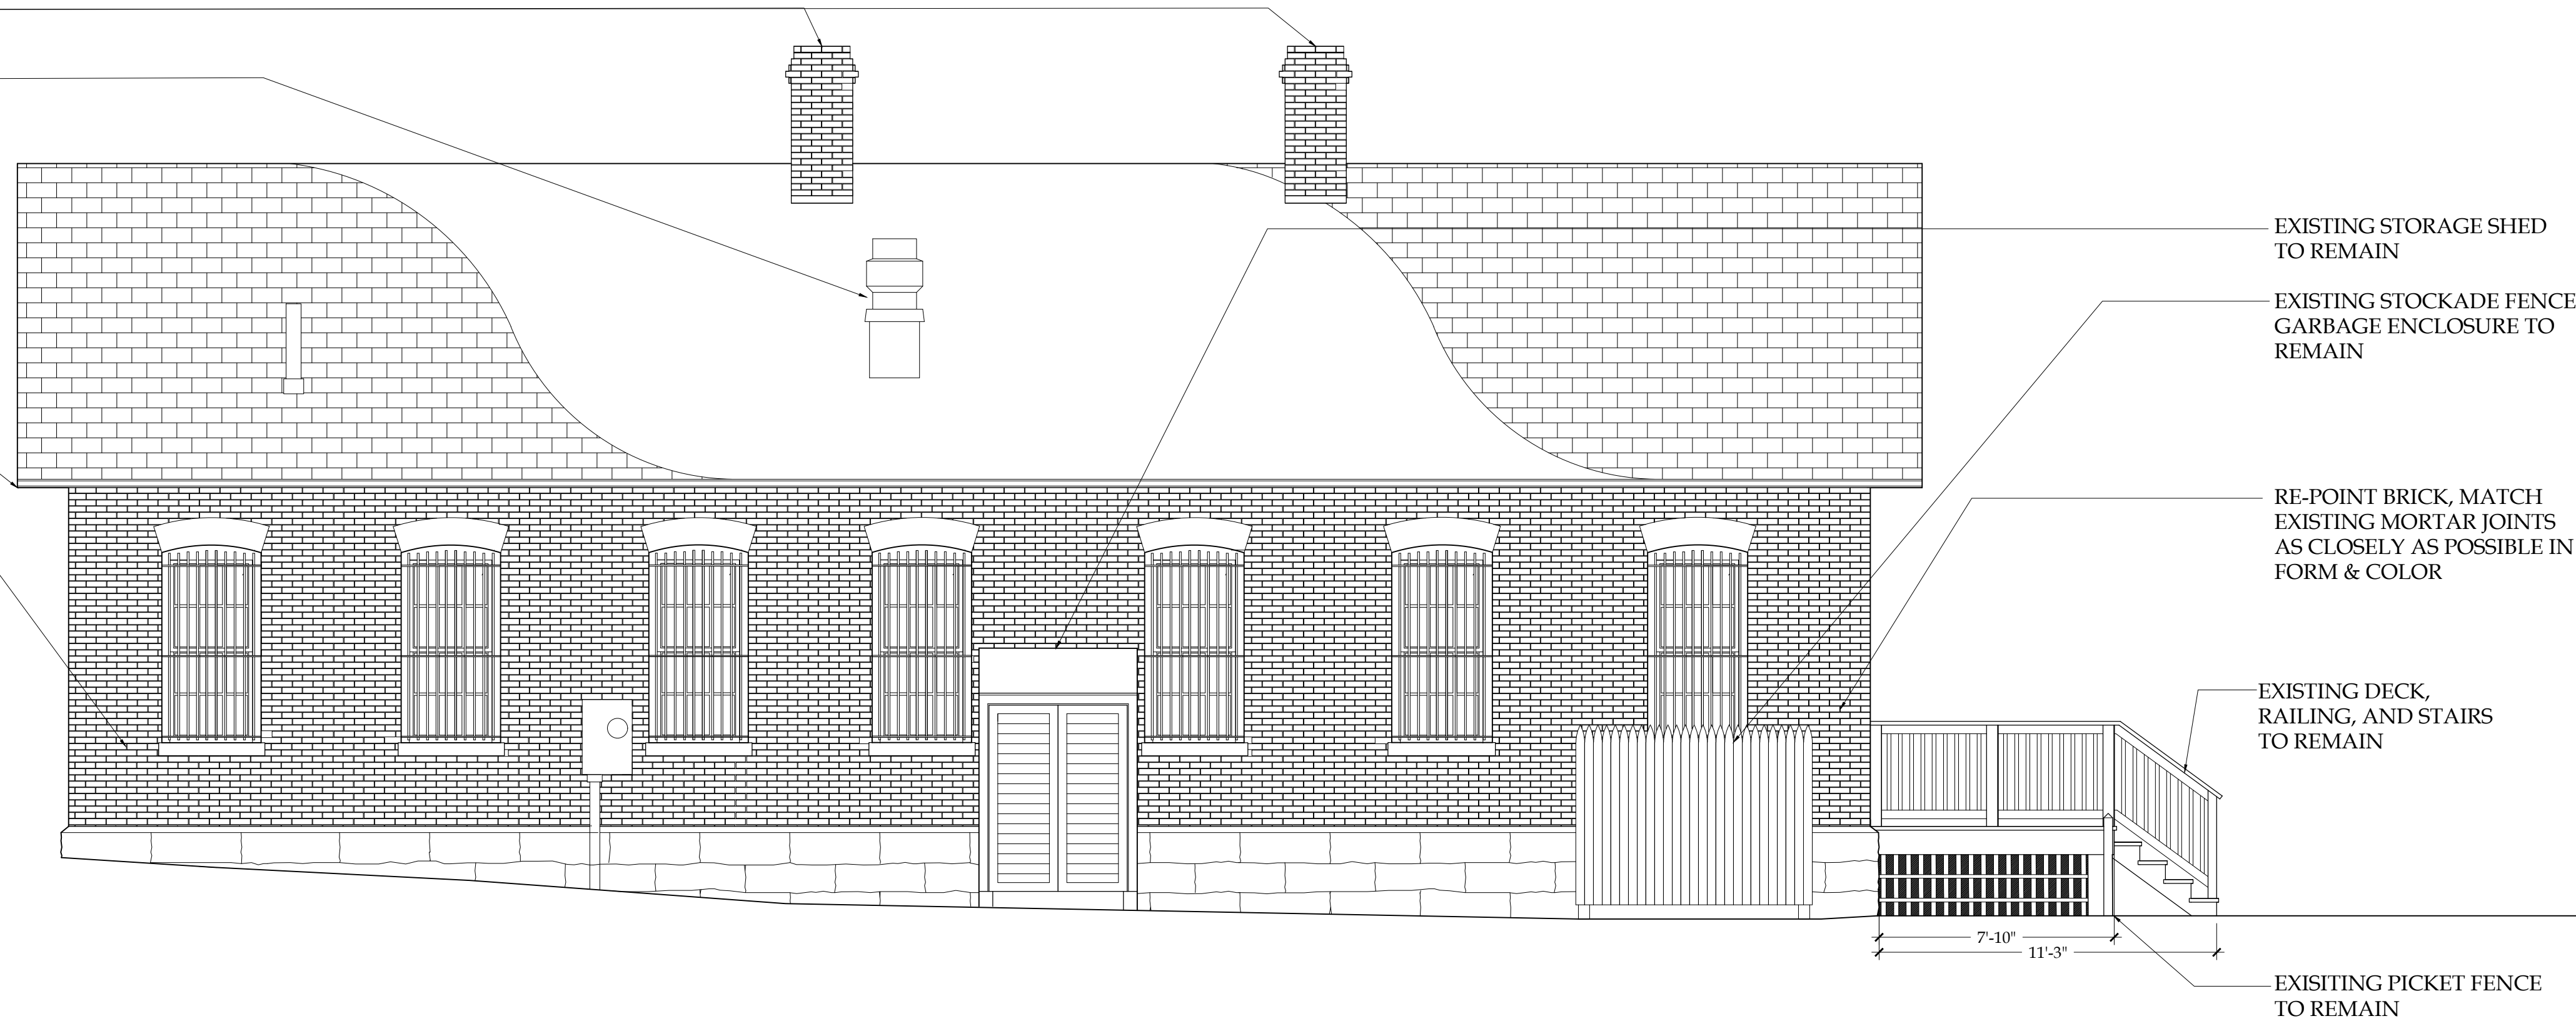
2 EAST ELEVATION
Scale: 1/4"=1'-0"

CAP OR SCREEN EXISTING CHIMNEY TO PREVENT WATER AND RODENT INFILTRATION
NEW EXHAUST VENT IN EXISTING LOCATION

REPAIR AND/OR REPLACE ANY LOOSE OR ROTTING FASCIA BOARDS TO MATCH EXISTING

RE-POINT BRICK, MATCH EXISTING MORTAR JOINTS AS CLOSELY AS POSSIBLE IN FORM & COLOR
