Drawing Name:	Details 2
Project:	Bangor Savings Bank 20 Marginal Way, Portland, Maine
Client:	Bangor Savings Bank 99 Franklin Street, Bangor, Maine 04401

Drawing No.
C402

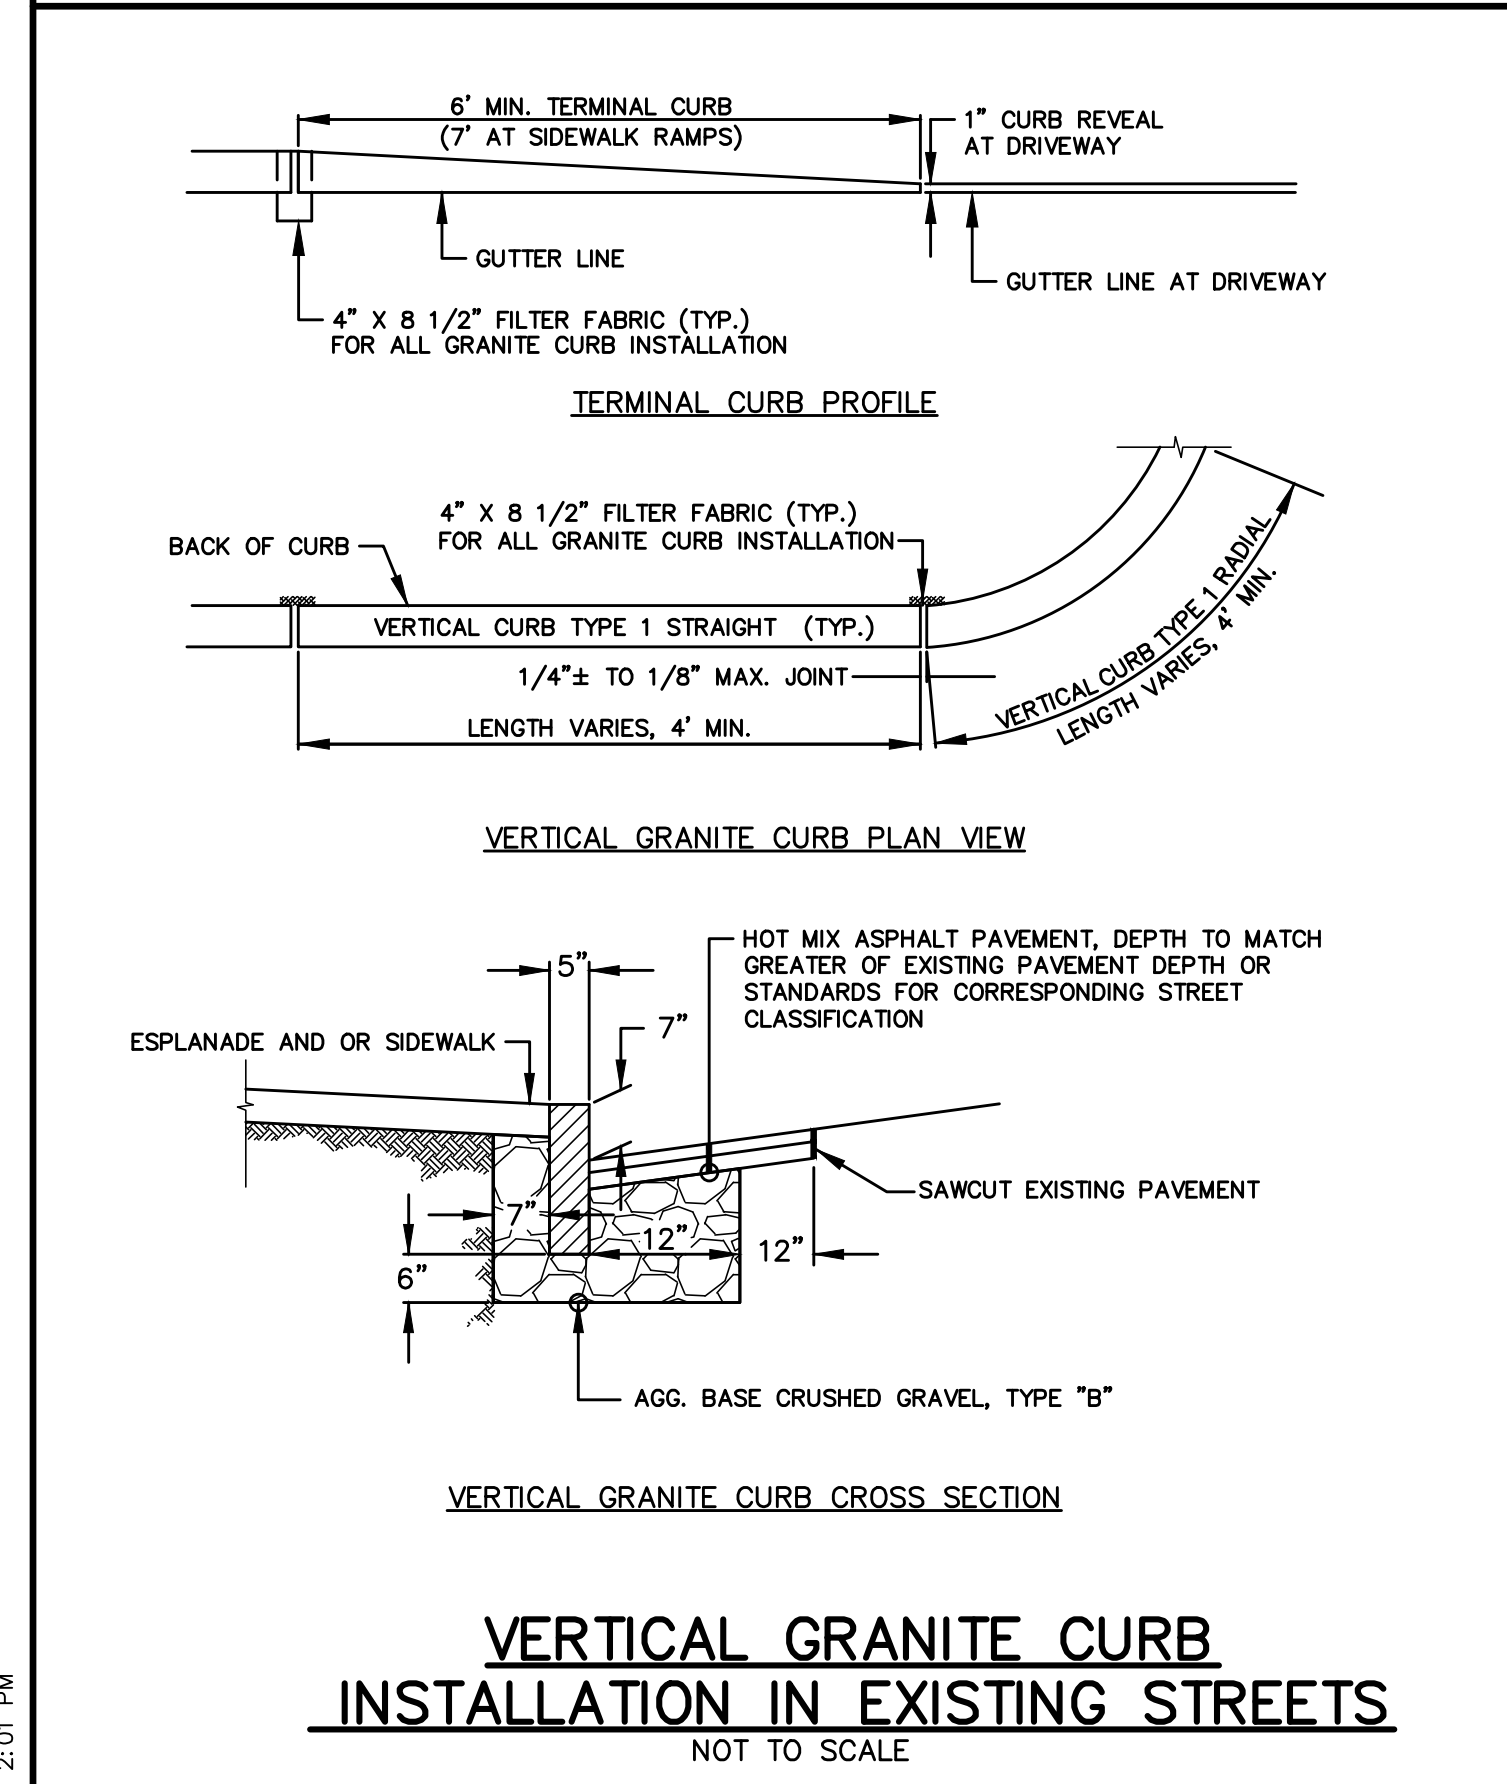
NOTES:
 1. SEE SITE PLAN FOR LOCATION OF CONCRETE DRIVE-THRU.
 2. #5 DIAGONAL BARS SHALL BE PLACED AT ALL OPENINGS.
 3. THE SITE CONTRACTOR SHALL PROVIDE SHOP DRAWINGS SHOWING THE LOCATION OF CONTROL AND CONSTRUCTION JOINTS TO THE ENGINEER FOR REVIEW PRIOR TO REPLACEMENT OF CONCRETE.

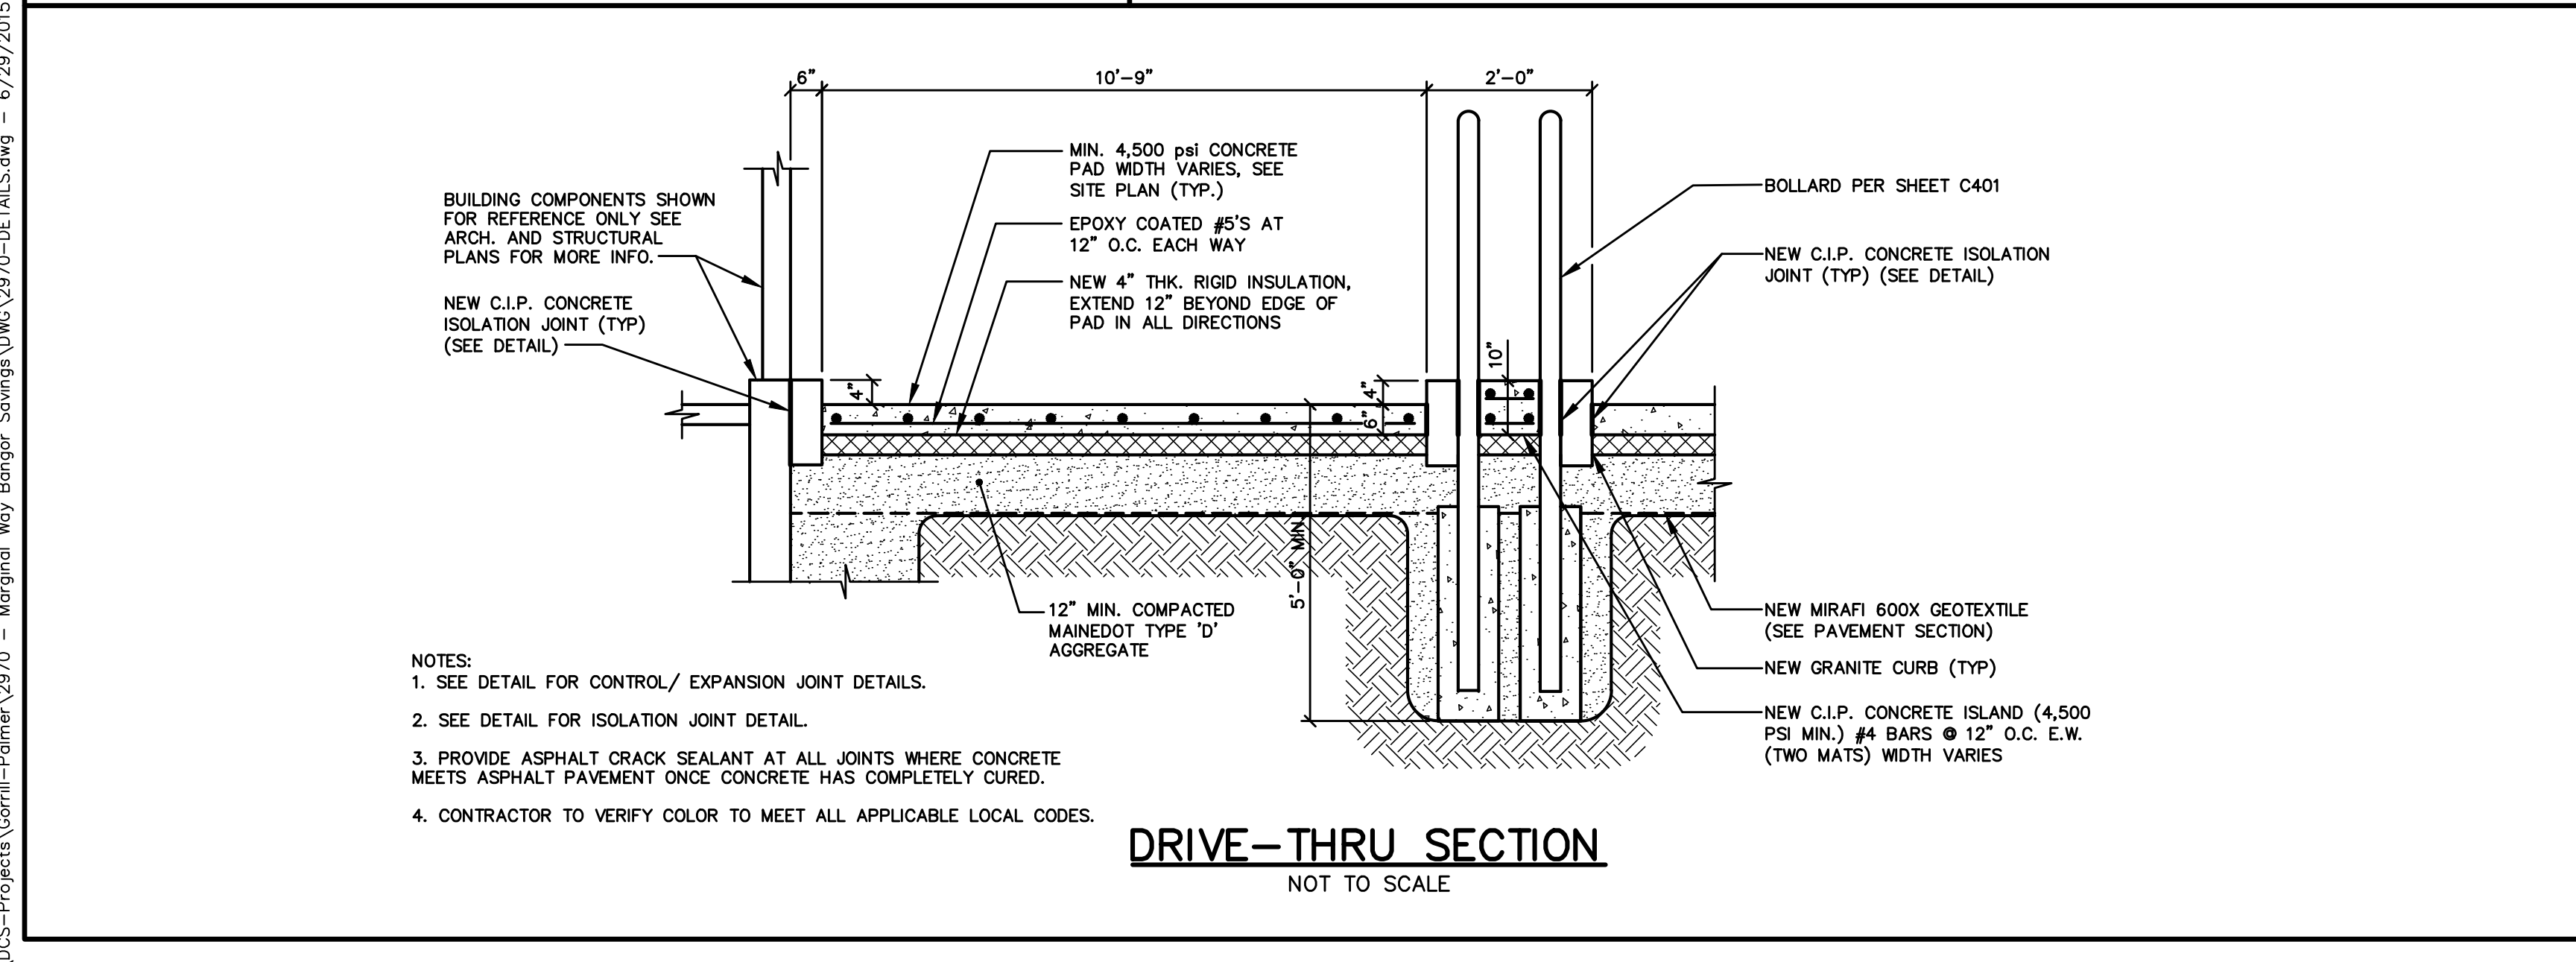
NOTES:
 1. SEE DETAIL FOR CONTROL/ EXPANSION JOINT DETAILS.
 2. SEE DETAIL FOR ISOLATION JOINT DETAIL.
 3. PROVIDE ASPHALT CRACK SEALANT AT ALL JOINTS WHERE CONCRETE MEETS ASPHALT PAVEMENT ONCE CONCRETE HAS COMPLETELY CURED.
 4. CONTRACTOR TO VERIFY COLOR TO MEET ALL APPLICABLE LOCAL CODES.
