House at 57 Coyle Street, Deering (1900)
James and Renee Cabot, owners
Visited 23 September 2014

57 Coyle Street pictures

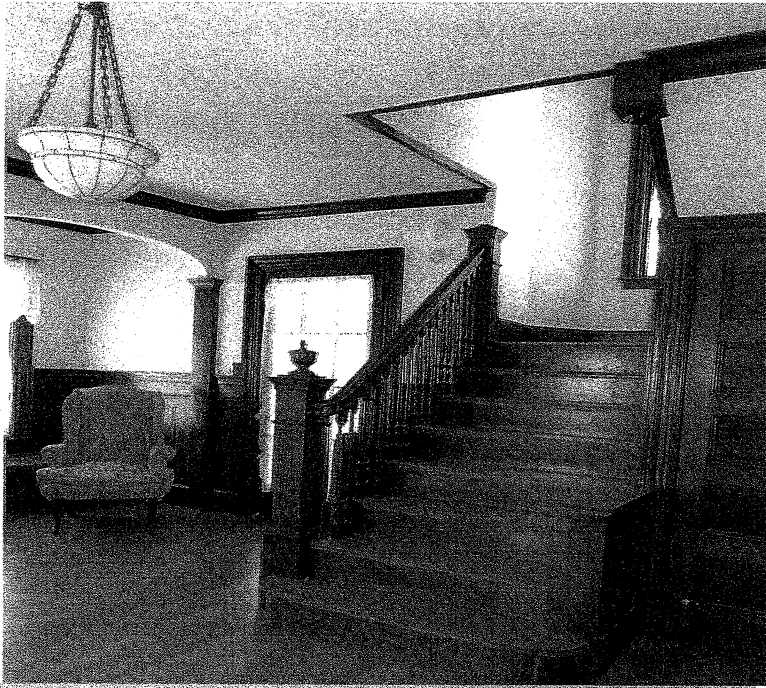
Stair Hall

Inside, the central hallway extends to the left corner with a window seat at the front. The woodwork, including a paneled wainscot and stair with colonial balustrade, is of oak, stained dark and varnished. The cut out "wave" motif on the stair ends is from the Federal Period. A smaller parlor occupies the right front, at the center rear is a dining room, and the kitchen takes up the right rear. Except for the kitchen, the rooms are devoid of any obvious structural alteration. The varnished finishes are in perfect

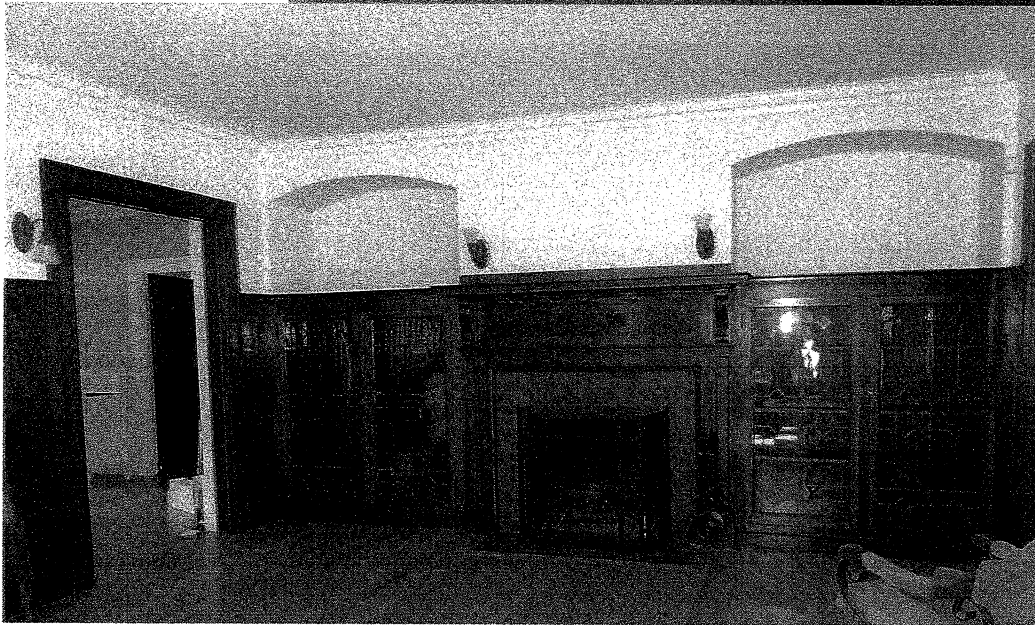
Living room

The living room, extra large as noted, has a high wainscot, cabinets, and fireplace surround in mahogany, retaining the original color and finish, a truly elegant room. Skylights let into the ceiling where the room projects give some added light but are sadly incongruous, indications of the fashion for "light and bright" which accounts for the white walls of most rooms. The skylights probably date from the 1990s.

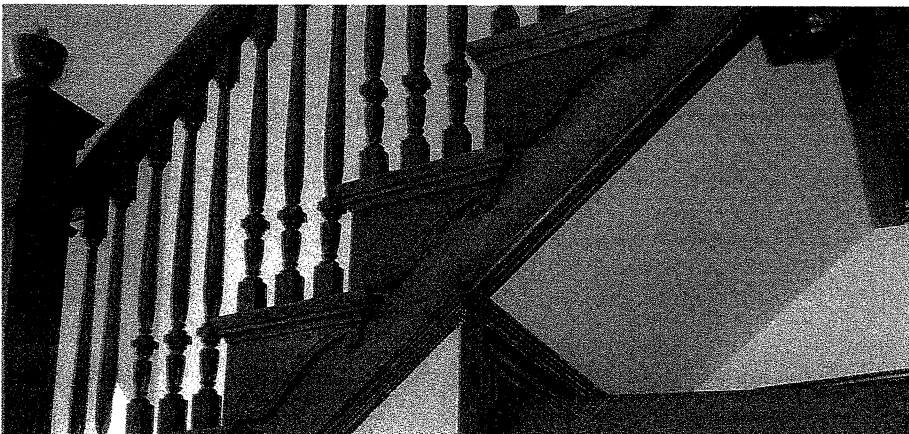
Trim on stair ends

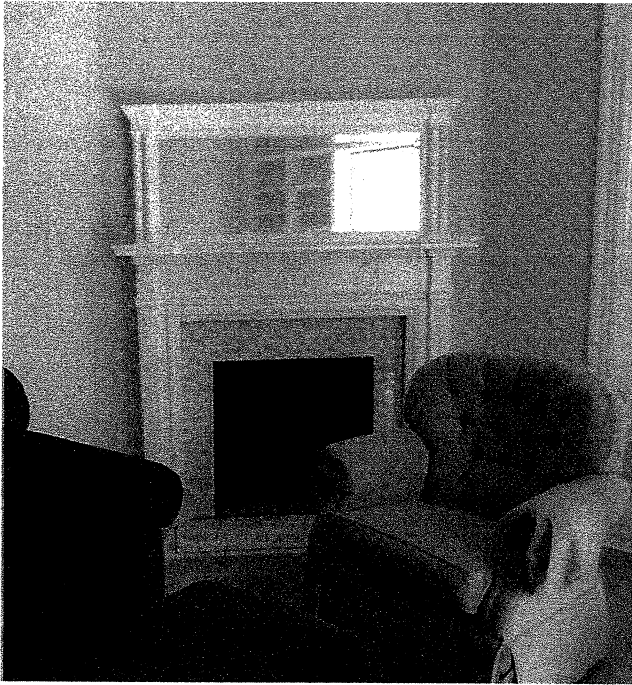
Above left: painted mantel in reception area.
