A-1	Drawing: <b>FLOOR PLAN</b>	Date: 6/19/15	Scale: 1/4" = 1'-0"	Architect: <b>SHIELDS ARCHITECTURE</b>	Builder: <b>HARDYPOND CONSTRUCTION</b>
	Project: <b>INTERIOR FIT-UP</b> 660 FOREST AVENUE PORTLAND, MAINE	Revisions: 1 10/9/15 - Kitchen and toilet room layouts changed. 2 10/26/15 - Amendment to BP#2015-01508, Kitchen and toilet room layouts changed.		CUMBERLAND, MAINE (207) 776-8926	7 TEE DRIVE PORTLAND, MAINE 04103

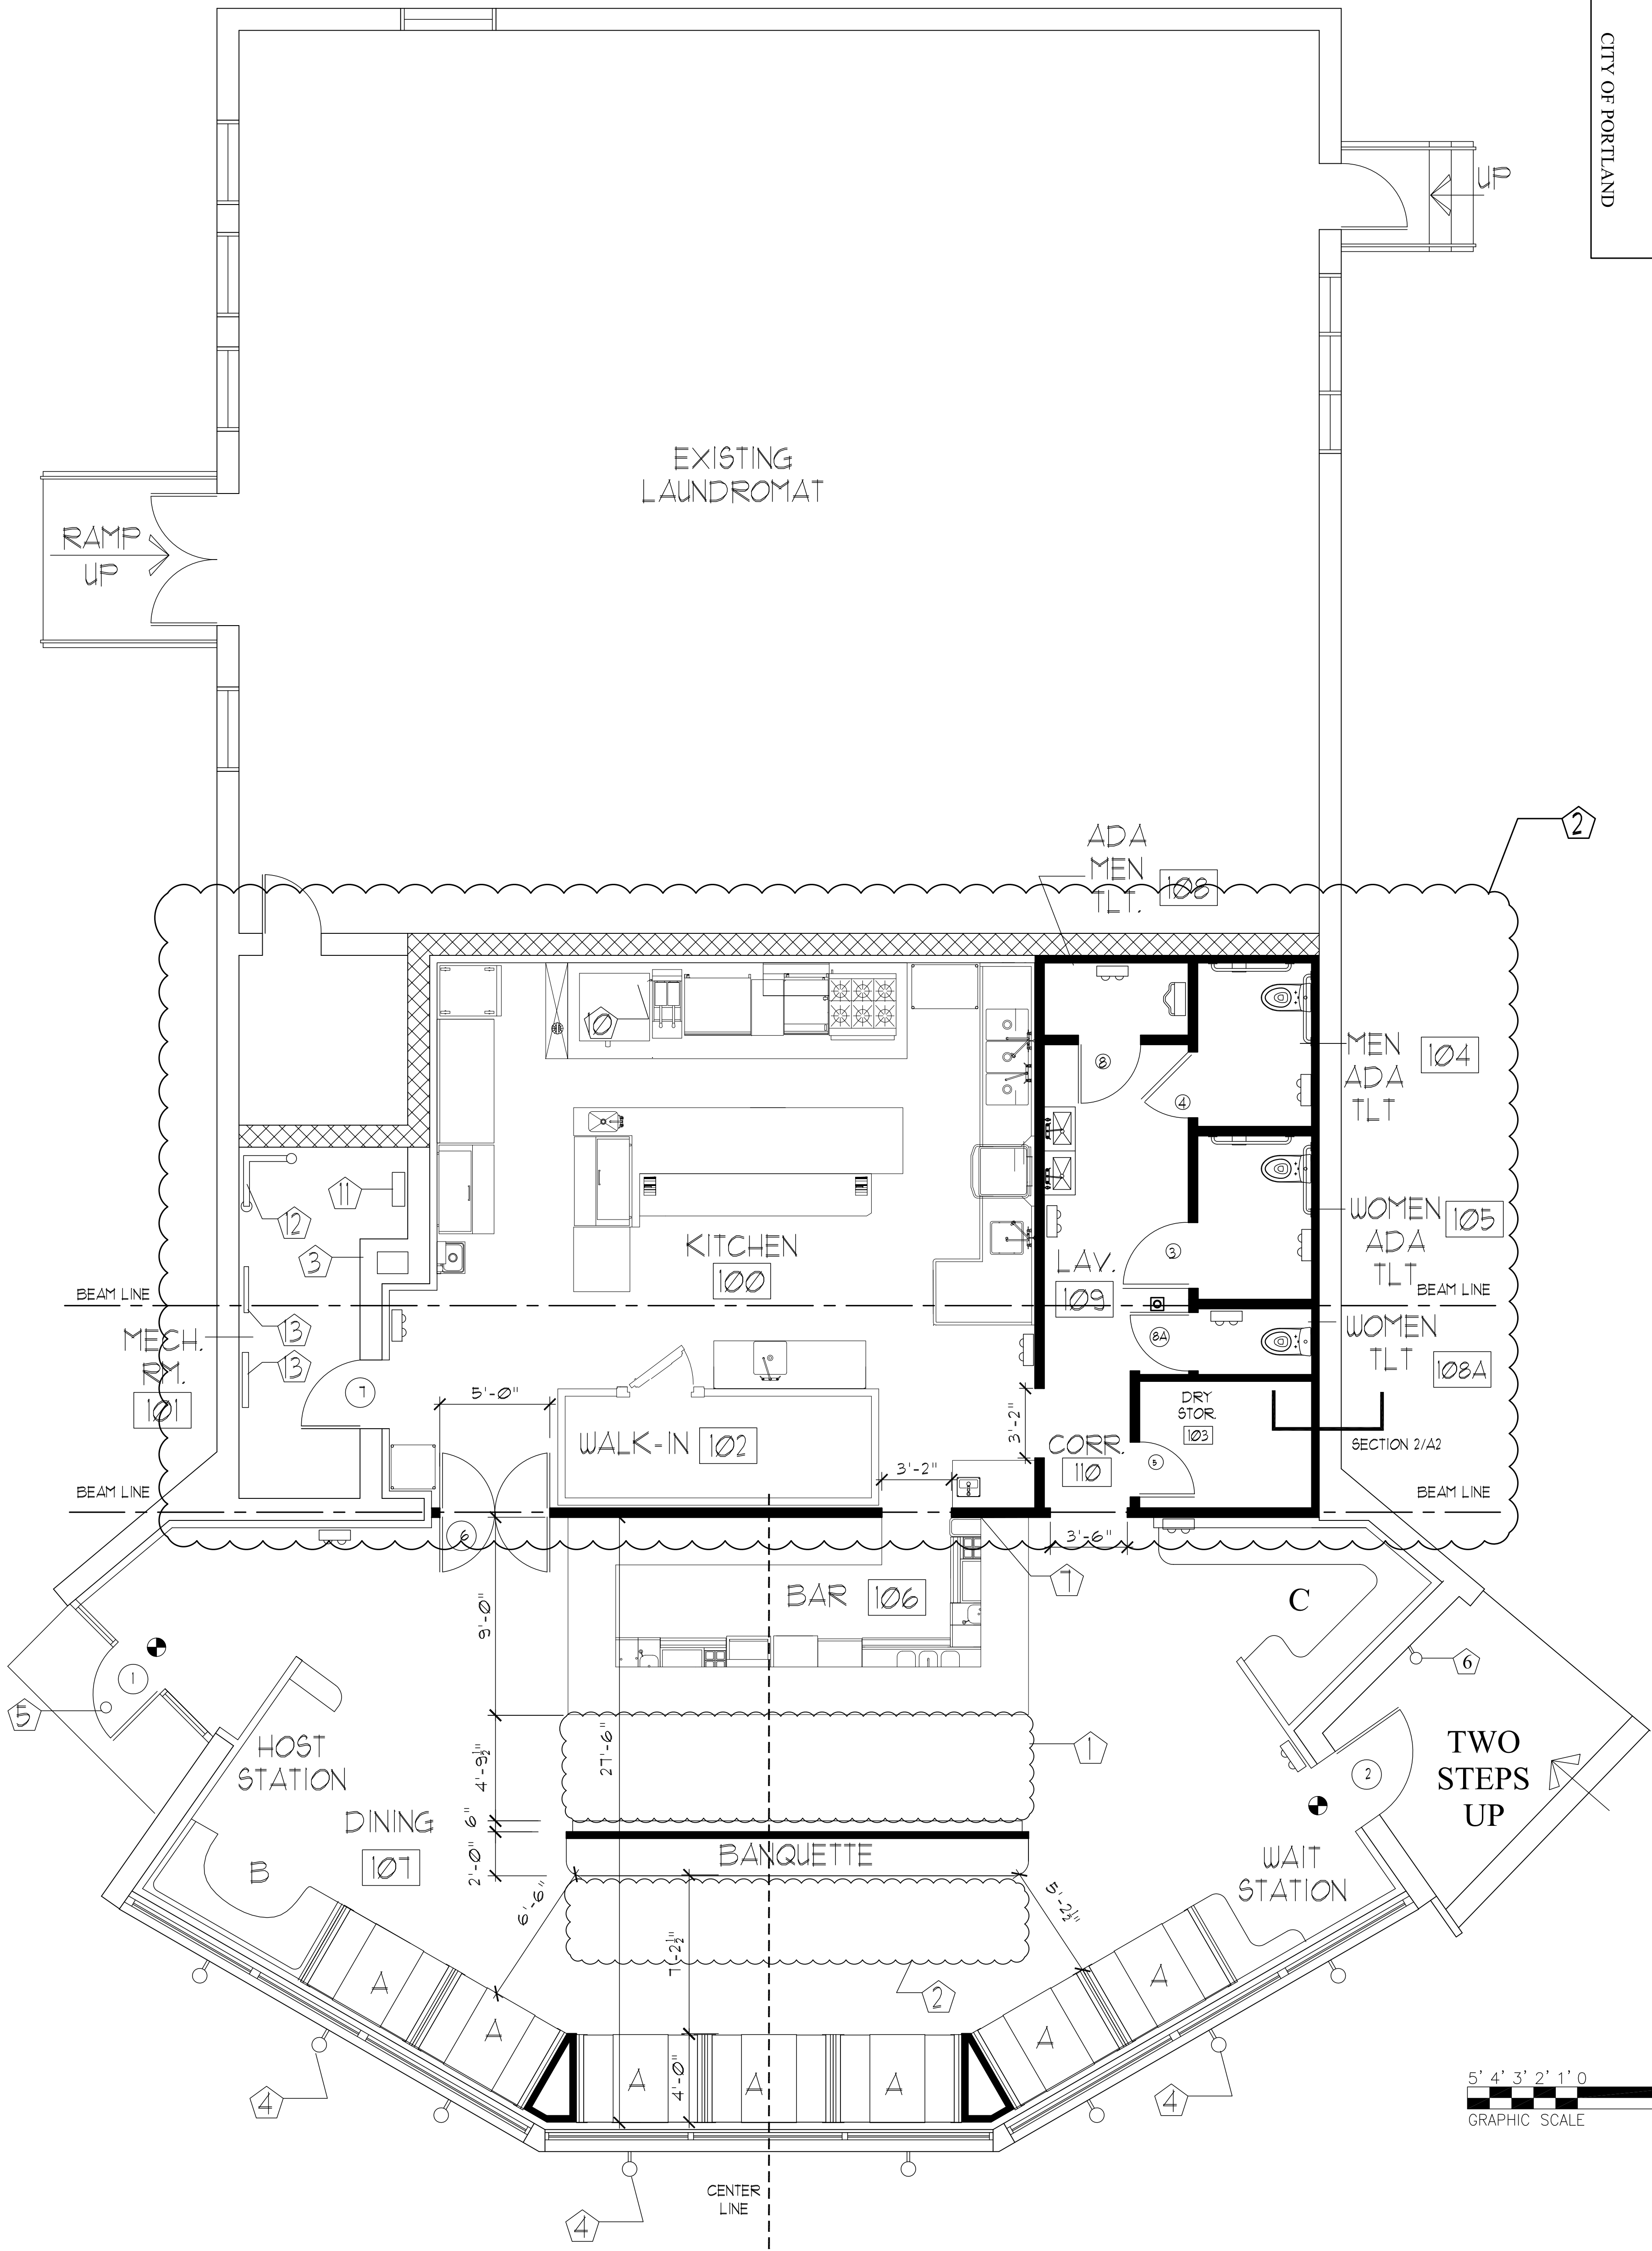
EXISTING DEMISING WALL - 1'-0" CMU W/2X4 STUD WALL W/G.B. FINISH ON RESTAURANT SIDE - 3 HOUR FIRE RESISTANCE RATING. SEE KEYED NOTE 10 FOR ADD'L INFO.  
EXIT SIGN  
EMERGENCY LIGHTING

- 3 EXISTING NON-ACTIVE CHIMNEY
- 4 EXISTING EXTERIOR LIGHT FIXTURES TO REMAIN - TYPICAL OF 2.
- 5 NEW RECESSED LIGHT FIXTURE INSTALLED IN EXISTING ROOF AT DOOR 1.
- 6 NEW SURFACE MOUNTED DOWN DIRECTED CAN-TYPE LIGHT FIXTURE INSTALLED AT DOOR 2.
- 7 NEW COLUMN & FOOTING - SEE STRUCTURAL DESIGN CONSULTING MEMO DATED 6/19/15.
- 8 NOT USED.
- 9 NOT USED.
- 10 NOT USED.
- 11 TELEPHONE PANEL.
- 12 WATER ENTRANCE.
- 13 ELECTRICAL PANEL.

- 1 ENCLOSED AREA INDICATES AREA OF CONCENTRATED USE, WITHOUT FIXED SEATING. ONE OCCUPANT PER 7 SQUARE FEET.
- 2 ENCLOSED AREA INDICATES AREA OF LESS CONCENTRATED USE, WITHOUT FIXED SEATING. ONE OCCUPANT PER 15 SQUARE FEET.
