SEGAL  
15 ALBA STREET  
PORTLAND, ME 04103  
133-D012 001

Permit Application for Roof and Porch Repair

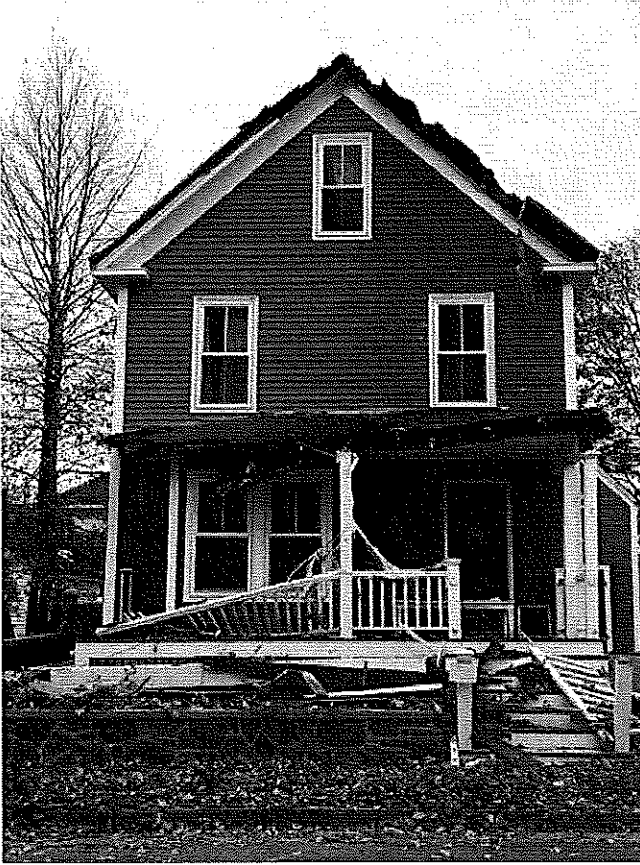
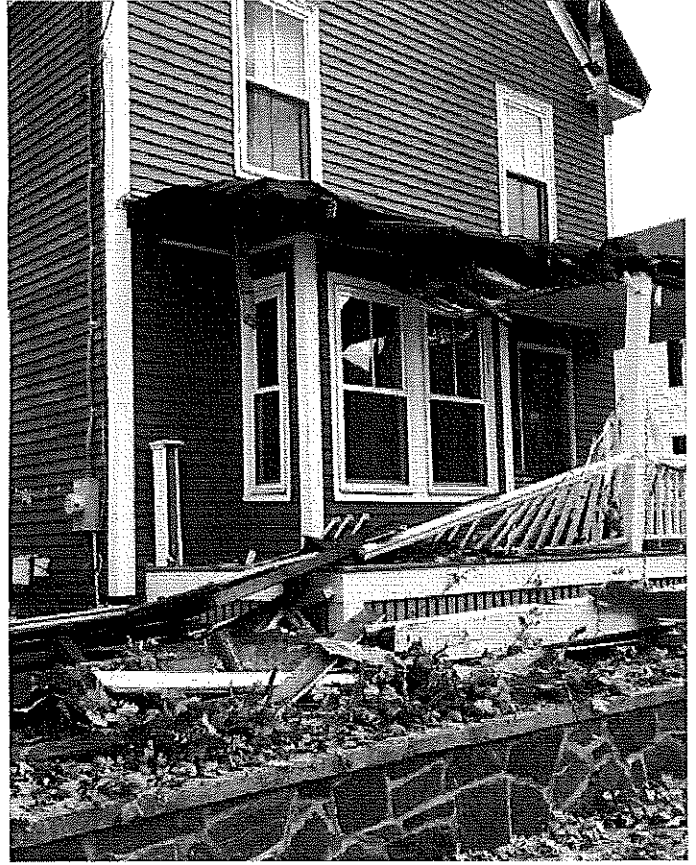
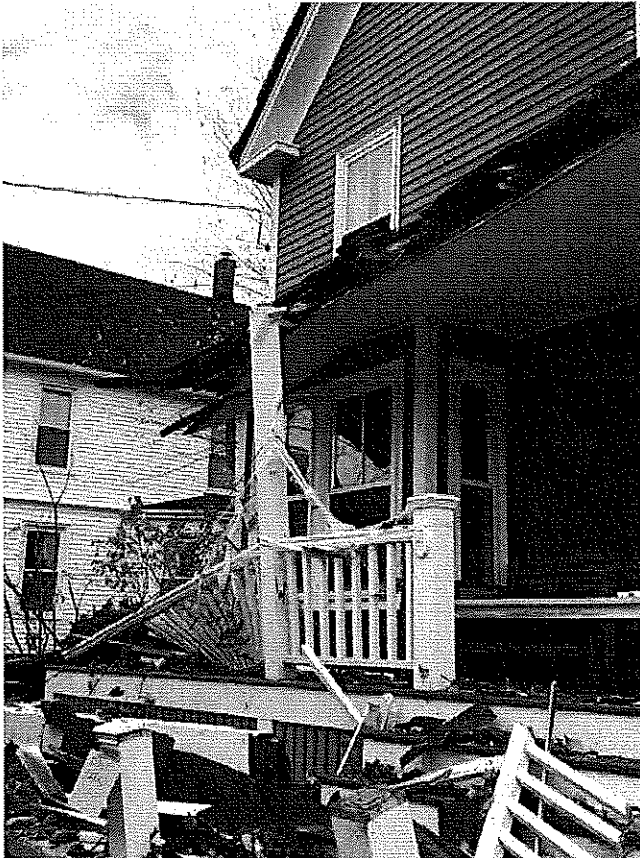
The roof and porch were damaged by a large tree that fell during storm on 10/29/17.

The upper roof rake will be rebuilt with wood trim and metal edging and the roof replaced with dark gray architectural shingles.

The 7.25' x 21' (152.25 sf) porch will be rebuilt in the same location with the same materials: wood railings, post, roof joists, and trim. The porch roof will match the upper roof shingles. The new porch decking will match existing composite decking.

The lowest step on the existing stairs meets the back side of the sidewalk. The porch is currently 12' from the road curbing, 4.6' from sidewalk, 14.25' +/- from the left side property line and 19.75' +/- from the right side property line. The rebuilt porch will be the same size as pre-existing porch.
