PROJECT NO.
15002
 PROJECT NAME
15 WALTON STREET
PORTLAND, ME

DRAWN BY
MKL
 SHEET TITLE
3rd Framing Plan

S
S1.4

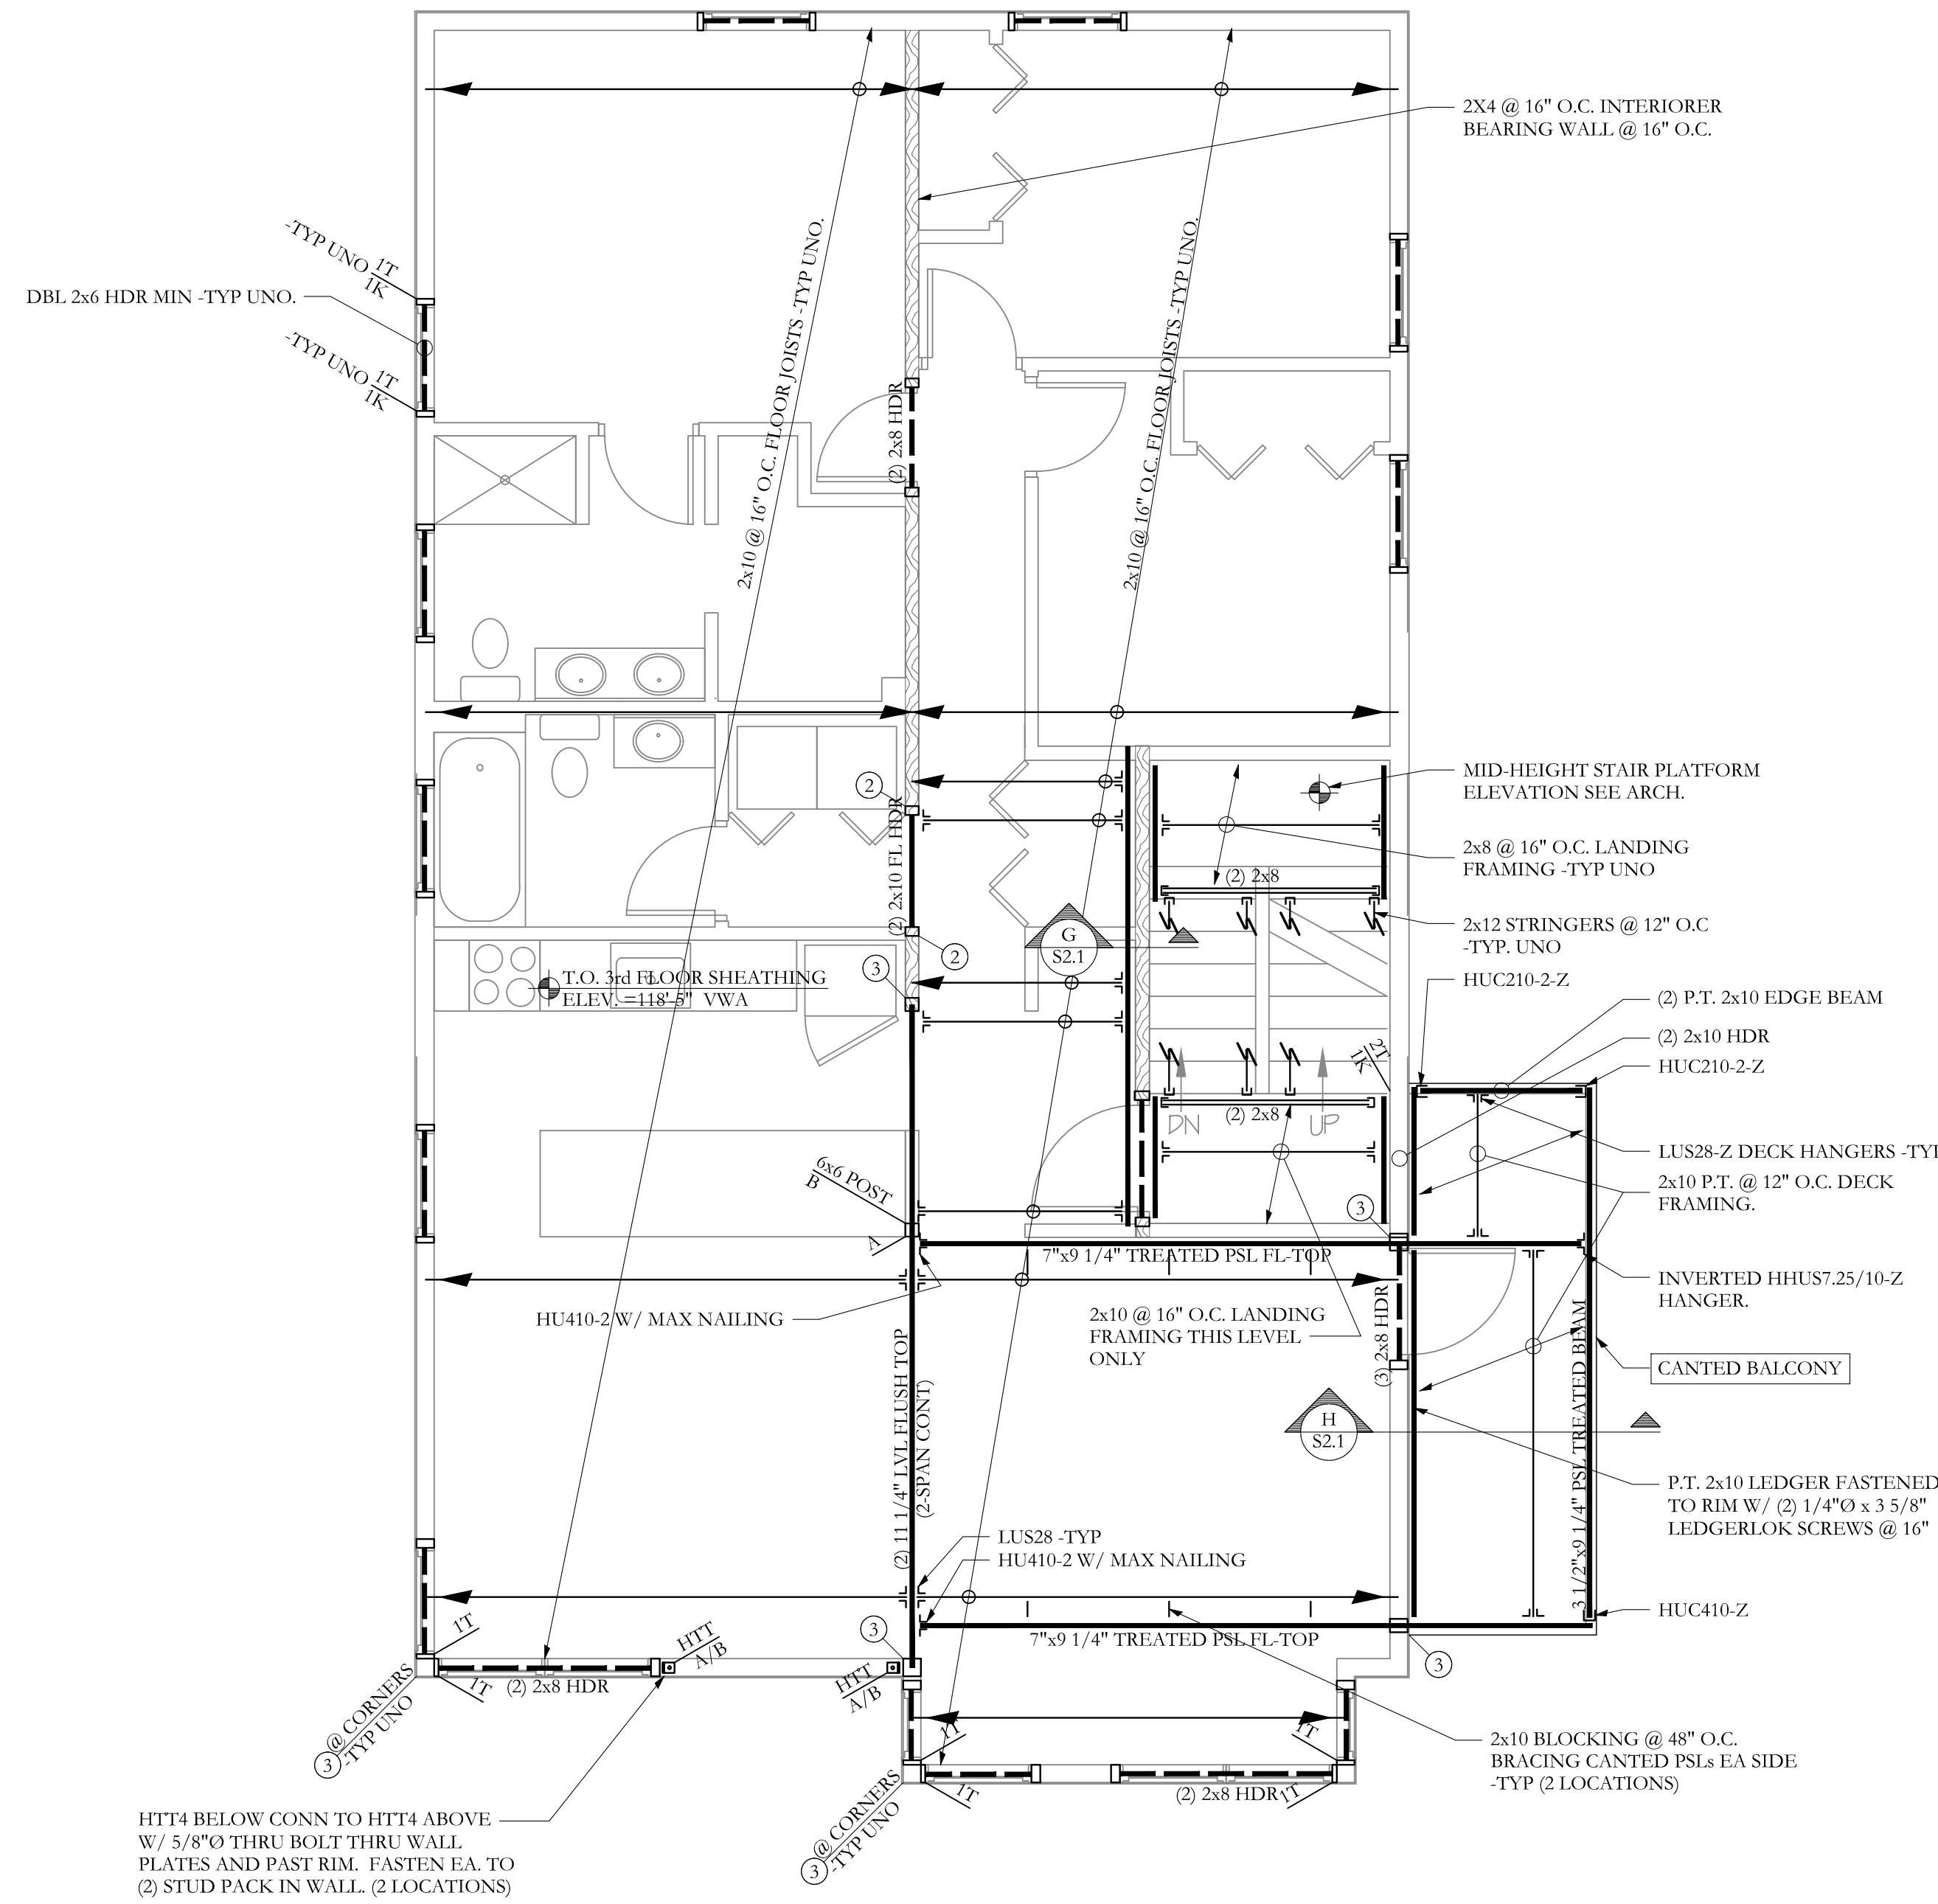
3RD FLOOR FRAMING PLAN
 SCALE 1/4" = 1'-0"

FRAMING PLAN SYMBOLS KEY	
□	WOOD POST
○	STEEL COLUMN
⊗	NUMBER OF WOOD STUDS IN POST BELOW
A	COLUMN ABOVE THIS LEVEL
C	COLUMN CONTINUOUS THROUGH THIS LEVEL
←	JOIST BEARING
→	CONTINUOUS JOIST WITH INTERMEDIATE BEARING
↔	FLUSH FRAMED JOIST BEARING WITH HANGER
▬	WOOD STUD BEARING WALL BELOW
▬	OVER FRAMING BY OTHERS -TYP
⊗	NUMBER OF TRIM STUDS UNDER HEADER
⊗	NUMBER OF KING STUDS ADJACENT TO HEADER
