Masonry Construction Observation Report

Project Name/Location:	Park Danforth				Project No:	14-0065.2	
Client/Client's Rep.:	The Park Danforth				Date:	4-28-16	
Masonry Contractor: Custom Masonry				Sheet:	1 of 1		
Placement Location: 8" CMU wall for Elevator A mid-h			jht on 2 nd 1	floor	S.W.COLE Rep.:	C. Cromwell	
Weather:	Sunny 40's				On Site:	7:30-10:30	
Referenced Drawings		Date	Page	Revision	Comments		
Becker-General Notes		10/16/15	S0.0				
Becker- Typical Concrete Sections and Details		10/16/15	S2.1				
Becker-Foundation Section and Details		10/16/15	S2.4				
Harris Rebar-Masonry Elevator A		12/11/15	R01B				
Masonry Construction			Observed				
Proportioning of site-mixed mortar			Yes 🛚	No 🗌	Quickrete Type S spec mix		
Placement of units and constru	nts	Yes 🛚	No 🗌	Full Joint Construction			
Joint reinforcing (type, spacing, laps)			Yes 🛚	No 🗌	16" O.C. ladder type		
Vertical reinforcing (size, spacing, positioners, laps)			Yes 🛚	No 🗌	#5 @ 32" O.C.

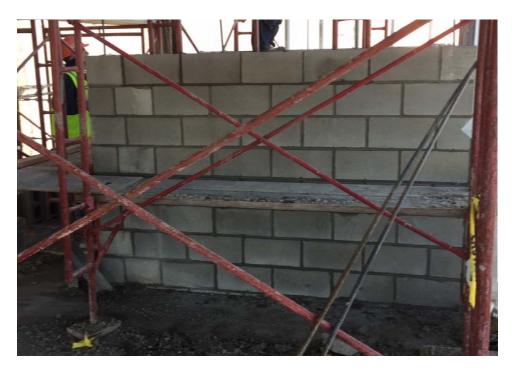
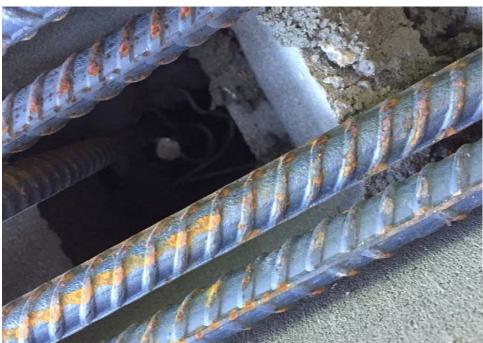
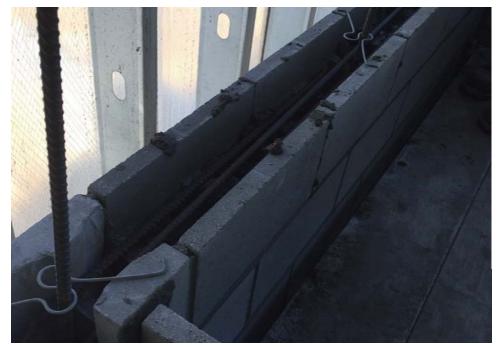
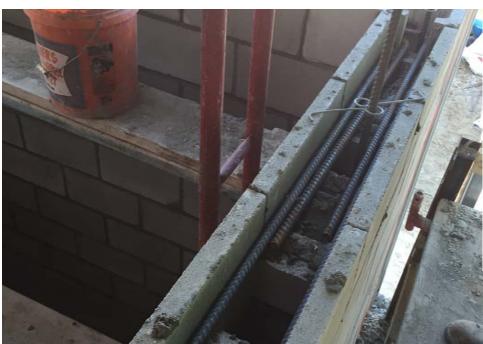
Attachments: Photos			Reviewed By: KBG

Horizontal reinforcing (size, spacing, positioners, laps)			Yes 🛚	No 🗌	(2) #5 mid height		
Cold-weather / Hot-weather construction (temperature, practices)			Yes 🗌	No 🖂	45°F		
Embedments and anchor bolts			Yes 🗌	No 🖂	N/A		
Installation of flashing and weeps – material and placement			Yes 🗌	No 🖂	N/A		
Grout Placement Observed							
Grout space (cleanliness, mortar fins, size/alignment, etc.)			Yes 🛚	No 🗌	Clean		
Lift height (cleanouts if needed)			Yes 🛚	No 🗌	4'-00" Low Lift		
Proportions of site-mixed grout or vendor mix used			Yes 🛚	No 🗌	Quickrete spec mix		
Placement of grout (consolidate	on)	Yes 🛚	No 🗌				
Field Testing Performed refer to associated spec	rformed Grout ⊠			Mortar ⊠		Prism 🖂	
	SET NO:	730-57		730	730-58 730-59		
NON-CONFORMANCE ITEMS OBSERVED (person notified)			Yes [☐ No 🗵			
Notes: On site as scheduled to perform a pre-grout inspection of cells and reinforcing steel and to form test specimens in accordance with the schedule of special inspections. When S.W.COLE arrived onsite Custom Masonry was finishing up laying block for bond beam course. Vertical reinforcing observed consisted of the #5 verticals at 32" O.C. and joint reinforcing at 16" O.C. Horizontal reinforcing consisted of two #5 horizontals for the bond beam at midway of walls. Vertical bars next to door opening where masons racked back for elevator door will be drilled and epoxied in after grouting. A set of mortar cubes and grout prisms were made onsite and Custom Masonry made three CMU prisms.
