SIDEWALK ABUTTING BRIGHTON AVENUE

1 Life Safety Plan

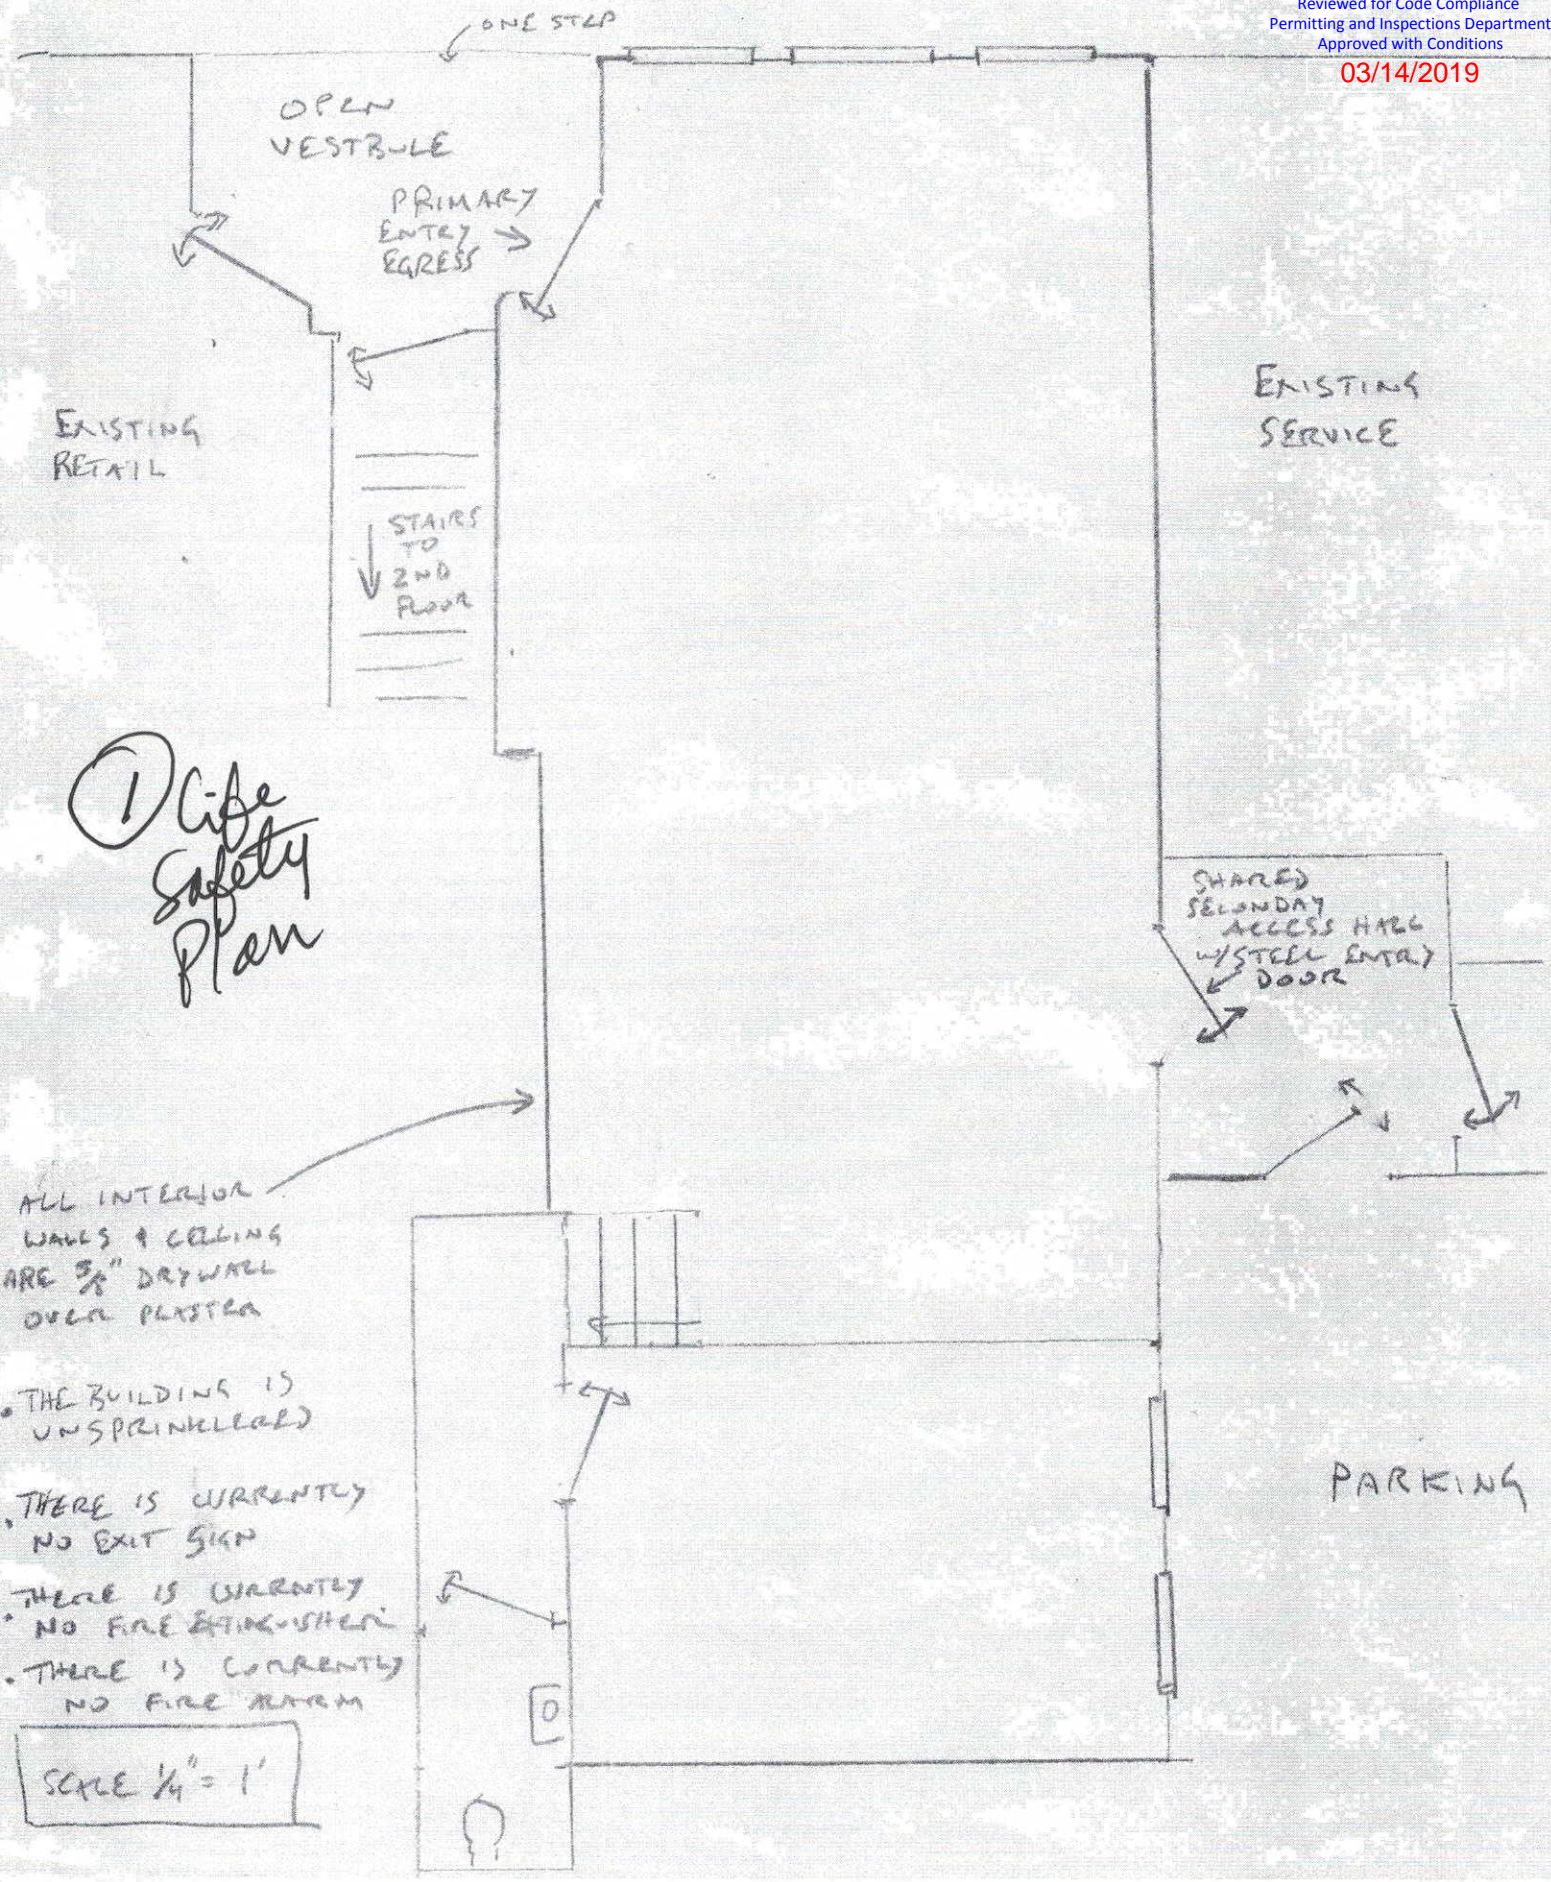
ALL INTERIOR WALLS & CEILING ARE 5/8" DRYWALL OVER PLASTER

• THE BUILDING IS UNSPRINKLED

• THERE IS CURRENTLY NO EXIT SIGN

• THERE IS CURRENTLY NO FIRE EXTINGUISHER

• THERE IS CURRENTLY NO FIRE ALARM

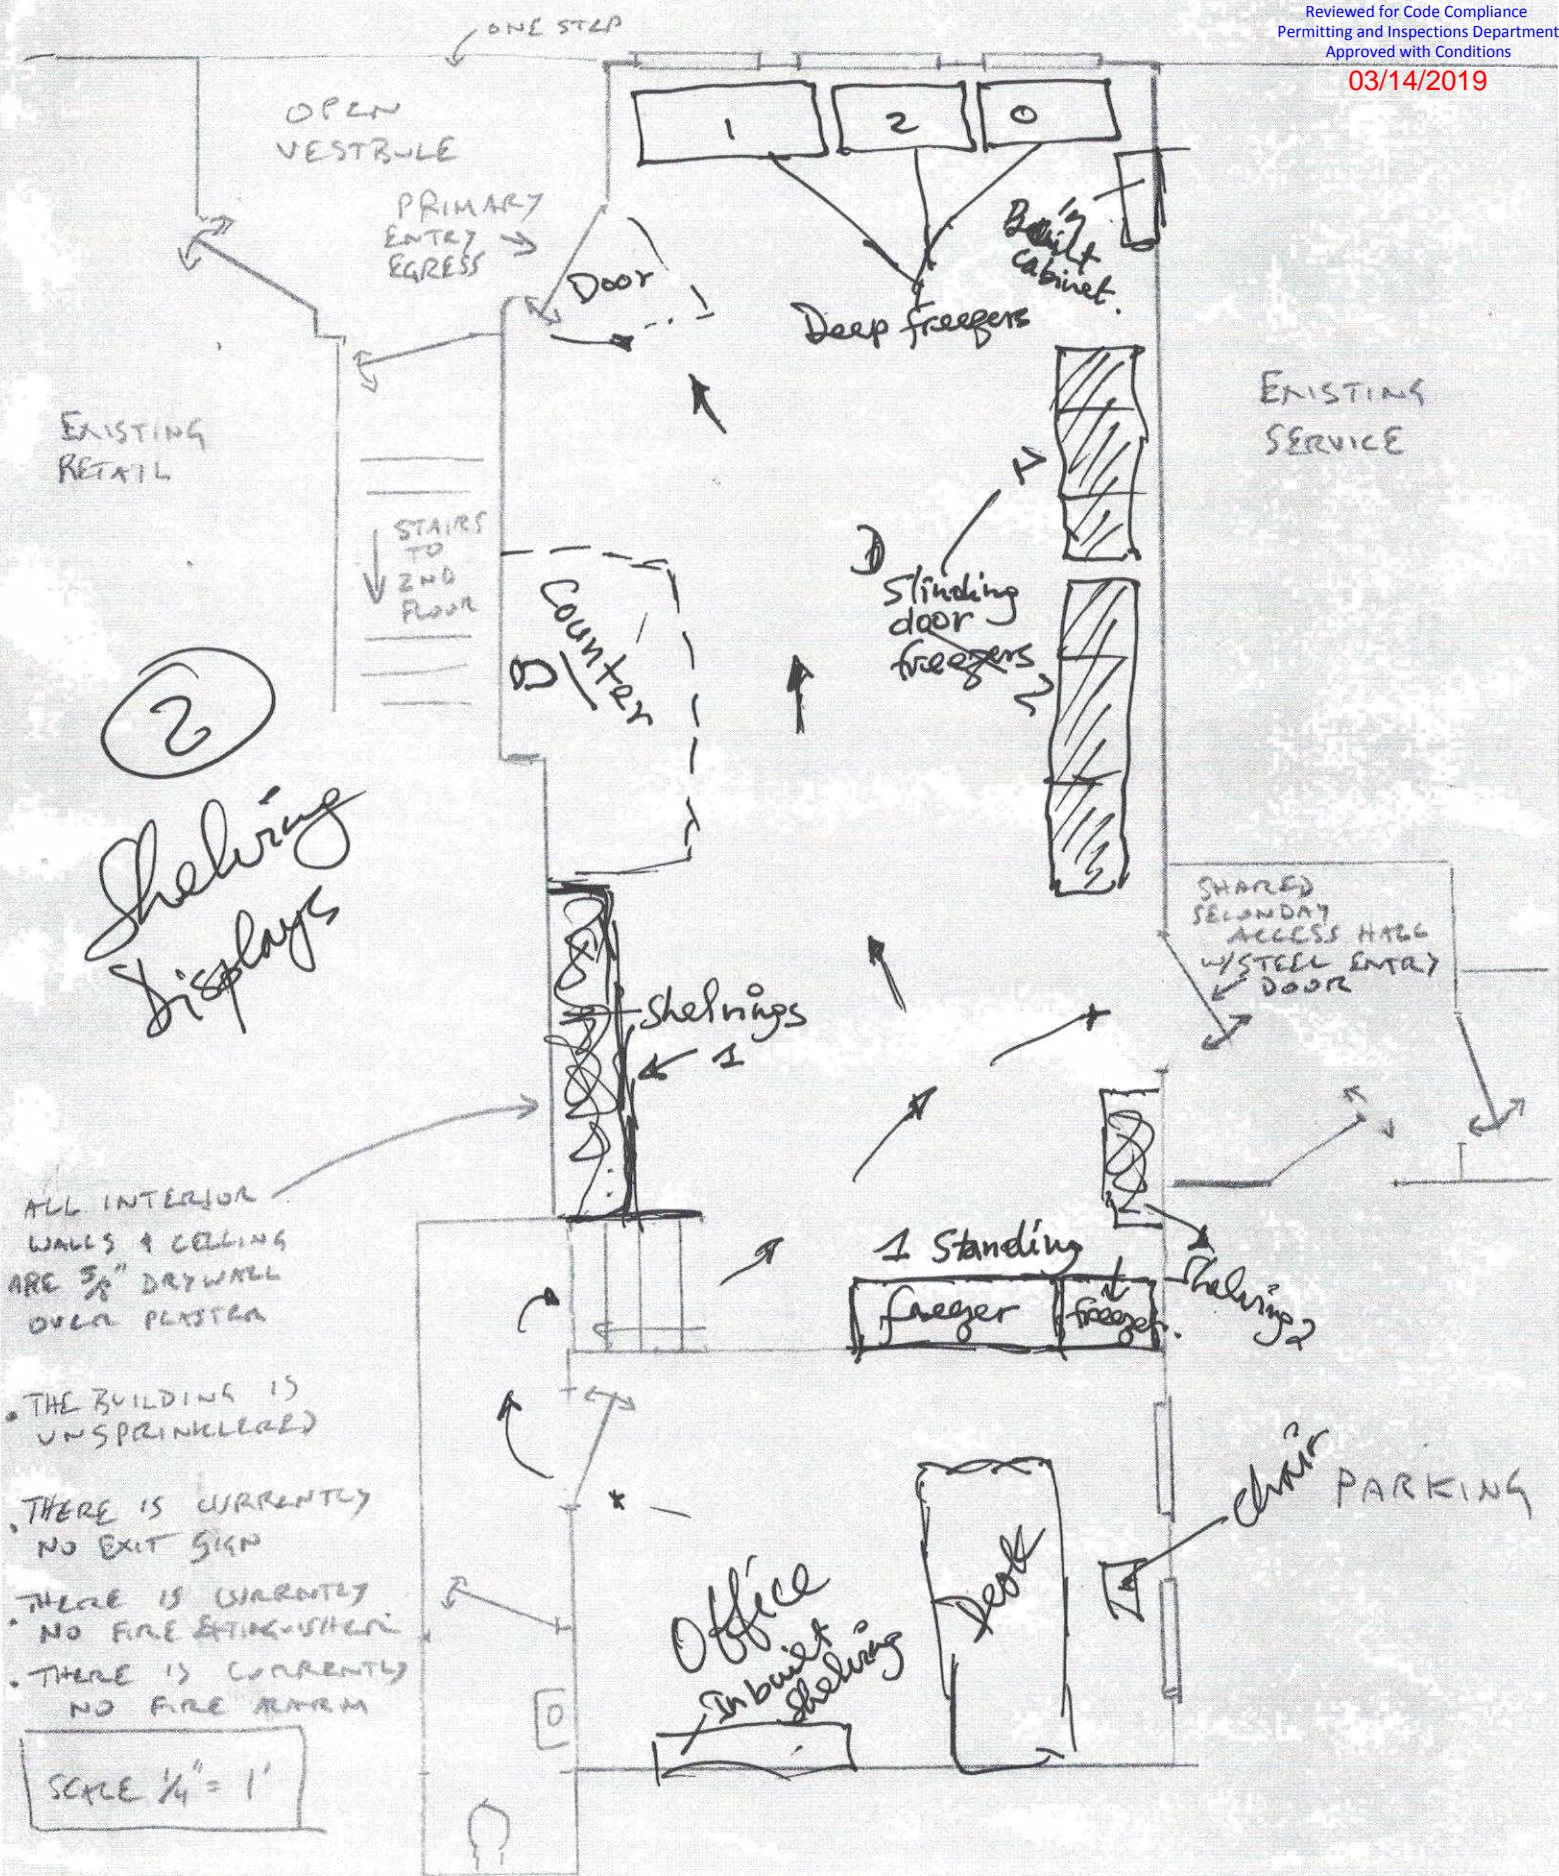
ALL INTERIOR WALLS & CEILING ARE 5/8" DRYWALL OVER PLASTER

THE BUILDING IS UNSPRINKLED

THERE IS CURRENTLY NO EXIT SIGN

THERE IS CURRENTLY NO FIRE EXTINGUISHER

THERE IS CURRENTLY NO FIRE ALARM
