PROJECT NAME:
1000 Riverside

RENOVATIONS
PORTLAND, ME

ROOF FRAMING PLAN-BUILDING 1

S101

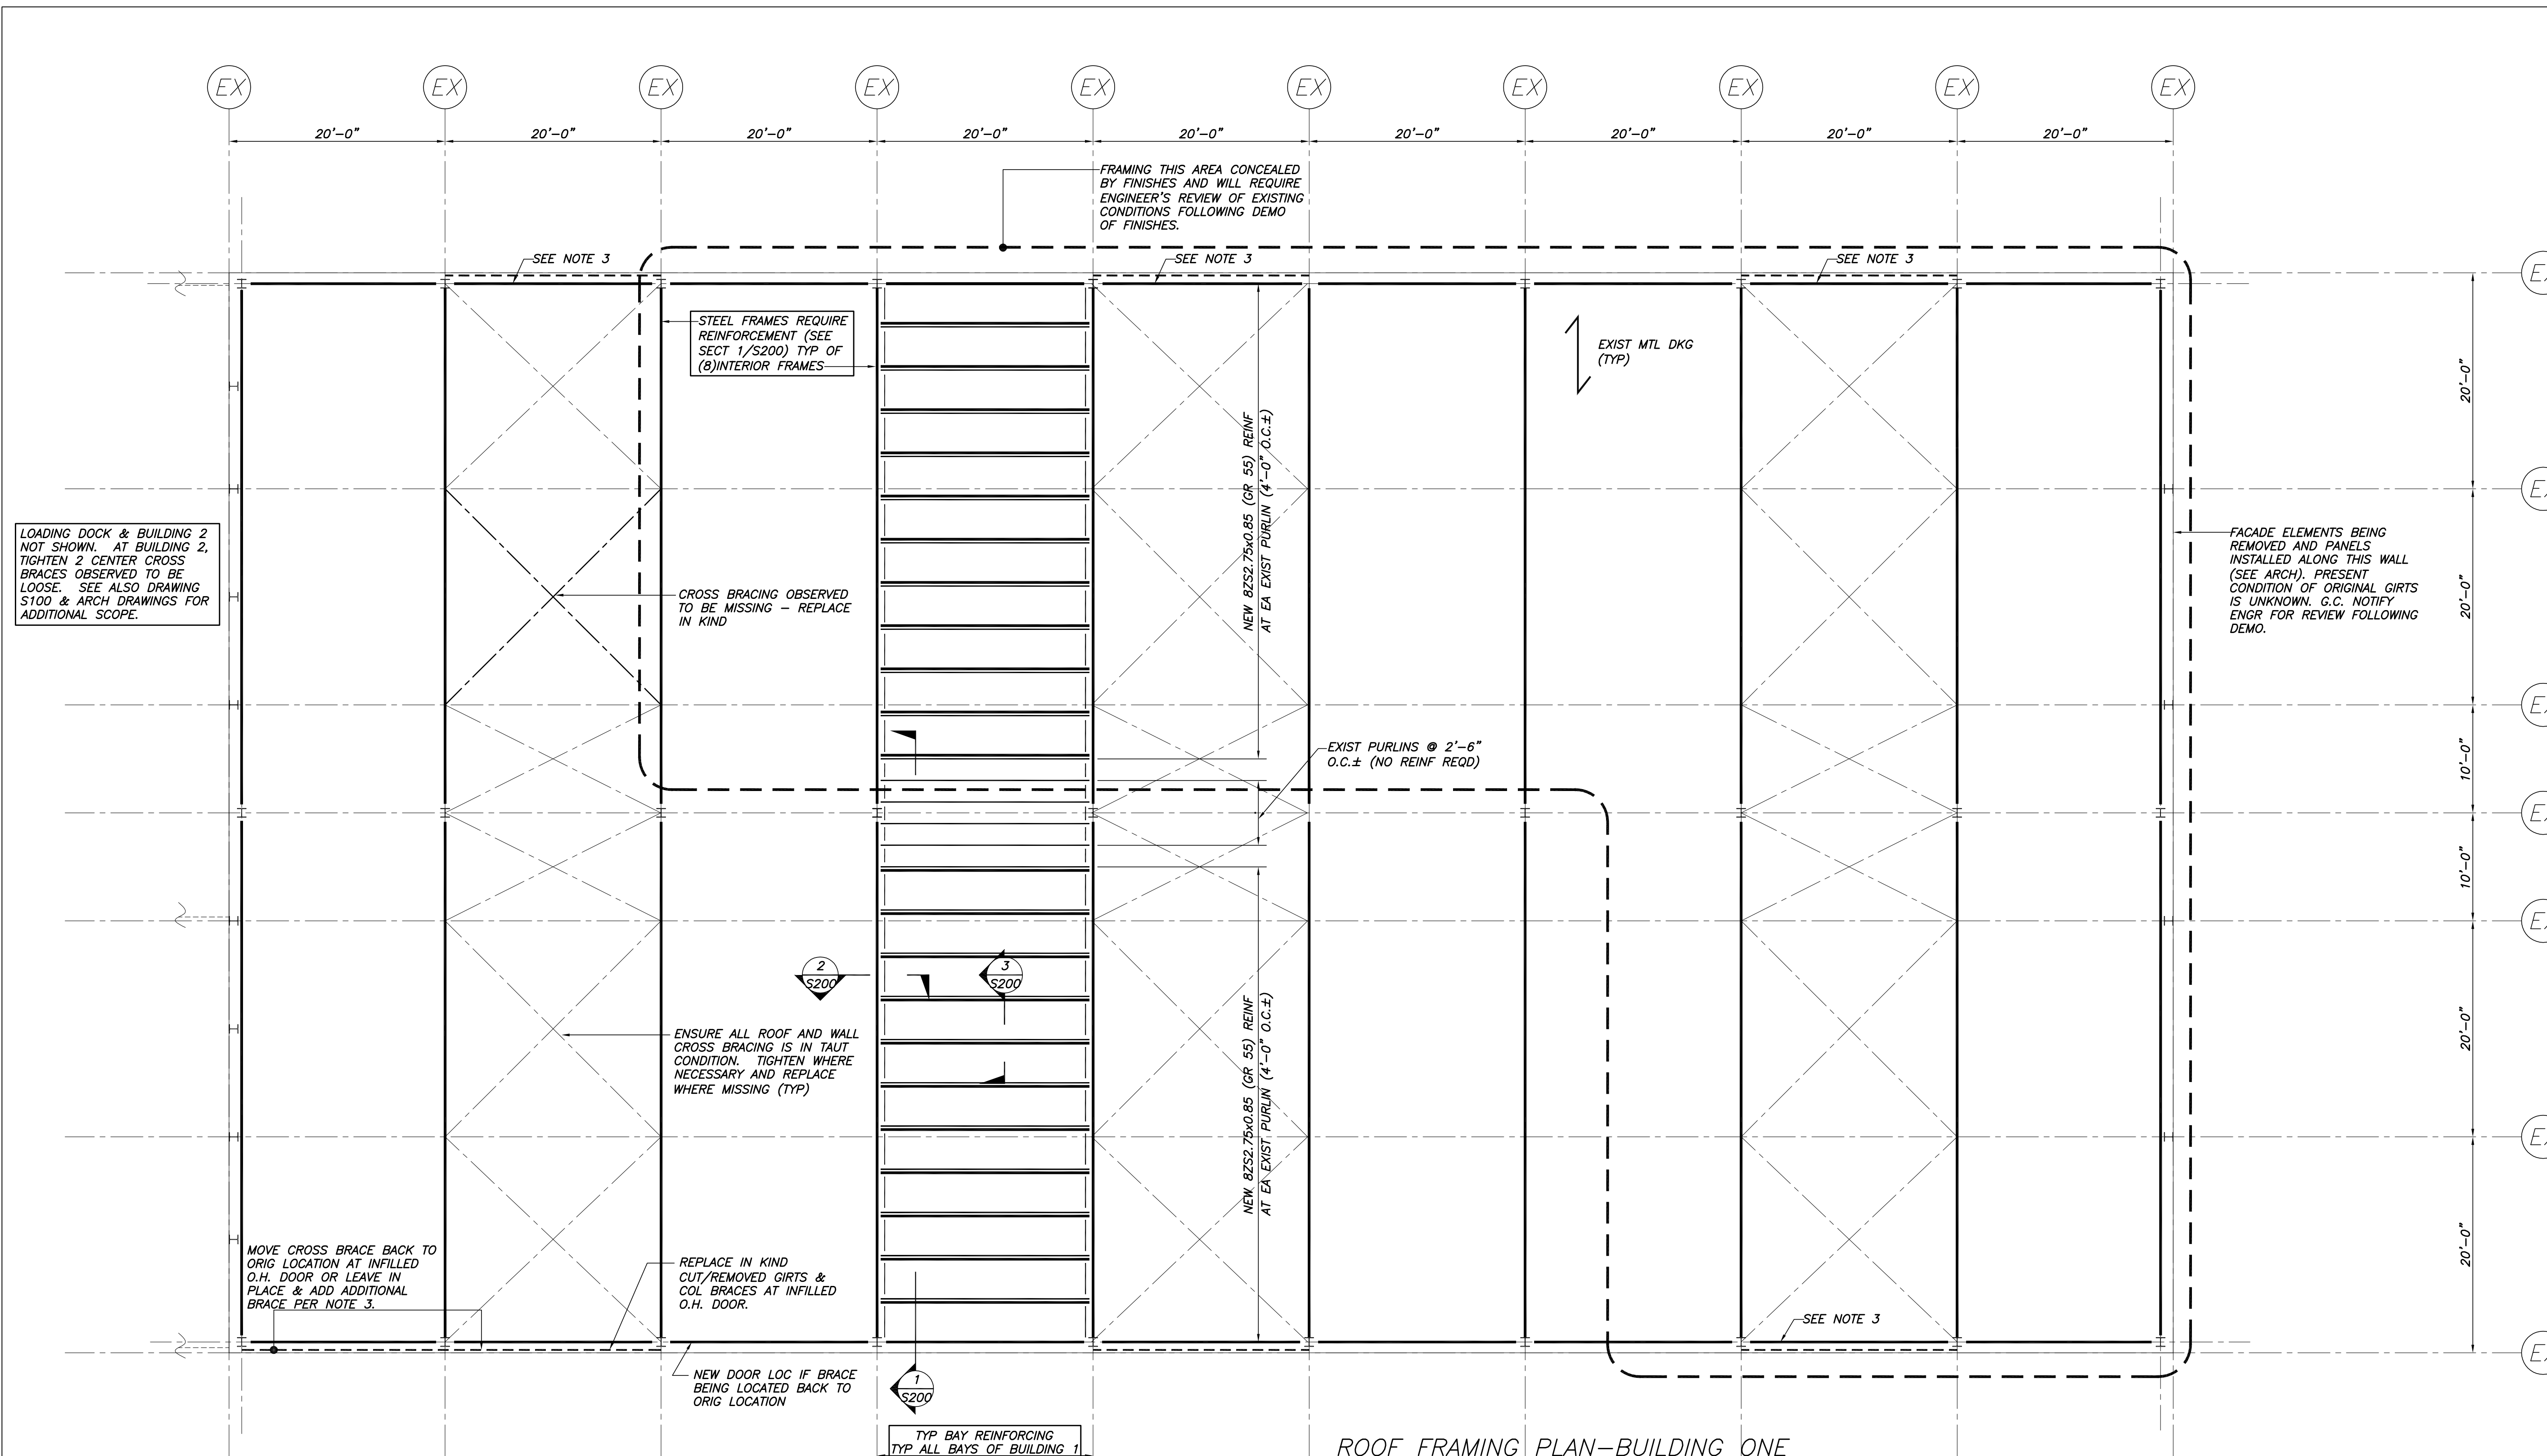
ROOF FRAMING PLAN—BUILDING ONE
1/8"=1'-0"

3. WALL CROSS BRACING HAS LIKELY BEEN REMOVED. CONFIRM & REPLACE ALL MISSING CROSS BRACING W/3/8" WIRE ROPE. ALL BRACING CONNECTIONS SIM TO EXISTING. INSTALL & TIGHTEN ALL BRACING COMPONENTS PRIOR TO REMOVAL OF EXISTING METAL SIDING. AT CONFLICT W/DOOR/WINDOW— OPTION TO OMIT BRACING AT ORIG LOCATION & PROVIDE BRACING AT ADJACENT BAYS, BOTH SIDES OF ORIG LOCATION.

4. LOCATIONS & WEIGHTS OF MECHANICAL R.T.U.'S ARE UNKNOWN & WILL LIKELY REQUIRE ADDITIONAL REINFORCEMENT OF PURLINS AND/OR STEEL FRAMES. G.C./OWNER SUBMIT SELECTED EQUIPMENT REQUIREMENTS TO ENGINEER FOR DESIGN OF REINFORCEMENT.

5. STRUCTURAL DESIGN OF ROOF REINFORCEMENT INCLUDES A 4 PSF ALLOWANCE FOR FUTURE SOLAR PANELS.
