PORTLAND
RETIREMENT RESIDENCE
802 OCEAN AVE. PORTLAND, MAINE 04103

STRUCTURAL
DETAILS

SHEET
S2.4

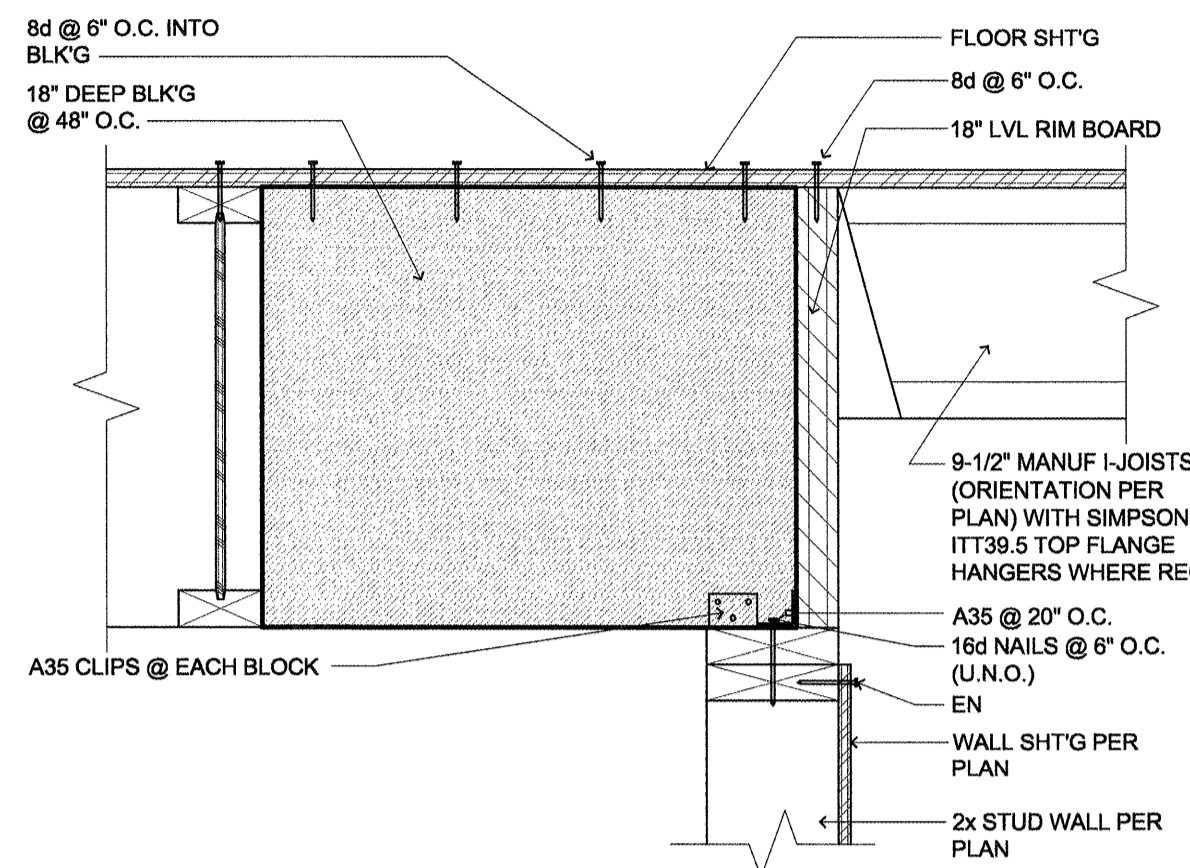
20 WALL / FLOOR INTERSECTION (JOISTS PERPENDICULAR/PARALLEL TO WALL)
SCALE: 1 1/2" = 1'-0"
