**PORTLAND RETIREMENT RESIDENCE**  
802 OCEAN AVE., PORTLAND, MAINE 04103

**ROOF DETAILS**

DATE: 8/28/2015  
REVISED DATE:  
SHEET: A7.2a

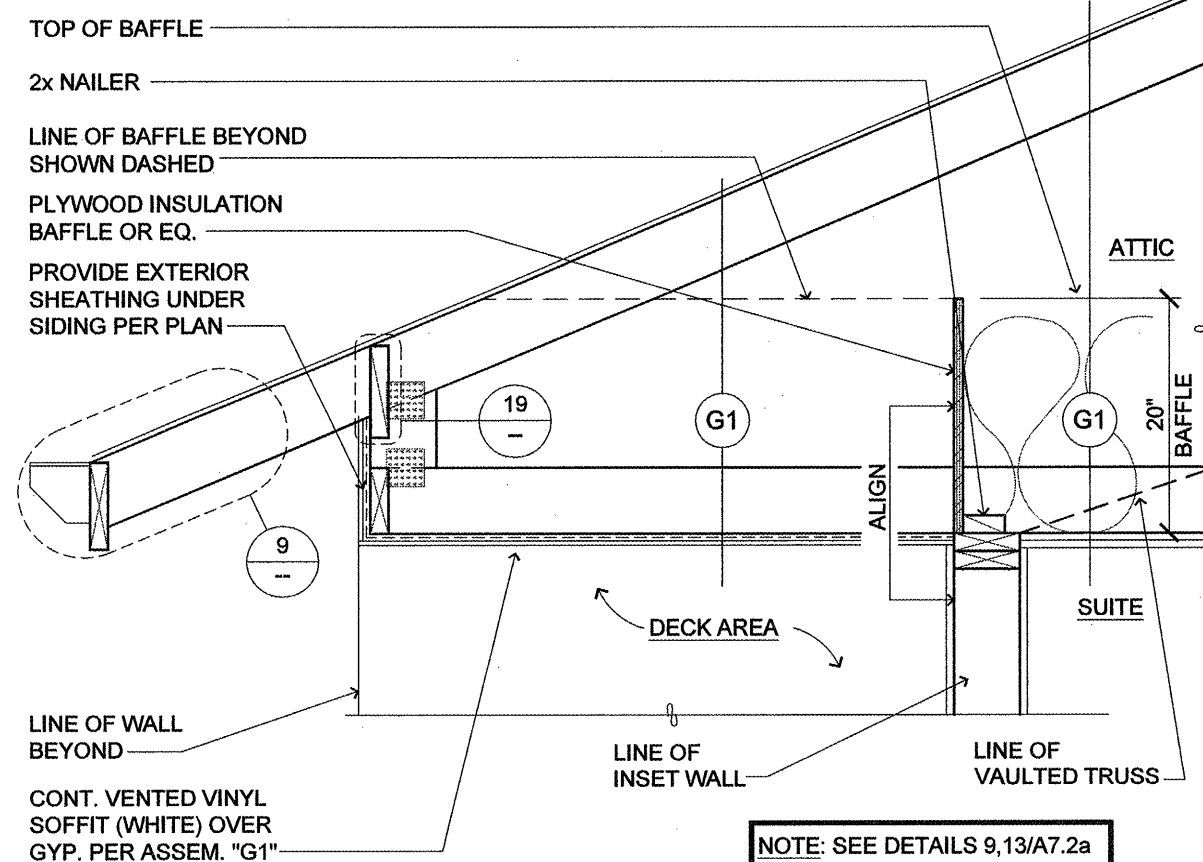
**20 INSUL. BAFFLE (AT DECK AND OVERHANGS GREATER THAN 24")**  
SCALE: 3/4" = 1'-0"

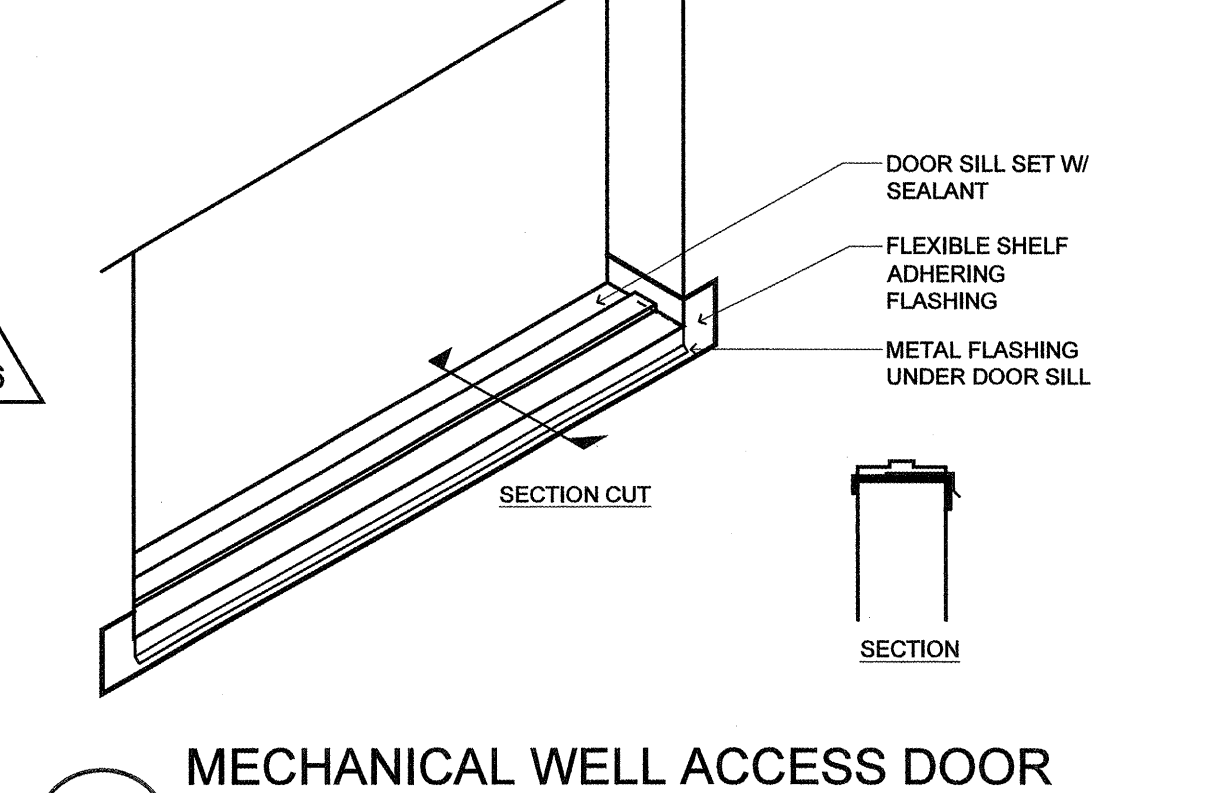
**14 MECHANICAL WELL ACCESS DOOR (SILL DETAIL)**  
SCALE: 1" = 1'-0"

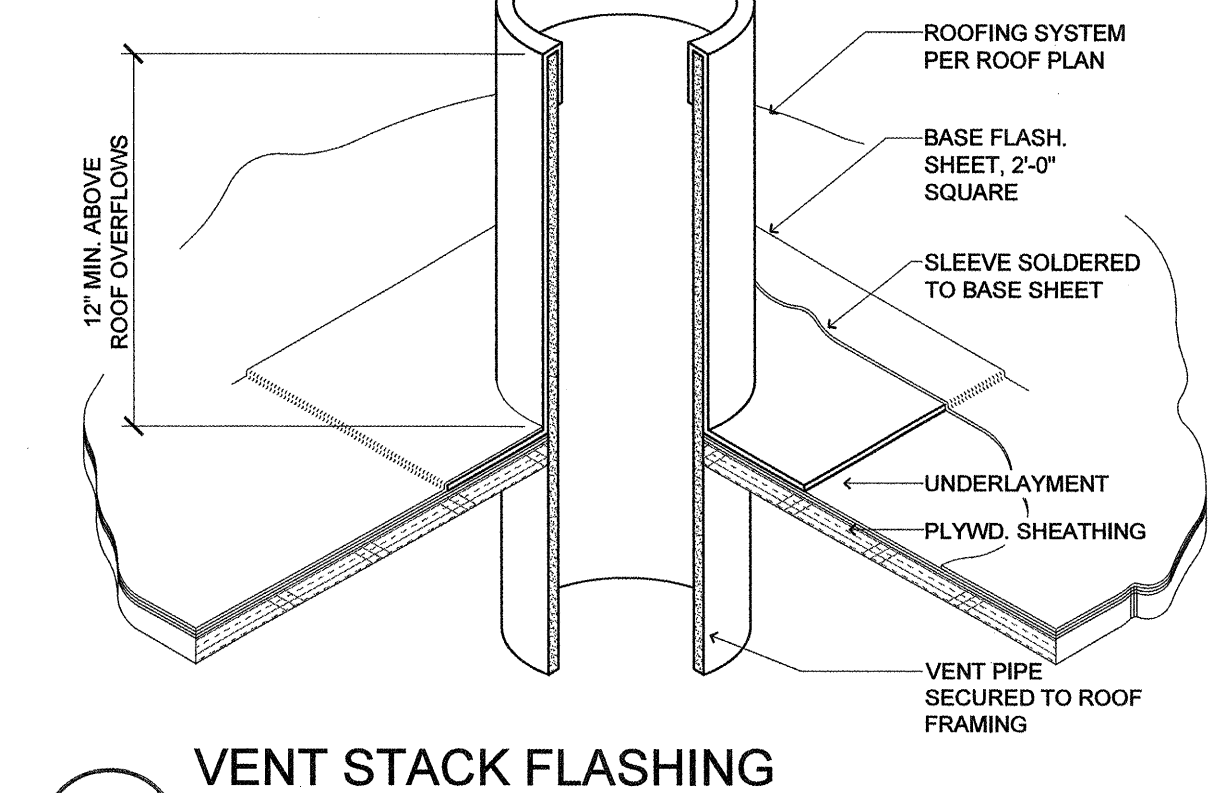
**10 VENT STACK FLASHING**  
SCALE: N.T.S.
