BUILDING 147 (BLDG NO. 2)

NORTHFIELD GREEN - RENOVATIONS
3 STRATON PLACE
PORTLAND, MAINE
ROOF REINFORCEMENT
BUILDING 147 (Bldg. no. 2) ROOF PLAN

S1

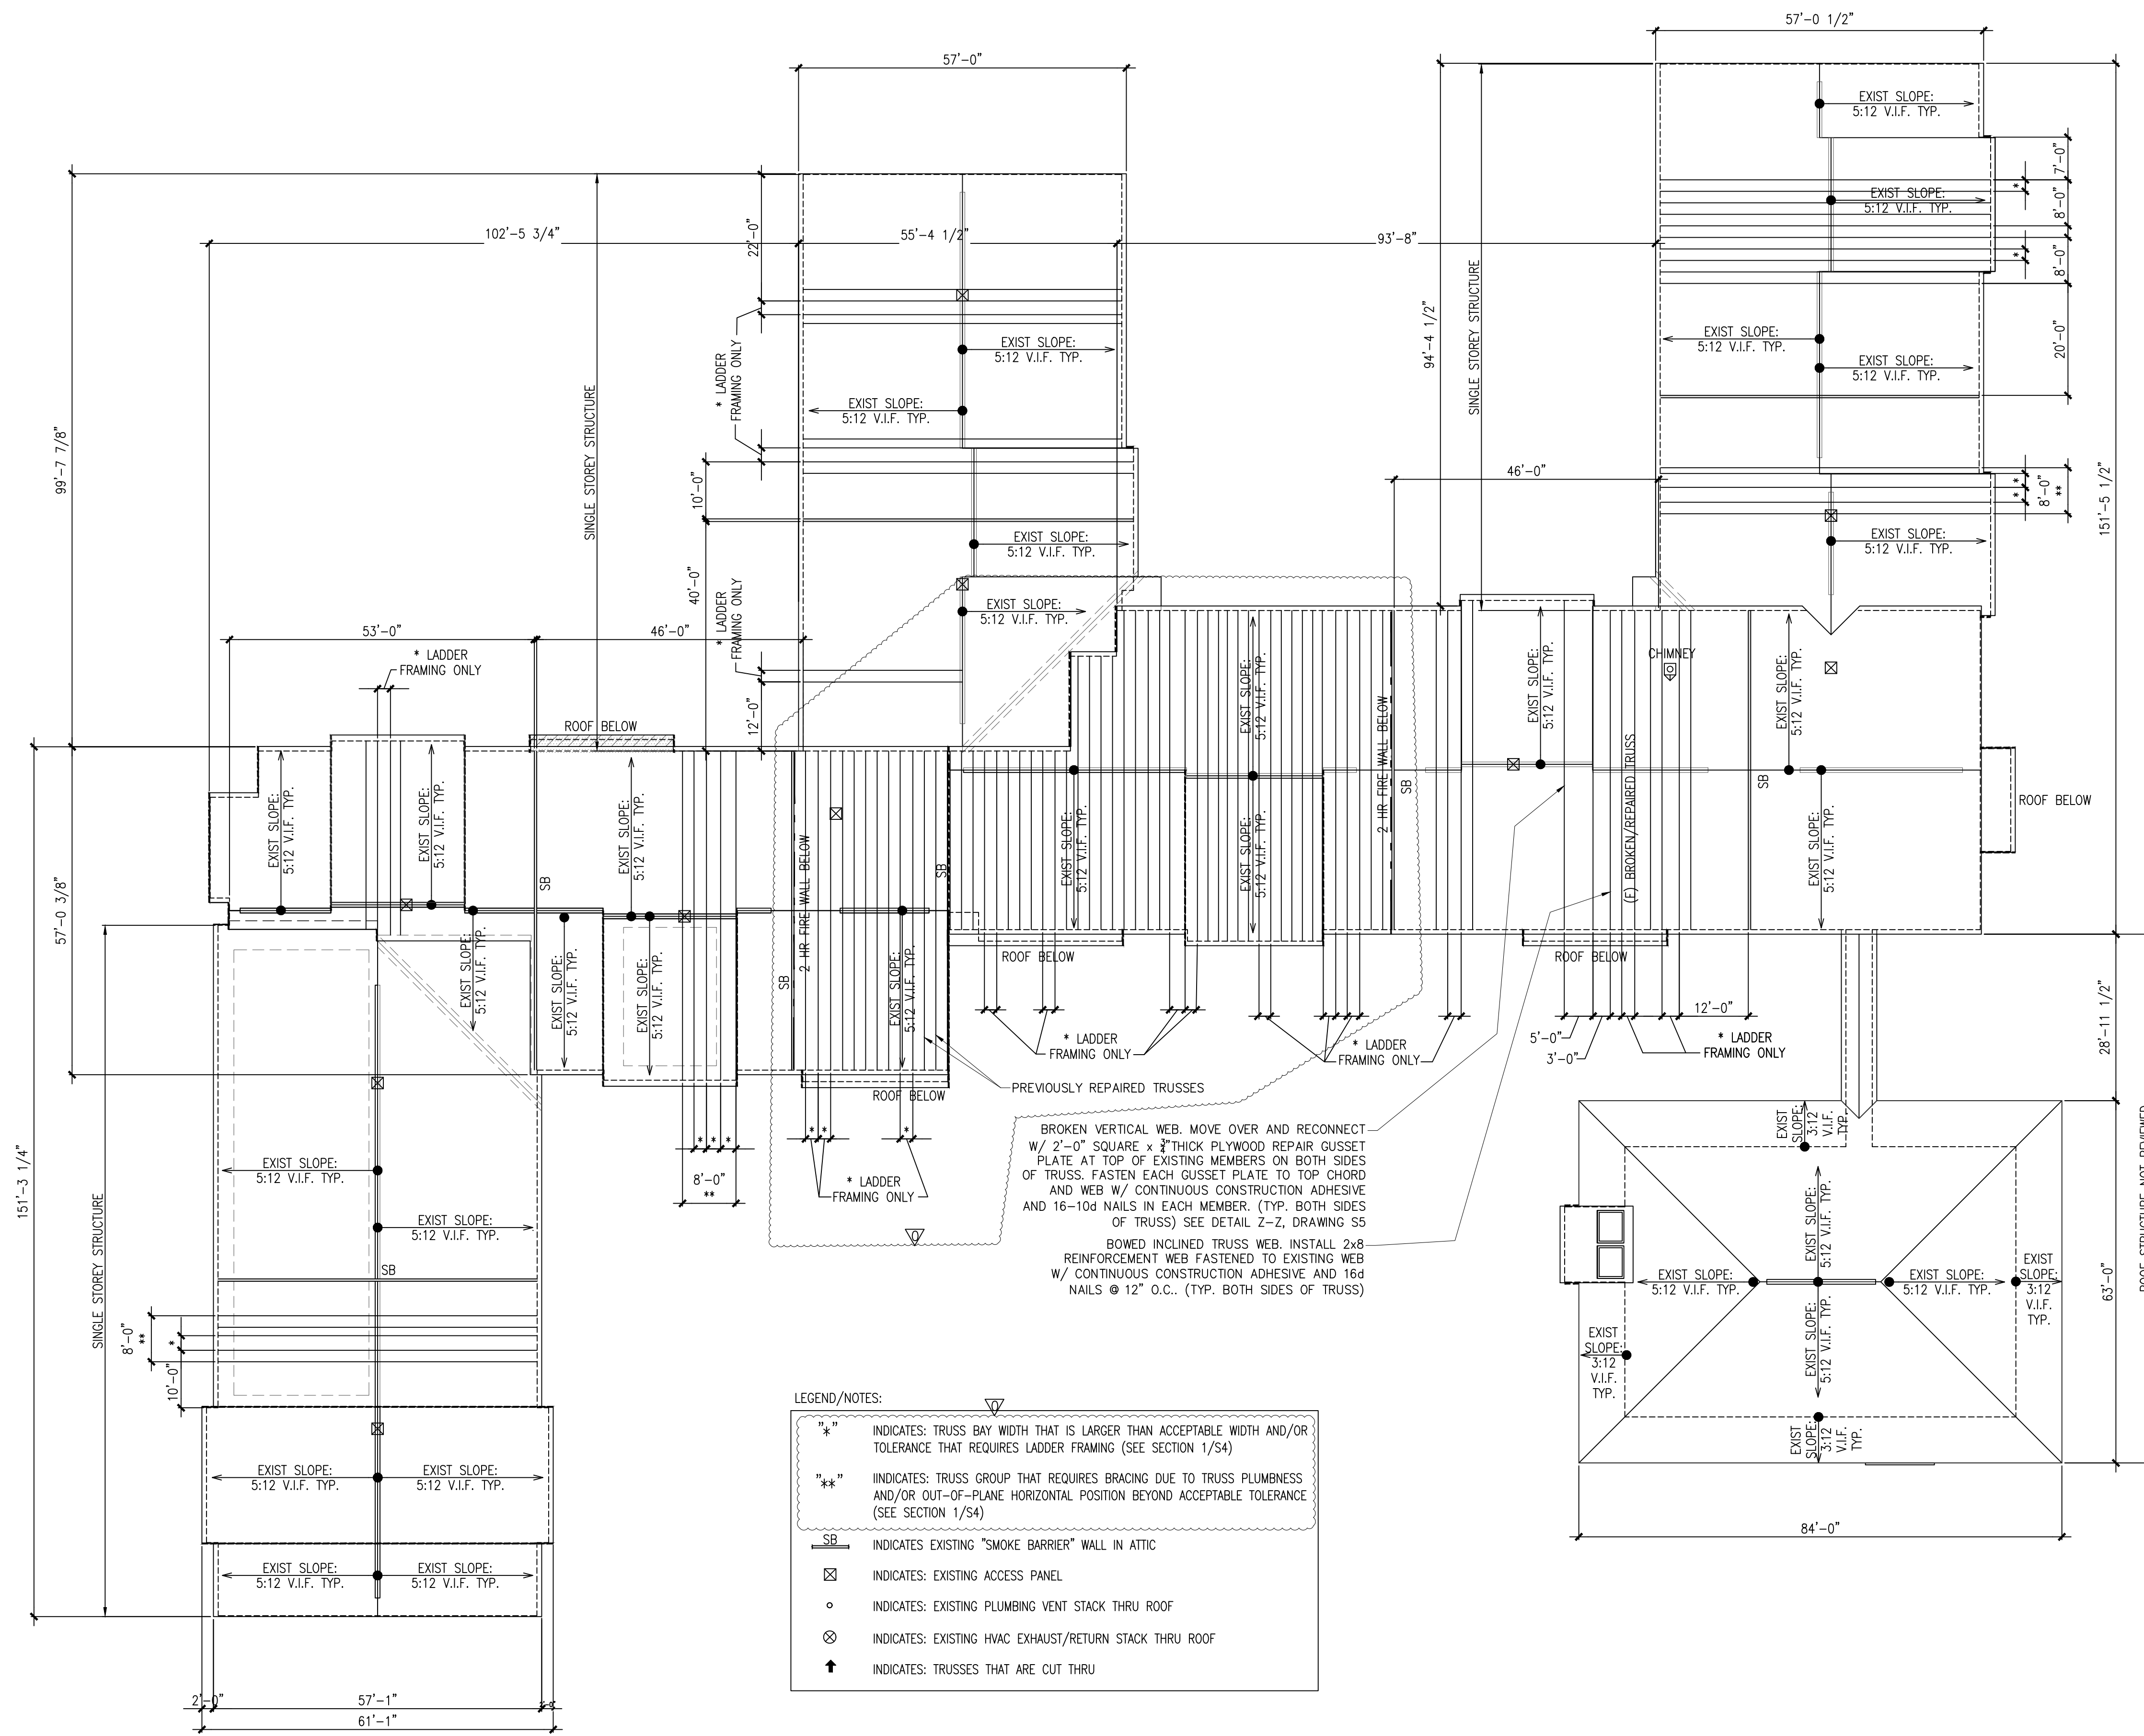
NOTE: ALL DIMENSIONS ARE APPROXIMATE TO LOCATE COMPROMISED TRUSSES ONLY (V.I.F.)
