# Final Report of Structural Special Inspections

Project: *New 3-Unit Building*  
Location: *62 Cumberland Street; Portland Maine*  
Owner: *Eco Capital, LLC*  
Structural Design Professional in  
Responsible Charge: *David A. Price, PE / Price Structural Engineers, Inc.*  
Date: *July 19, 2011*

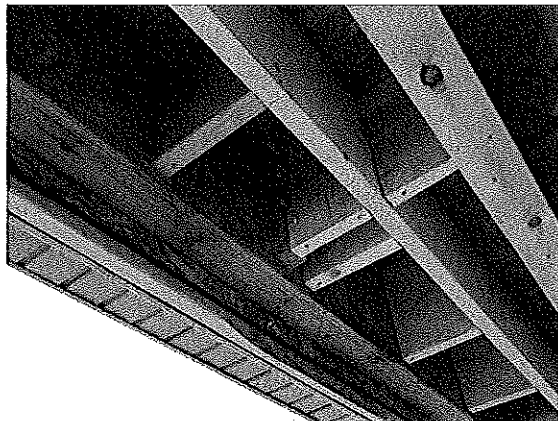
1. A double 2x10 beam supporting the front porch was supported at the east end near the steel column at B/2 by a column underneath, see attached photos.
2. Pressure -treated door jambs were observed adjacent to the garage door openings, see attached photos.
3. Guardrail post anchorage connections were reinforced, see attached photos.
4. The stair stringers at the primary stair were relocated and connected directly to the existing VLAM beam with approved hangers, see attached photos.
5. The beam extending between grid B/5 and B/6 was reinforced with a Versalam sister, see attached photos.
6. The triple 2x beam at the west side of the elevator was connected with beam hangers at each end, see attached photos.
7. The center stringer leading to the 3<sup>rd</sup> floor had a ledger underneath at the connection near the top of the stair, see attached photos.

Photo #12 – Similar area as previous
