Re: Special Inspections Final Report
645 Congress St.
Portland, Maine

Final Report of Structural Special Inspections

Project: *Renovations to 645 Congress Street*
Location: *645 Congress Street; Portland Maine*
Owner: *Bayside Maine, LLC*

Structural Design Professional in
Responsible Charge: *David A. Price, PE / Price Structural Engineers, Inc.*

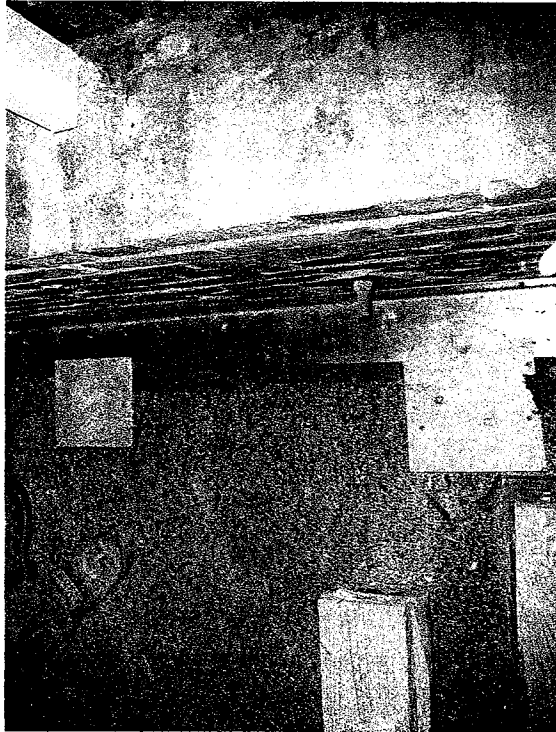
Photo #4 – Grid F.1/9.5 sawcut slab (Photo rotated 90 deg.)

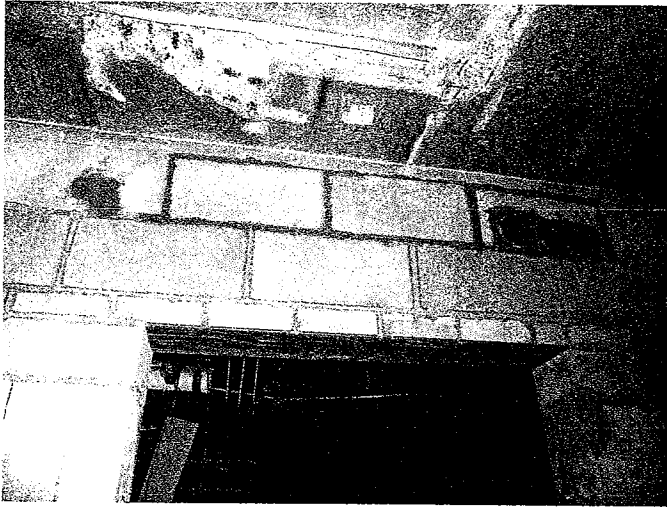
Photo # 7 Basement Lintel @ Grid F.5/2.5 (Looking North)
